# Seismic Performance of Buried Cables and Pot Heads

John Eiding

G&E Engineering Systems Inc.

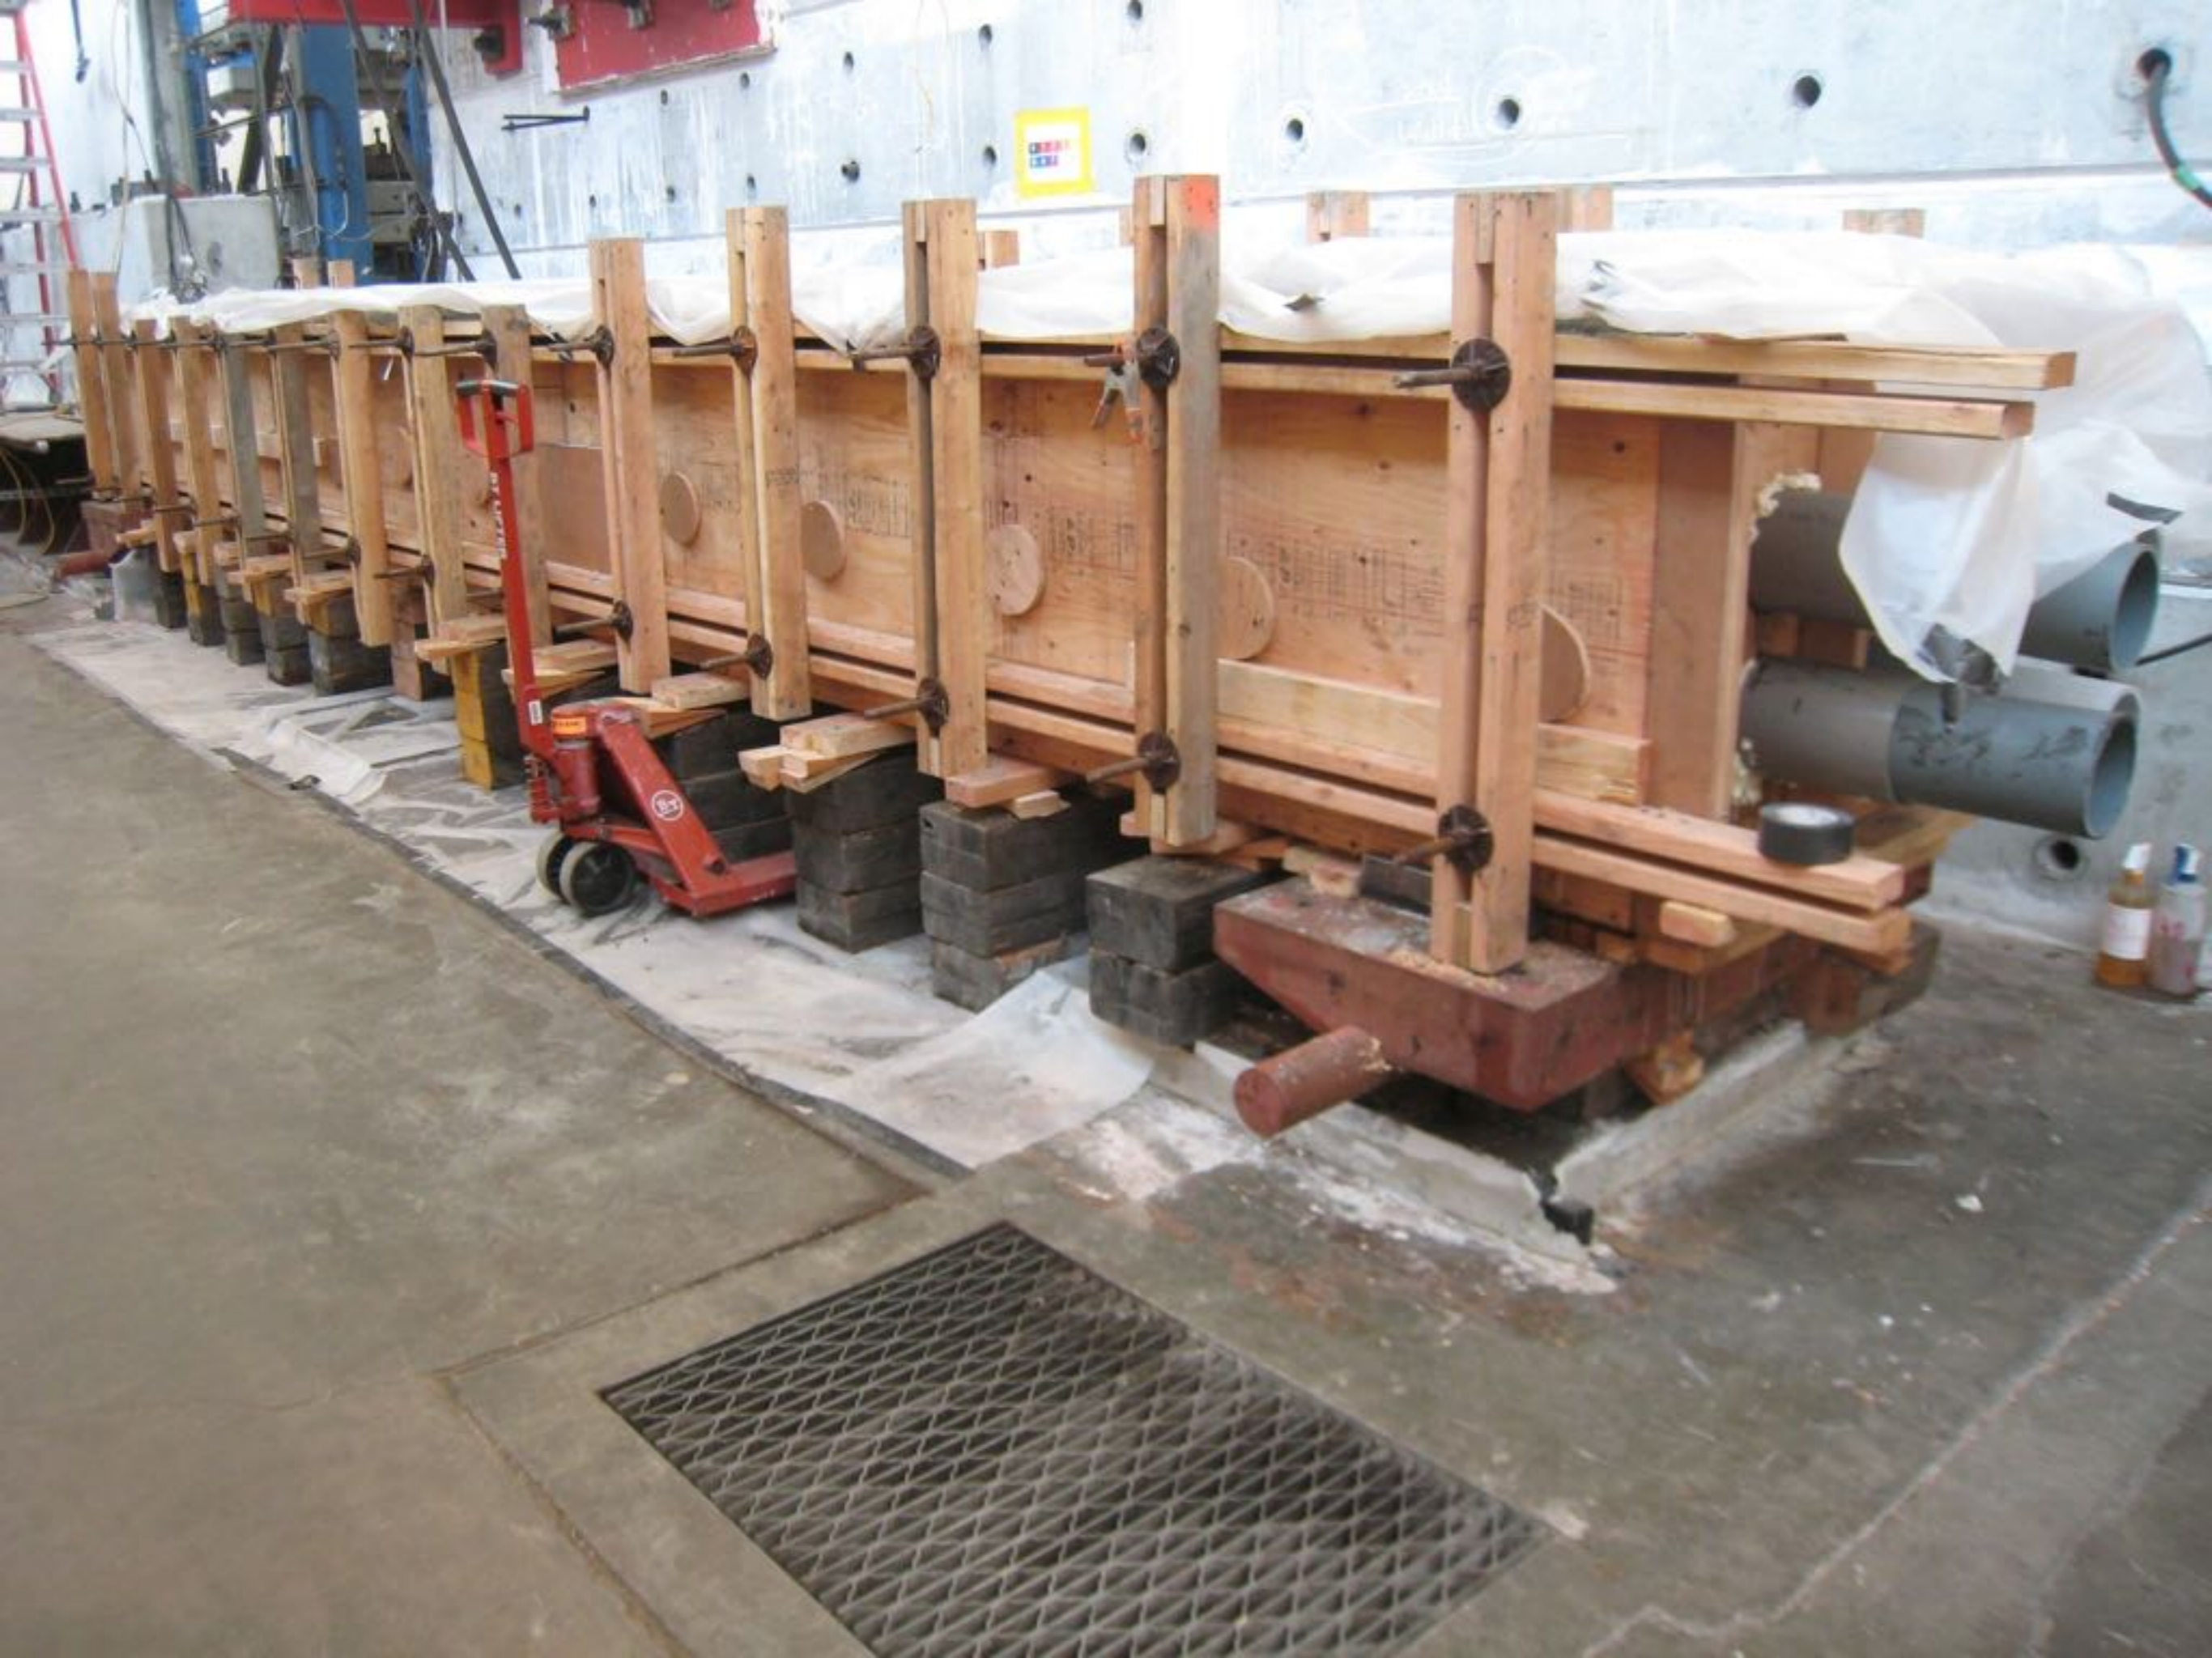
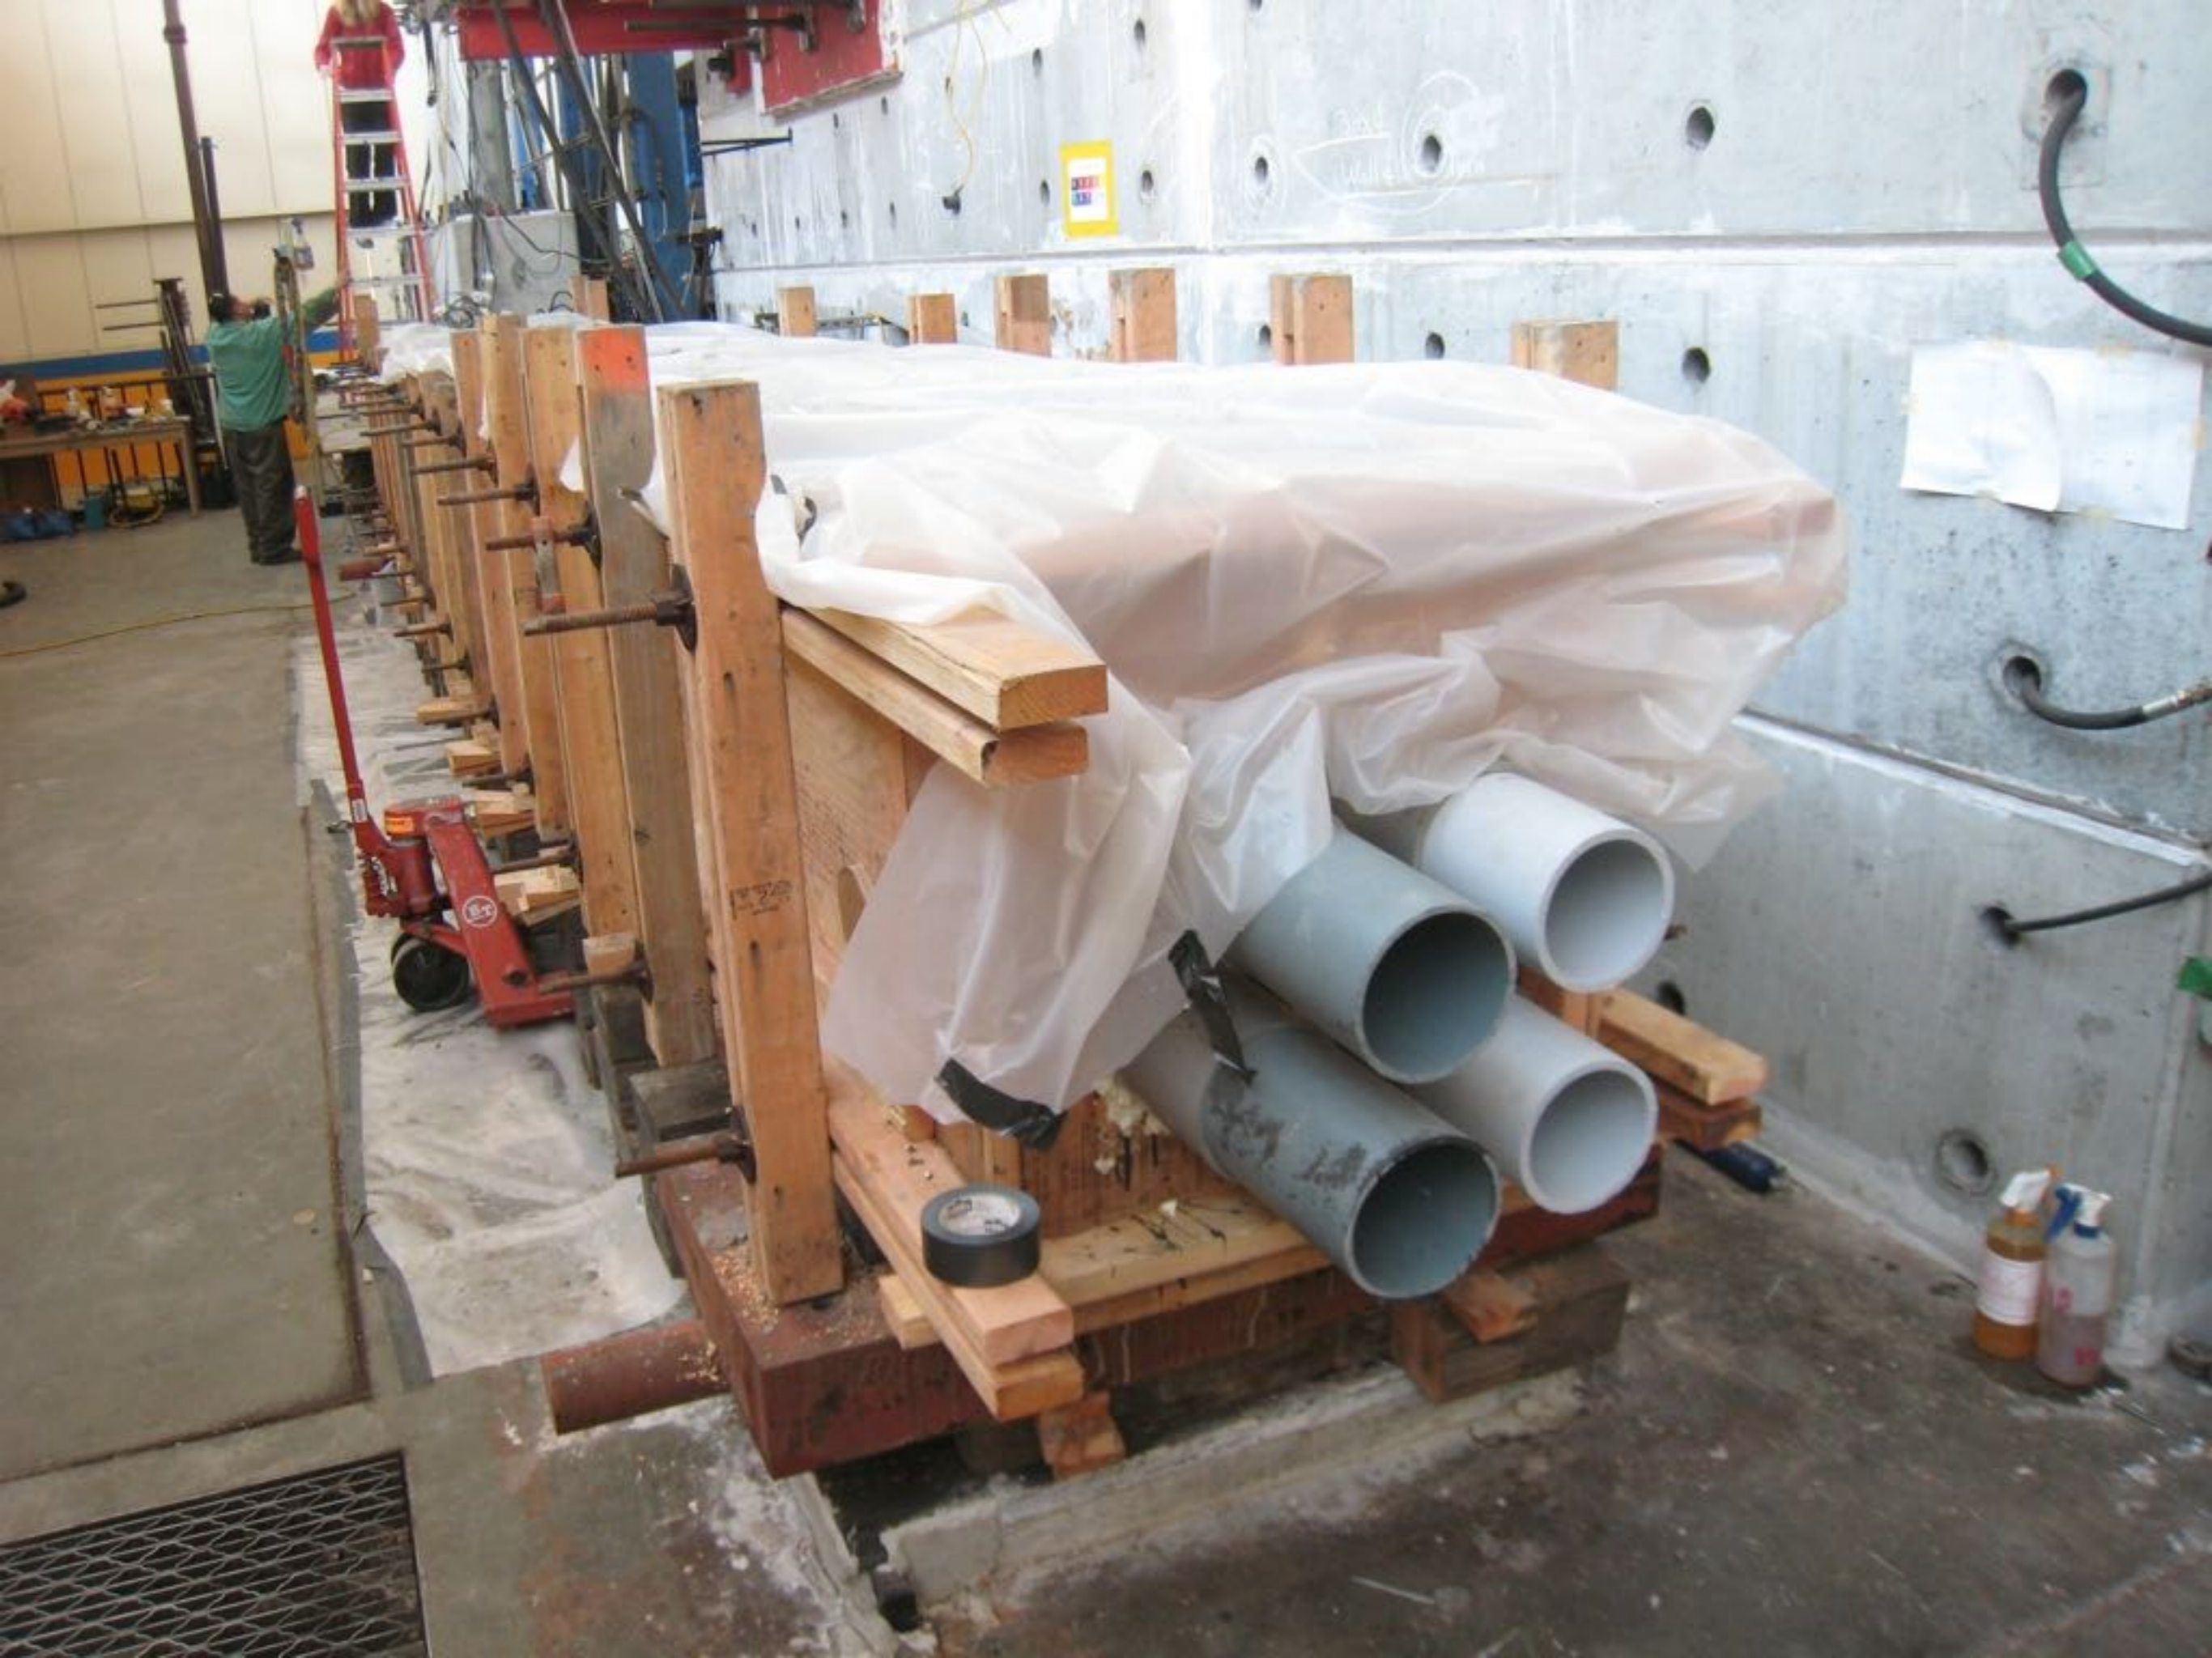
# Full-scale Test 31"x 34" Cross-section

\* The duct bank beam has almost no resistance to bending after initial cracking. Conduit susceptible to shear offset displacement at cracks.

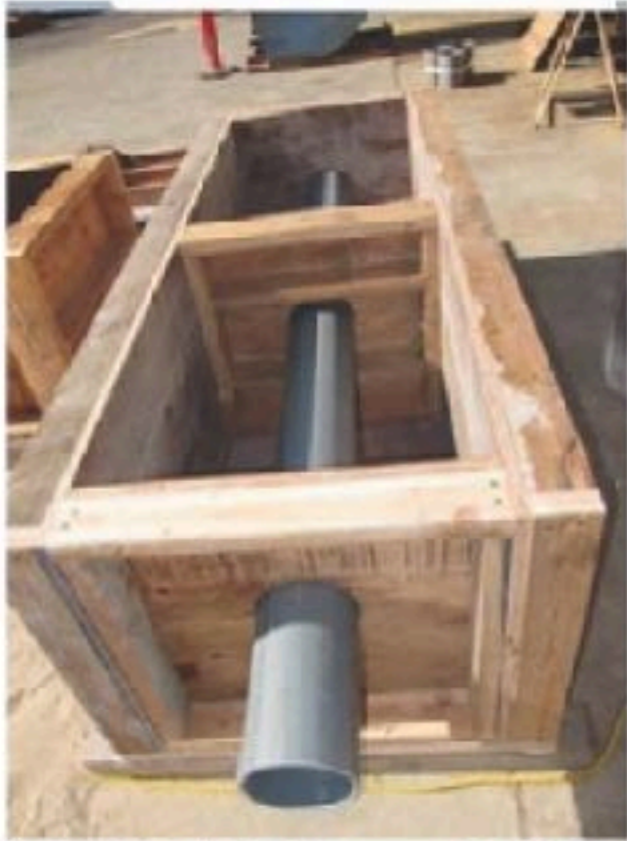
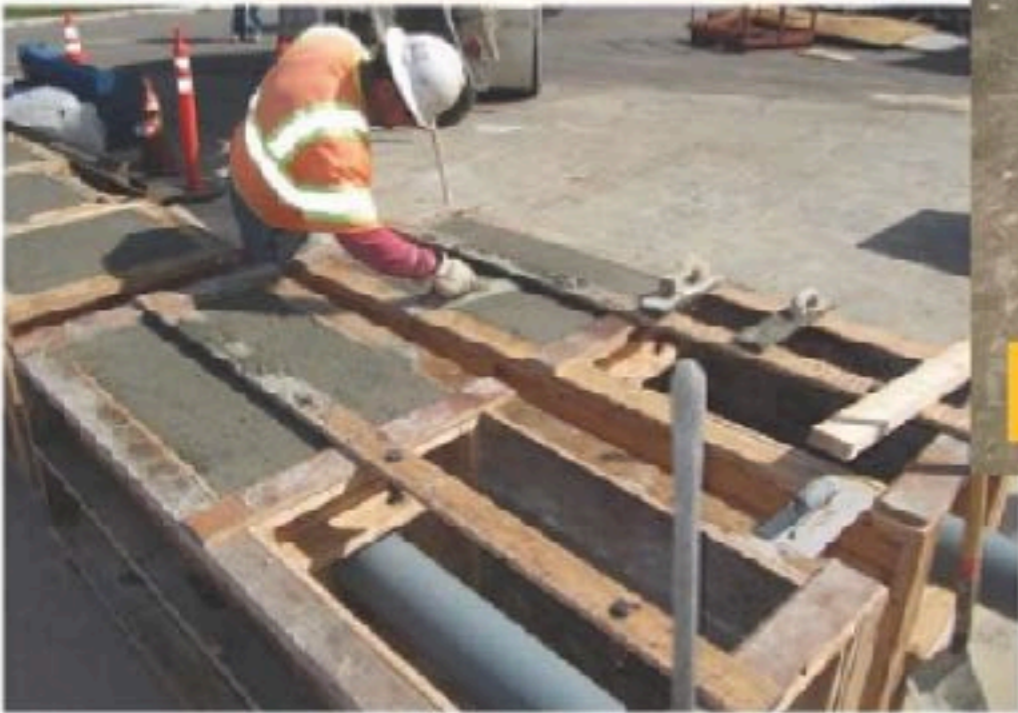
# Shear Offset Test

| Test | Gap (inches) | Ultimate force (kips) | Displacement at Failure (inches) |
|---|---|---|---|
| #2 | 1/8 | 22.6 | 1.76 |

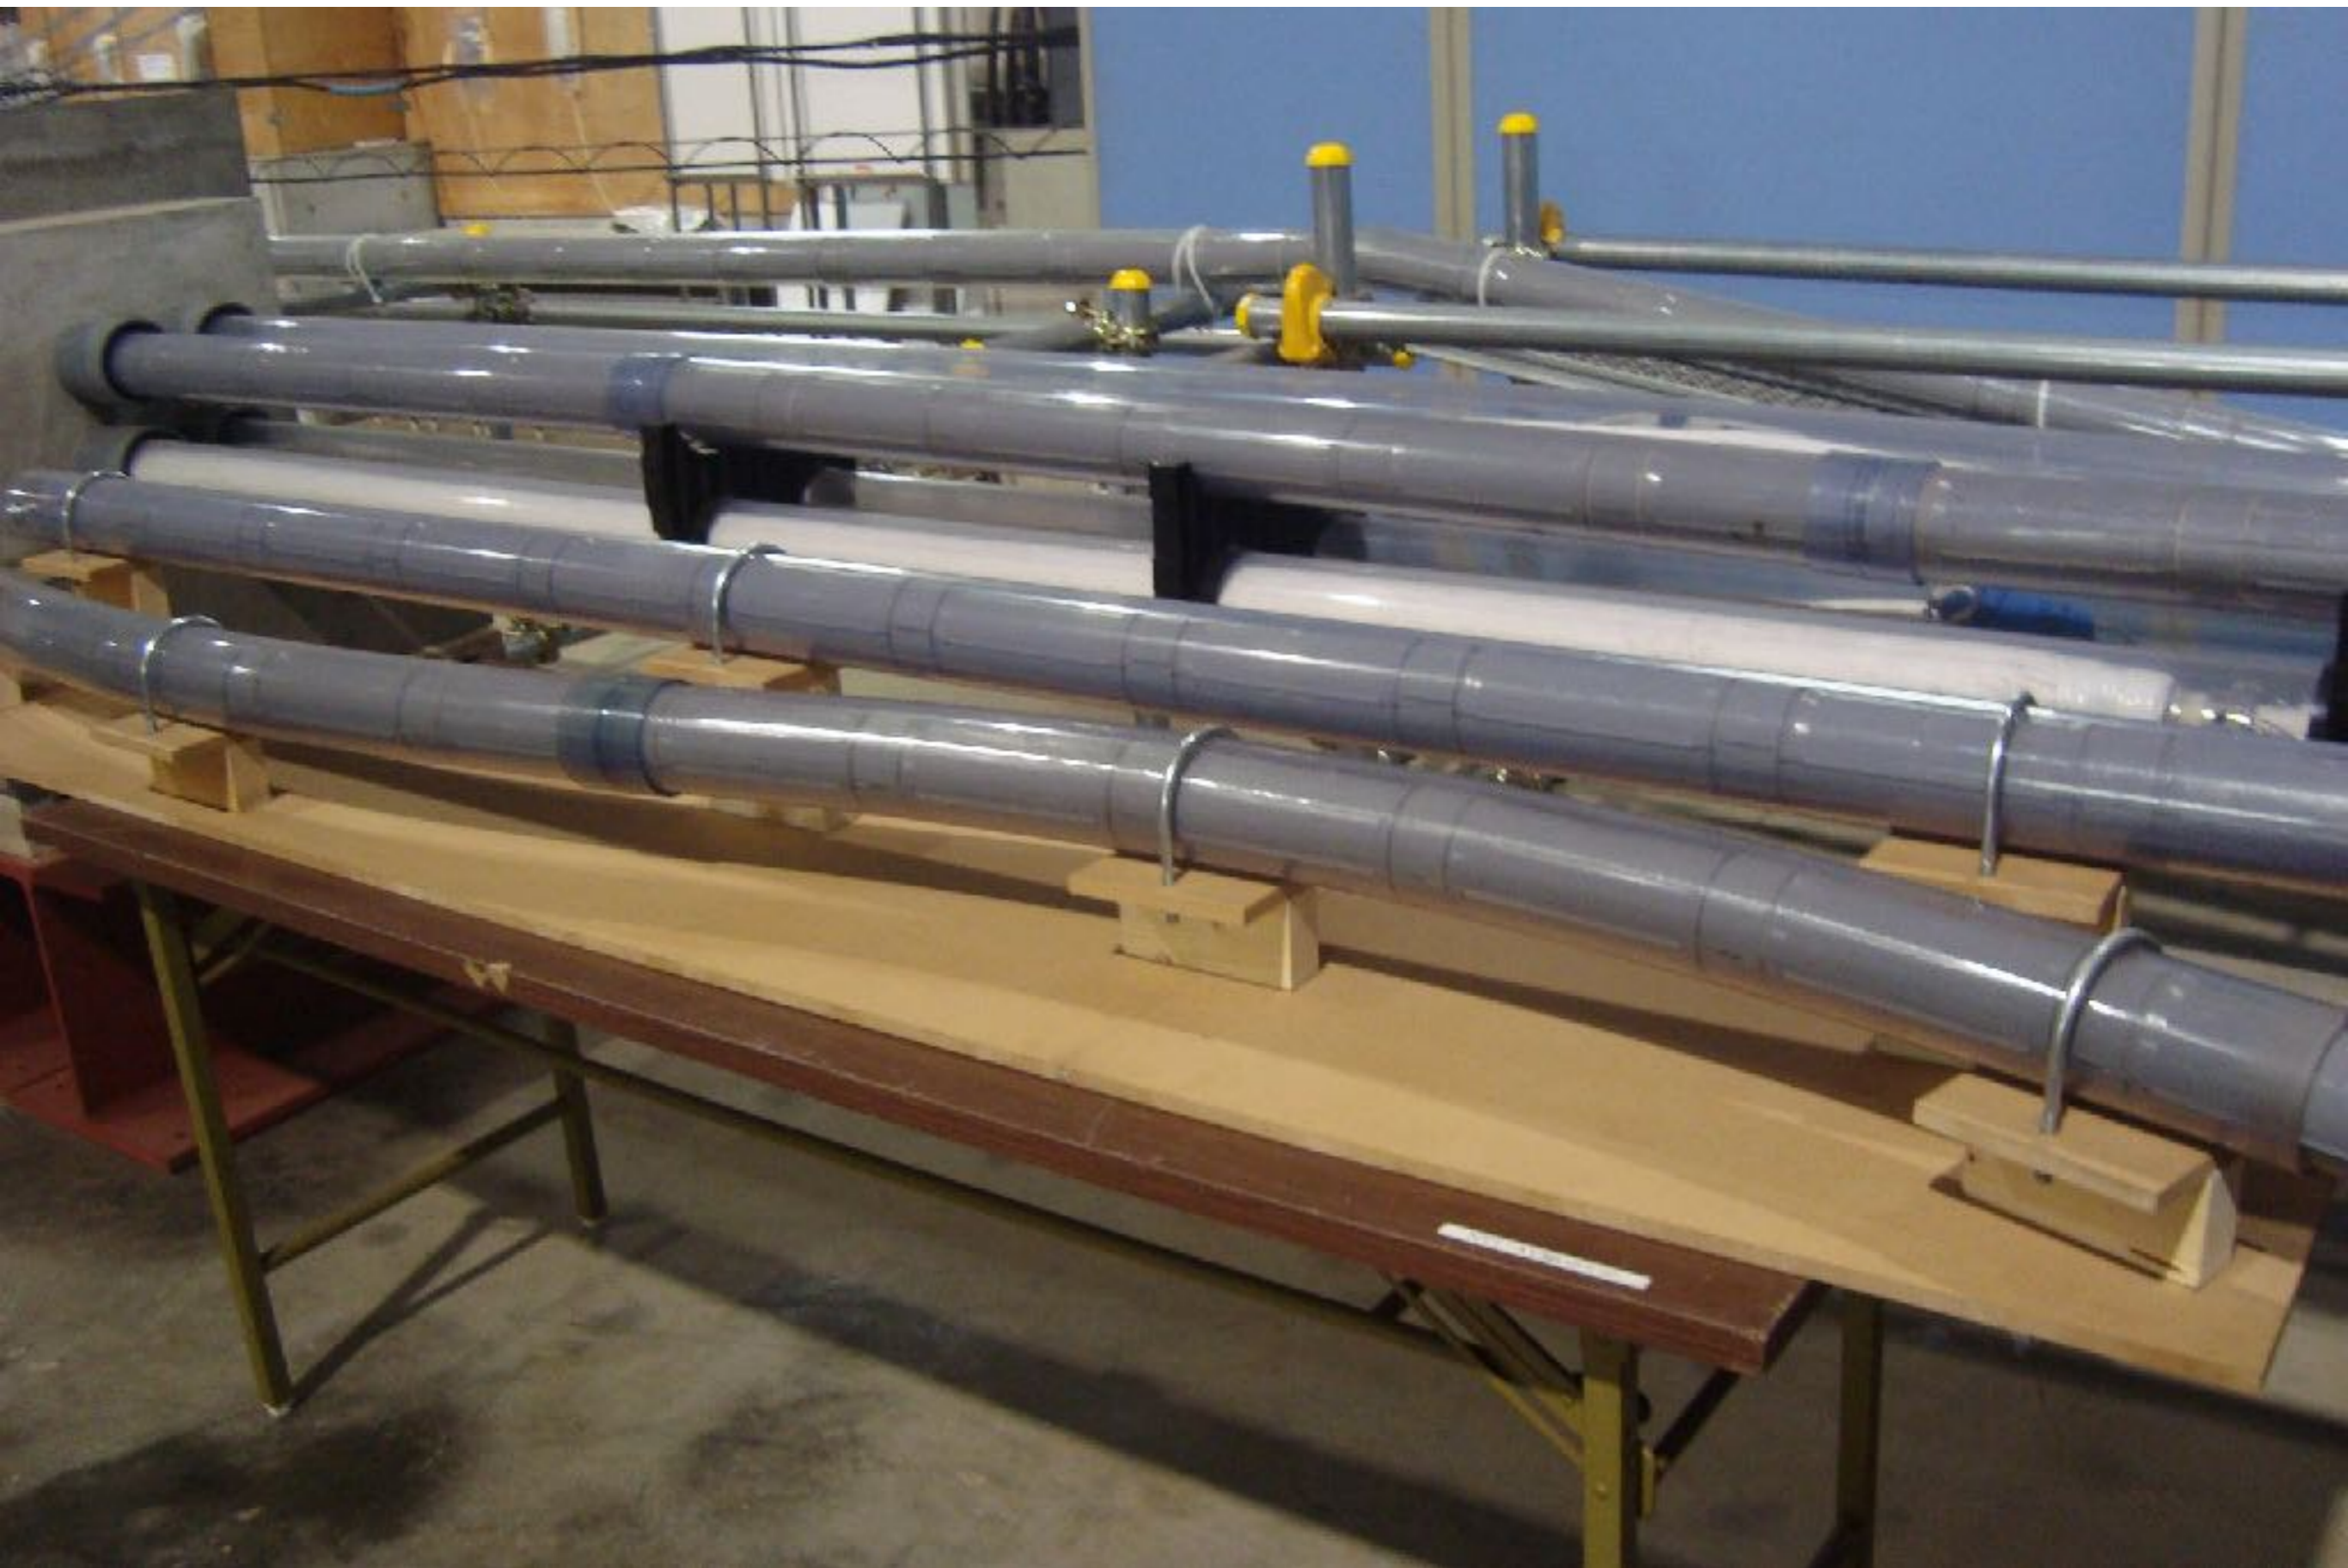
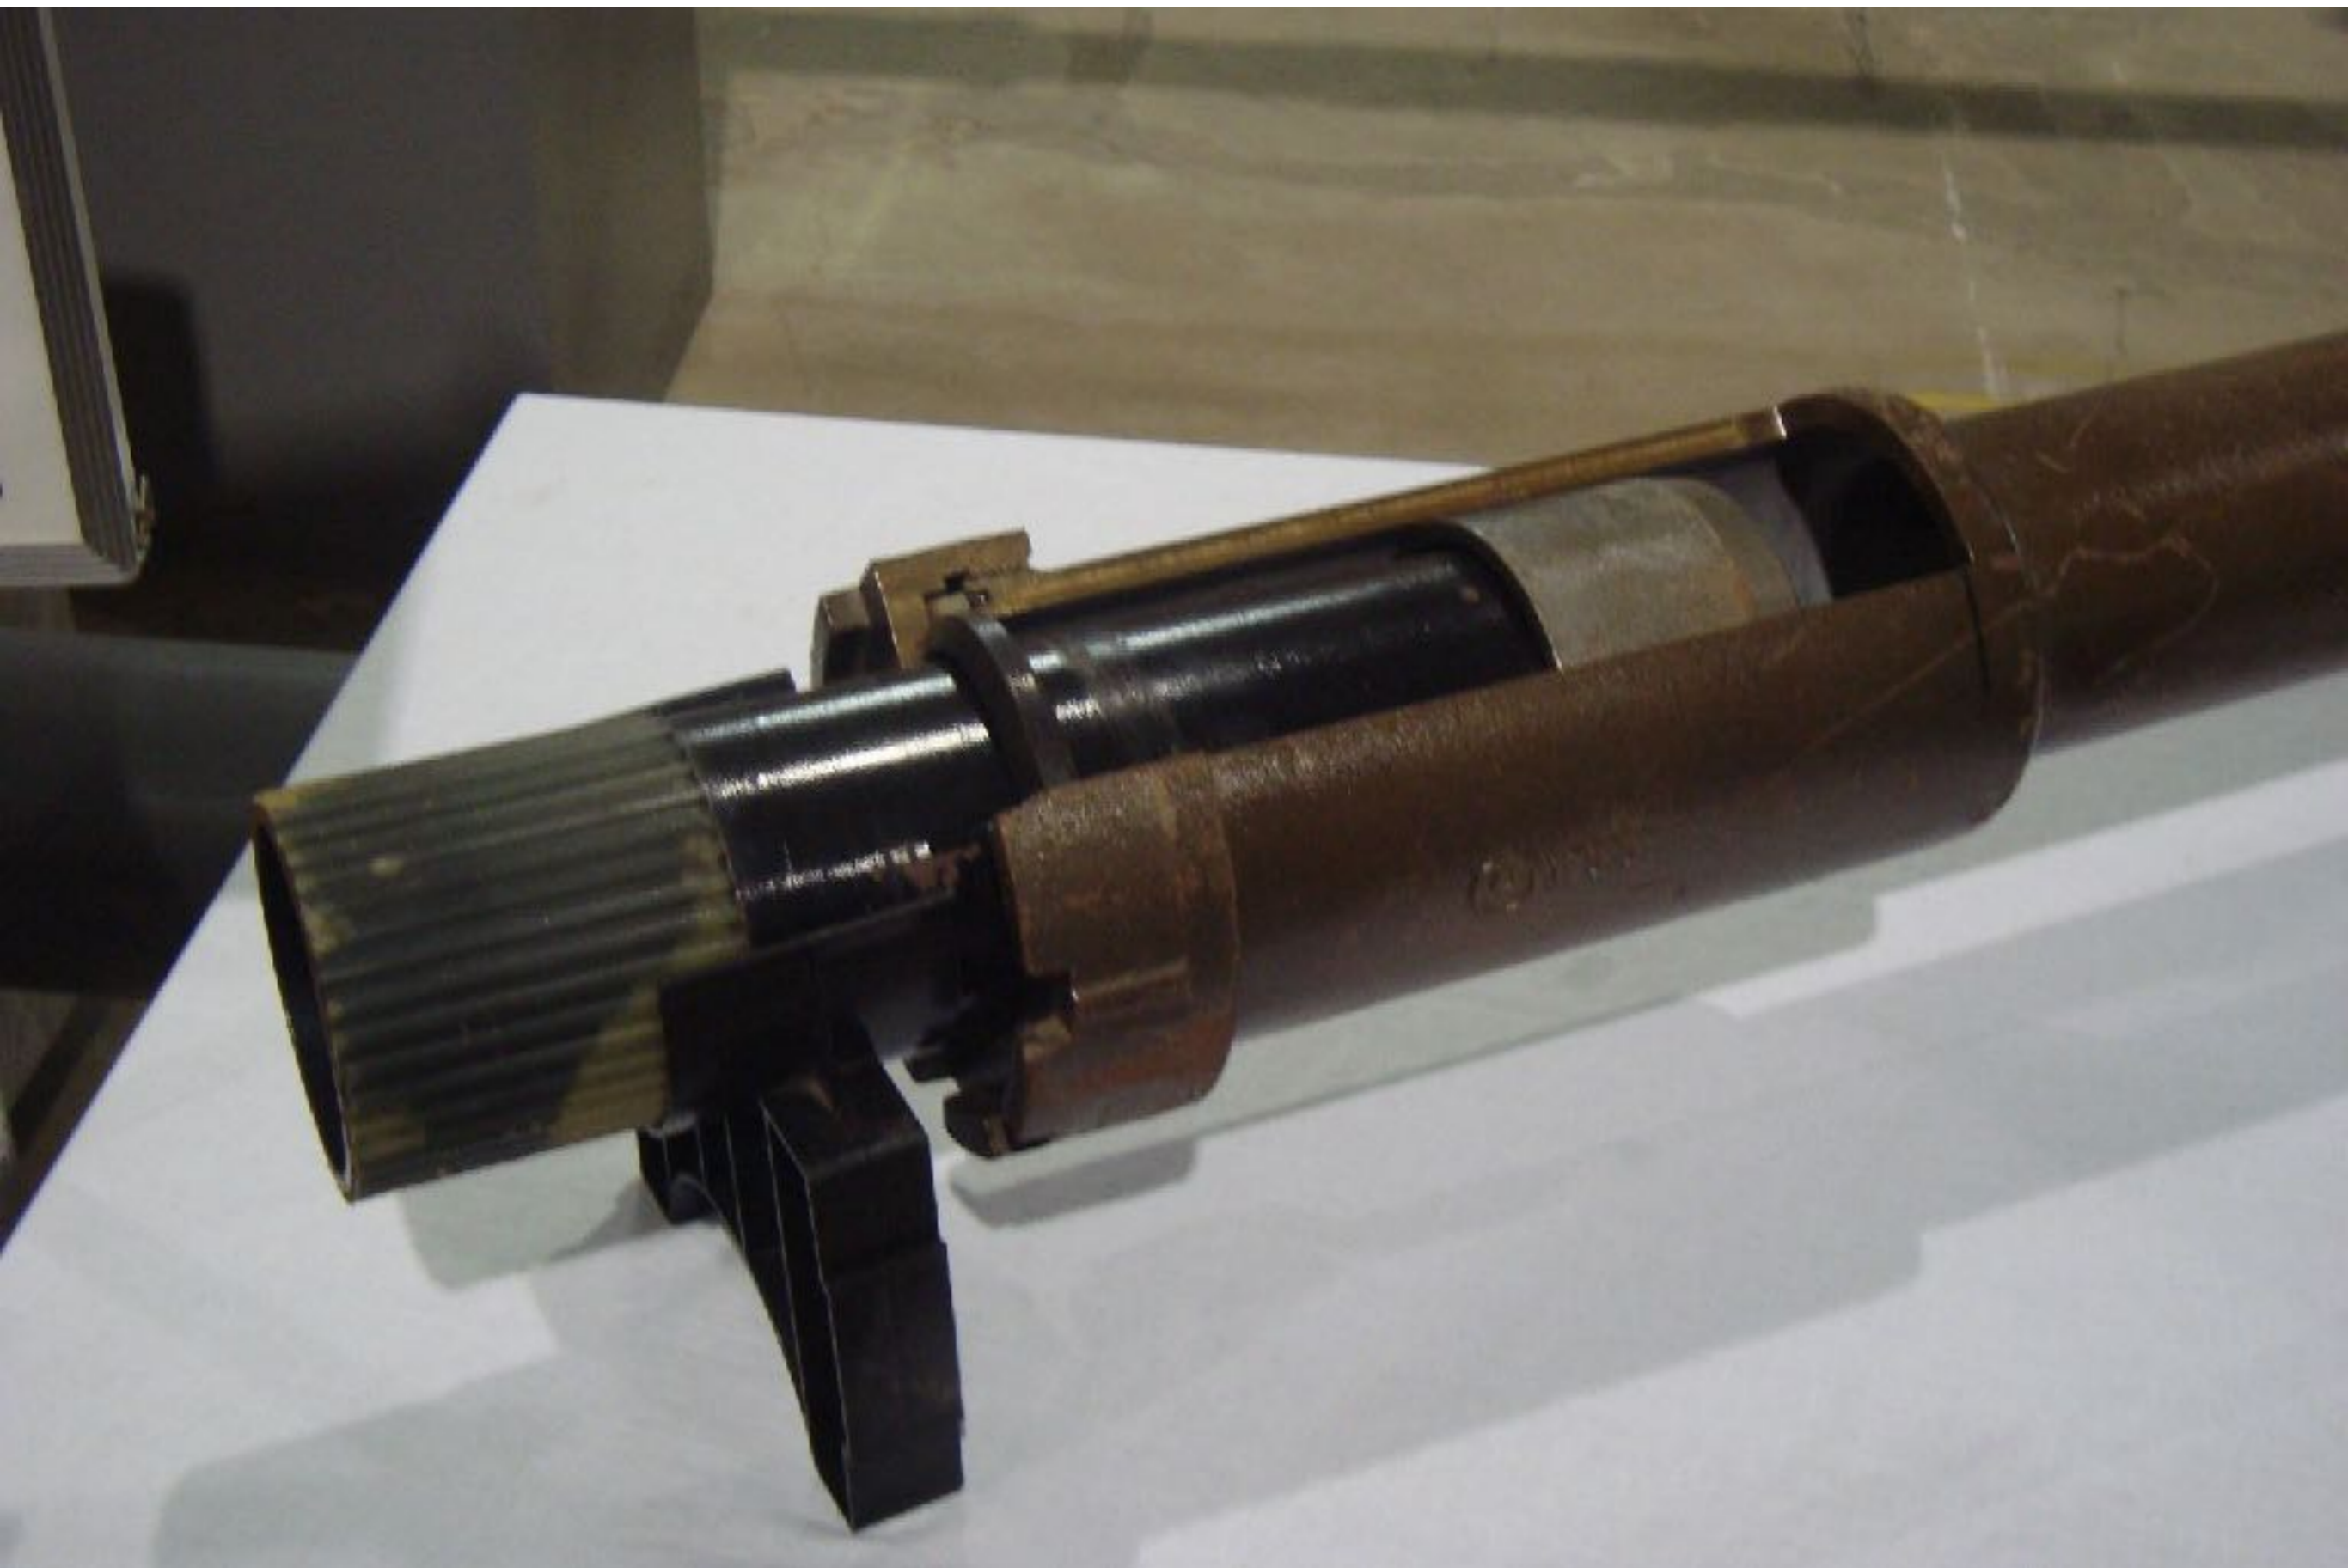
# NTT Telecommunication Research Lab, Tsukuba

- NTT does not bury their cables without a conduit
- Telecom cables bundles and power cable bundles are in separate conduits
- Moisture and telecom cables cannot co-exist particularly optical fiber cables
