Christchurch, Feb 22 2011 and Sept 4 2010

John Eiding  
G&E Engineering Systems Inc.  
[eidinger@geEngineeringSystems.com](mailto:eidinger@geEngineeringSystems.com)

## Impact to Electric Power Systems

ASCE - Structural Congress

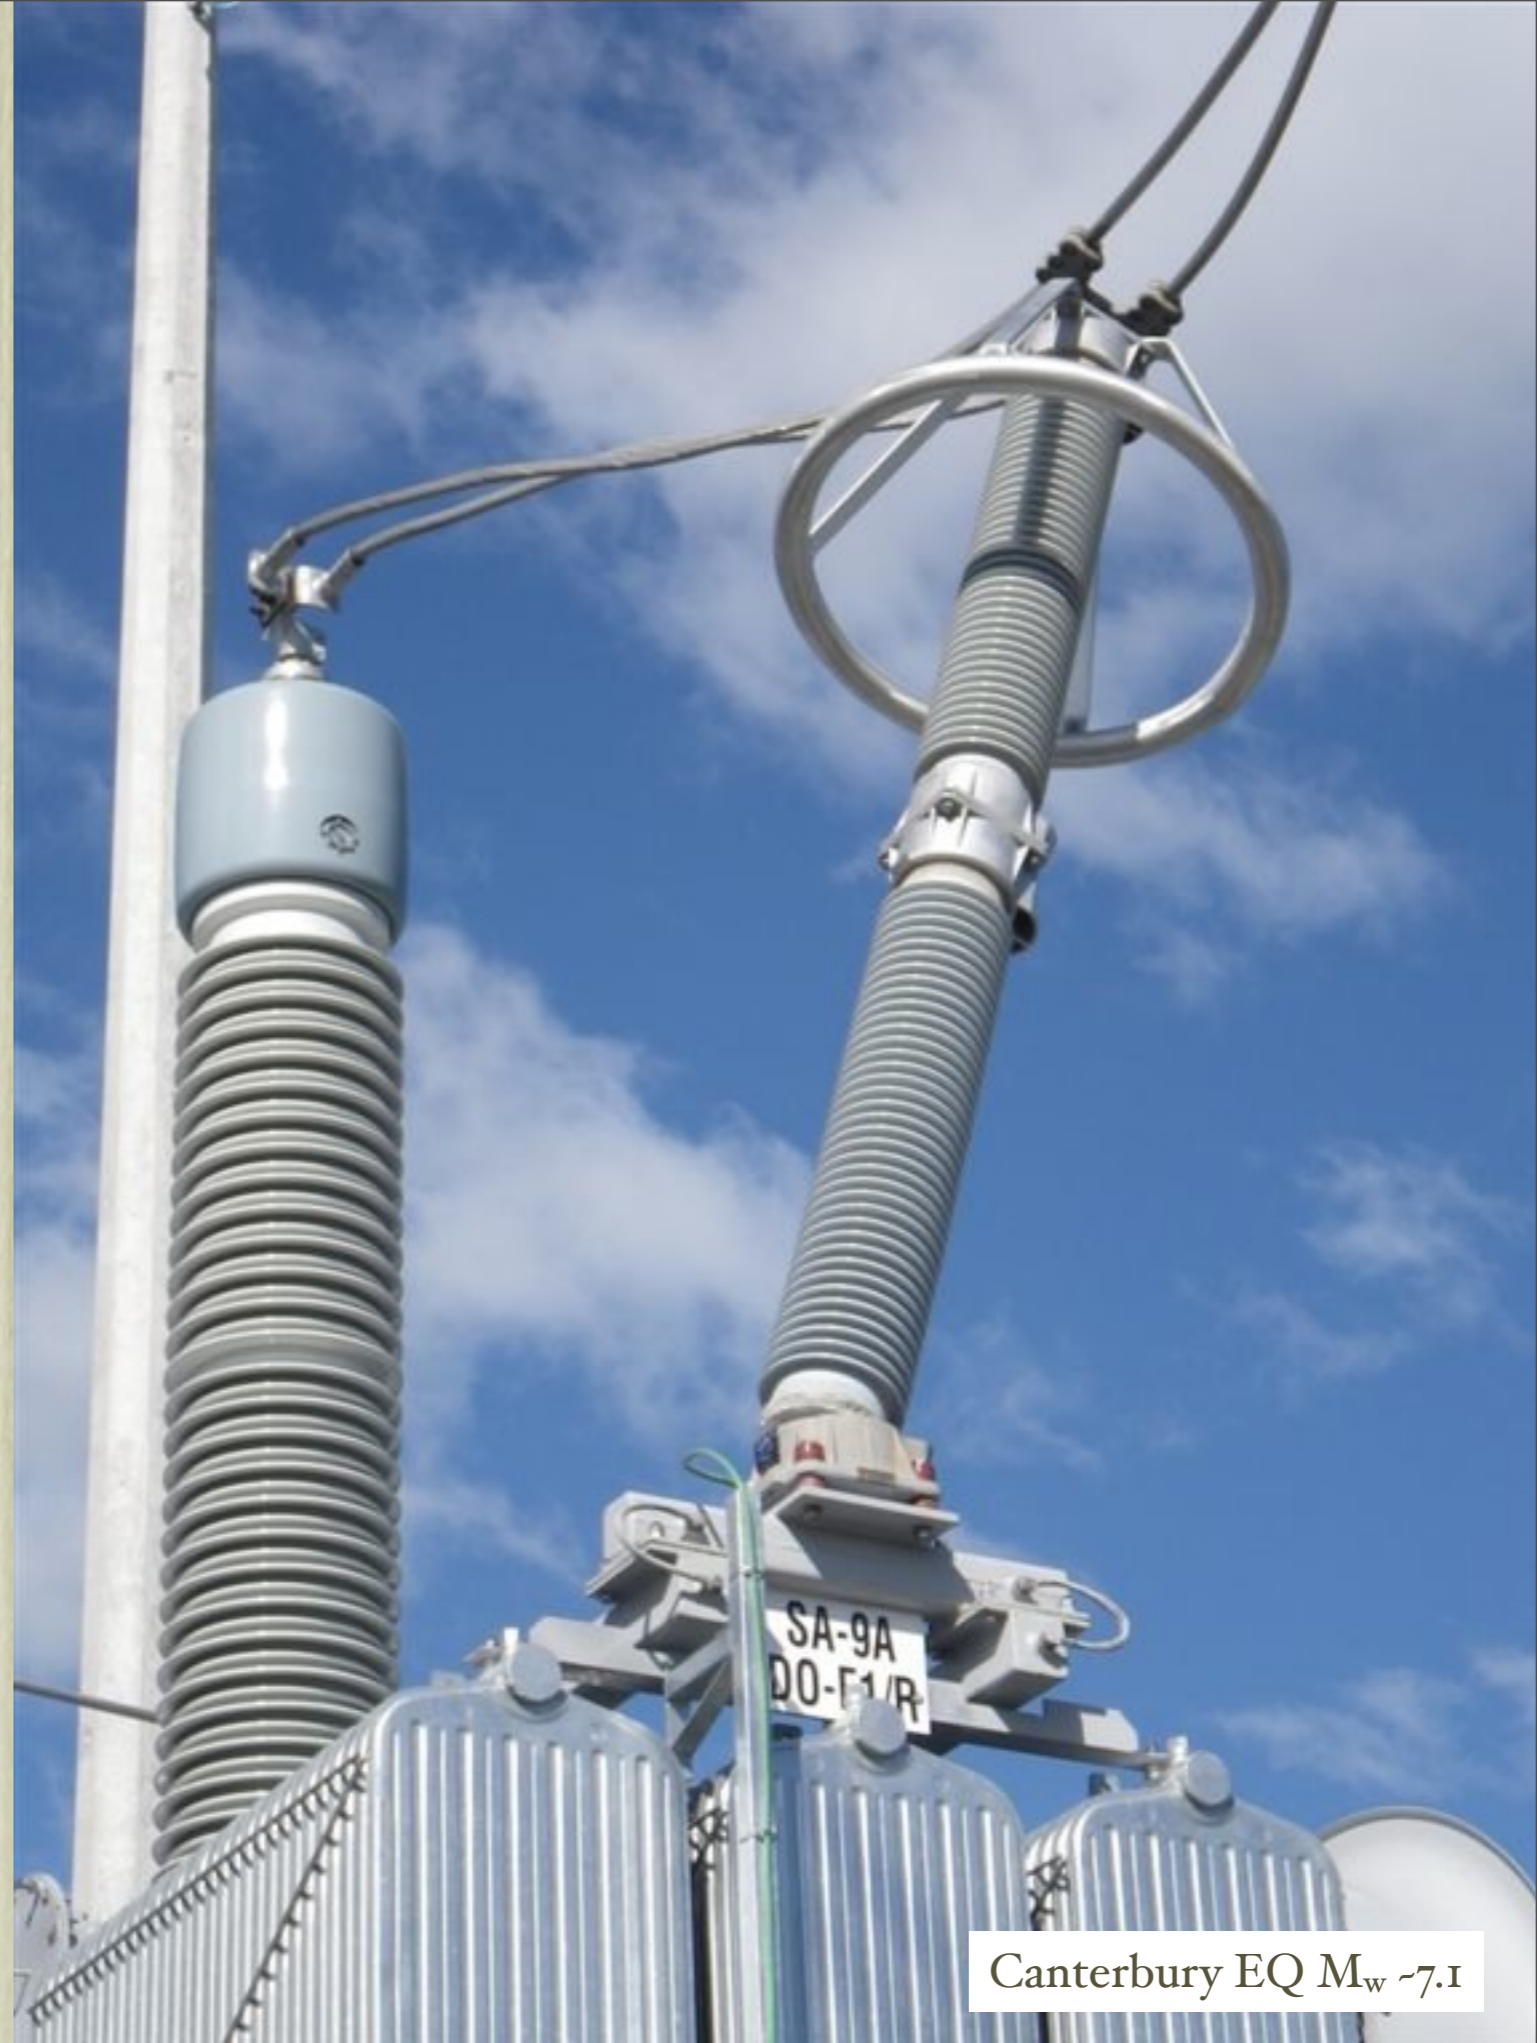
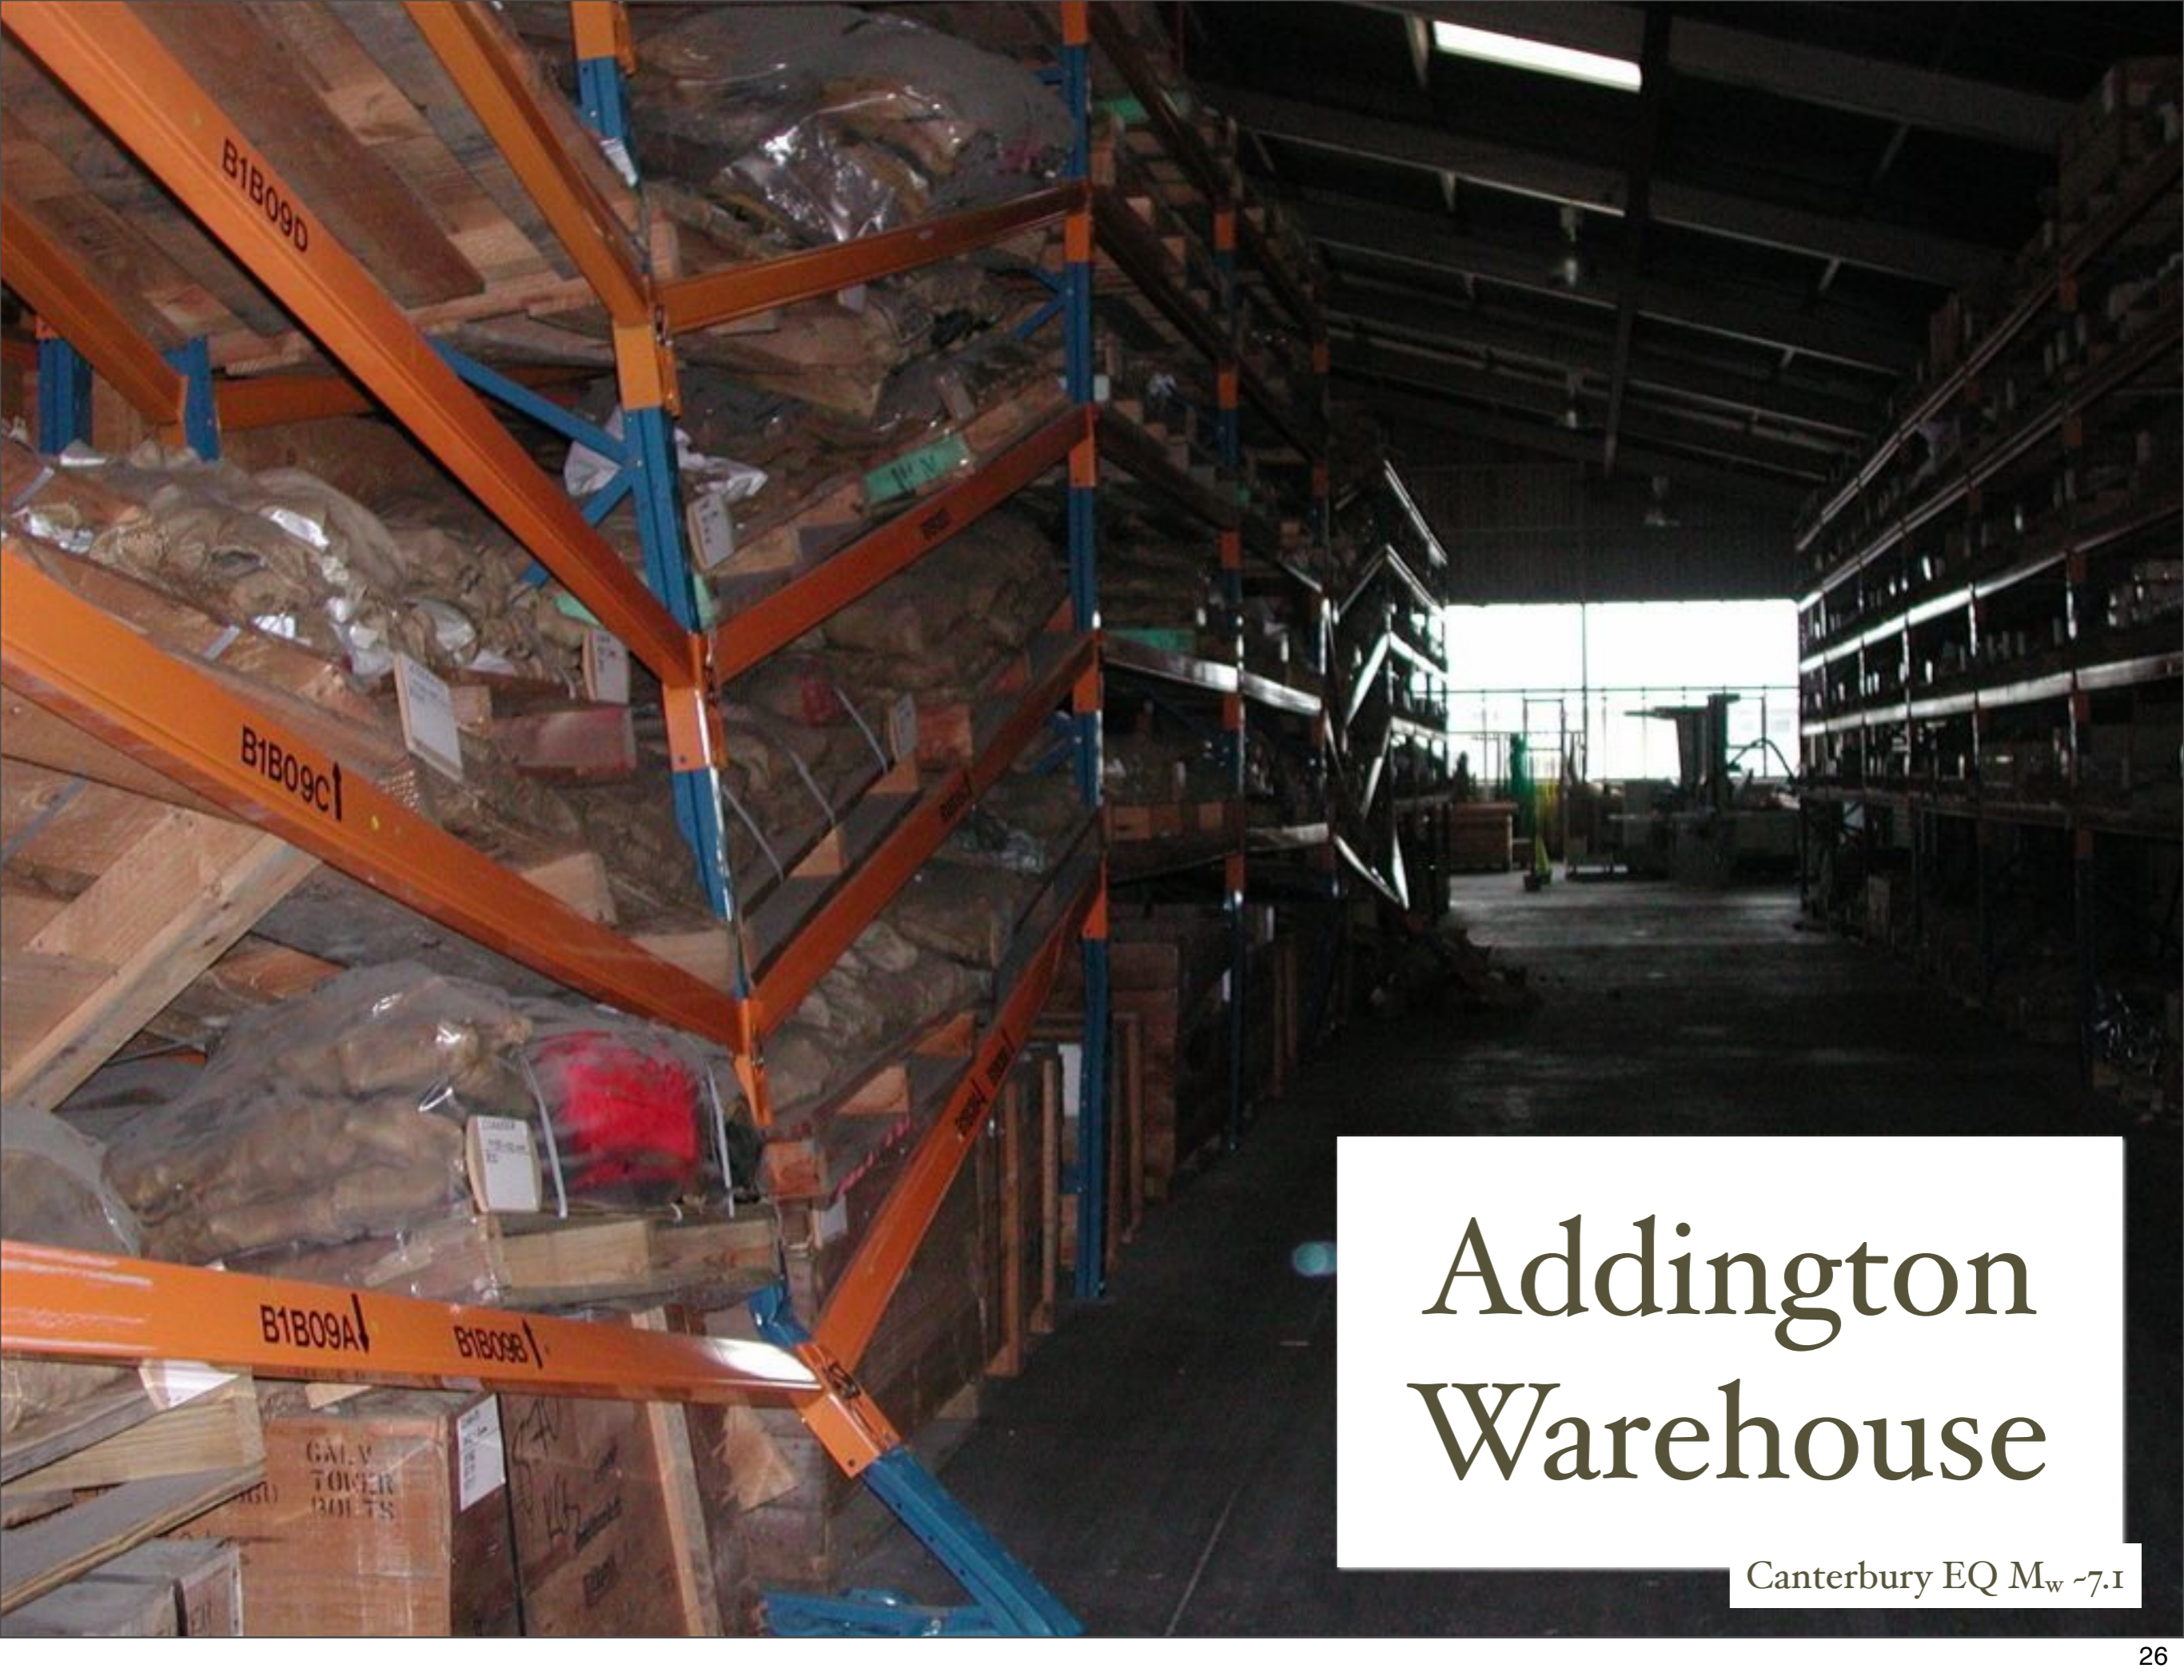
2010: Islington  
(PGA ~0.20g - 0.25g)

220 kV SA Broken  
220 Bushing OK  
SA failure found 2 days  
later. SA replacement is  
identical.

Cracks in wall and floor of battery room

Holding bolts sheared off for roof  
support frame at Condenser Building

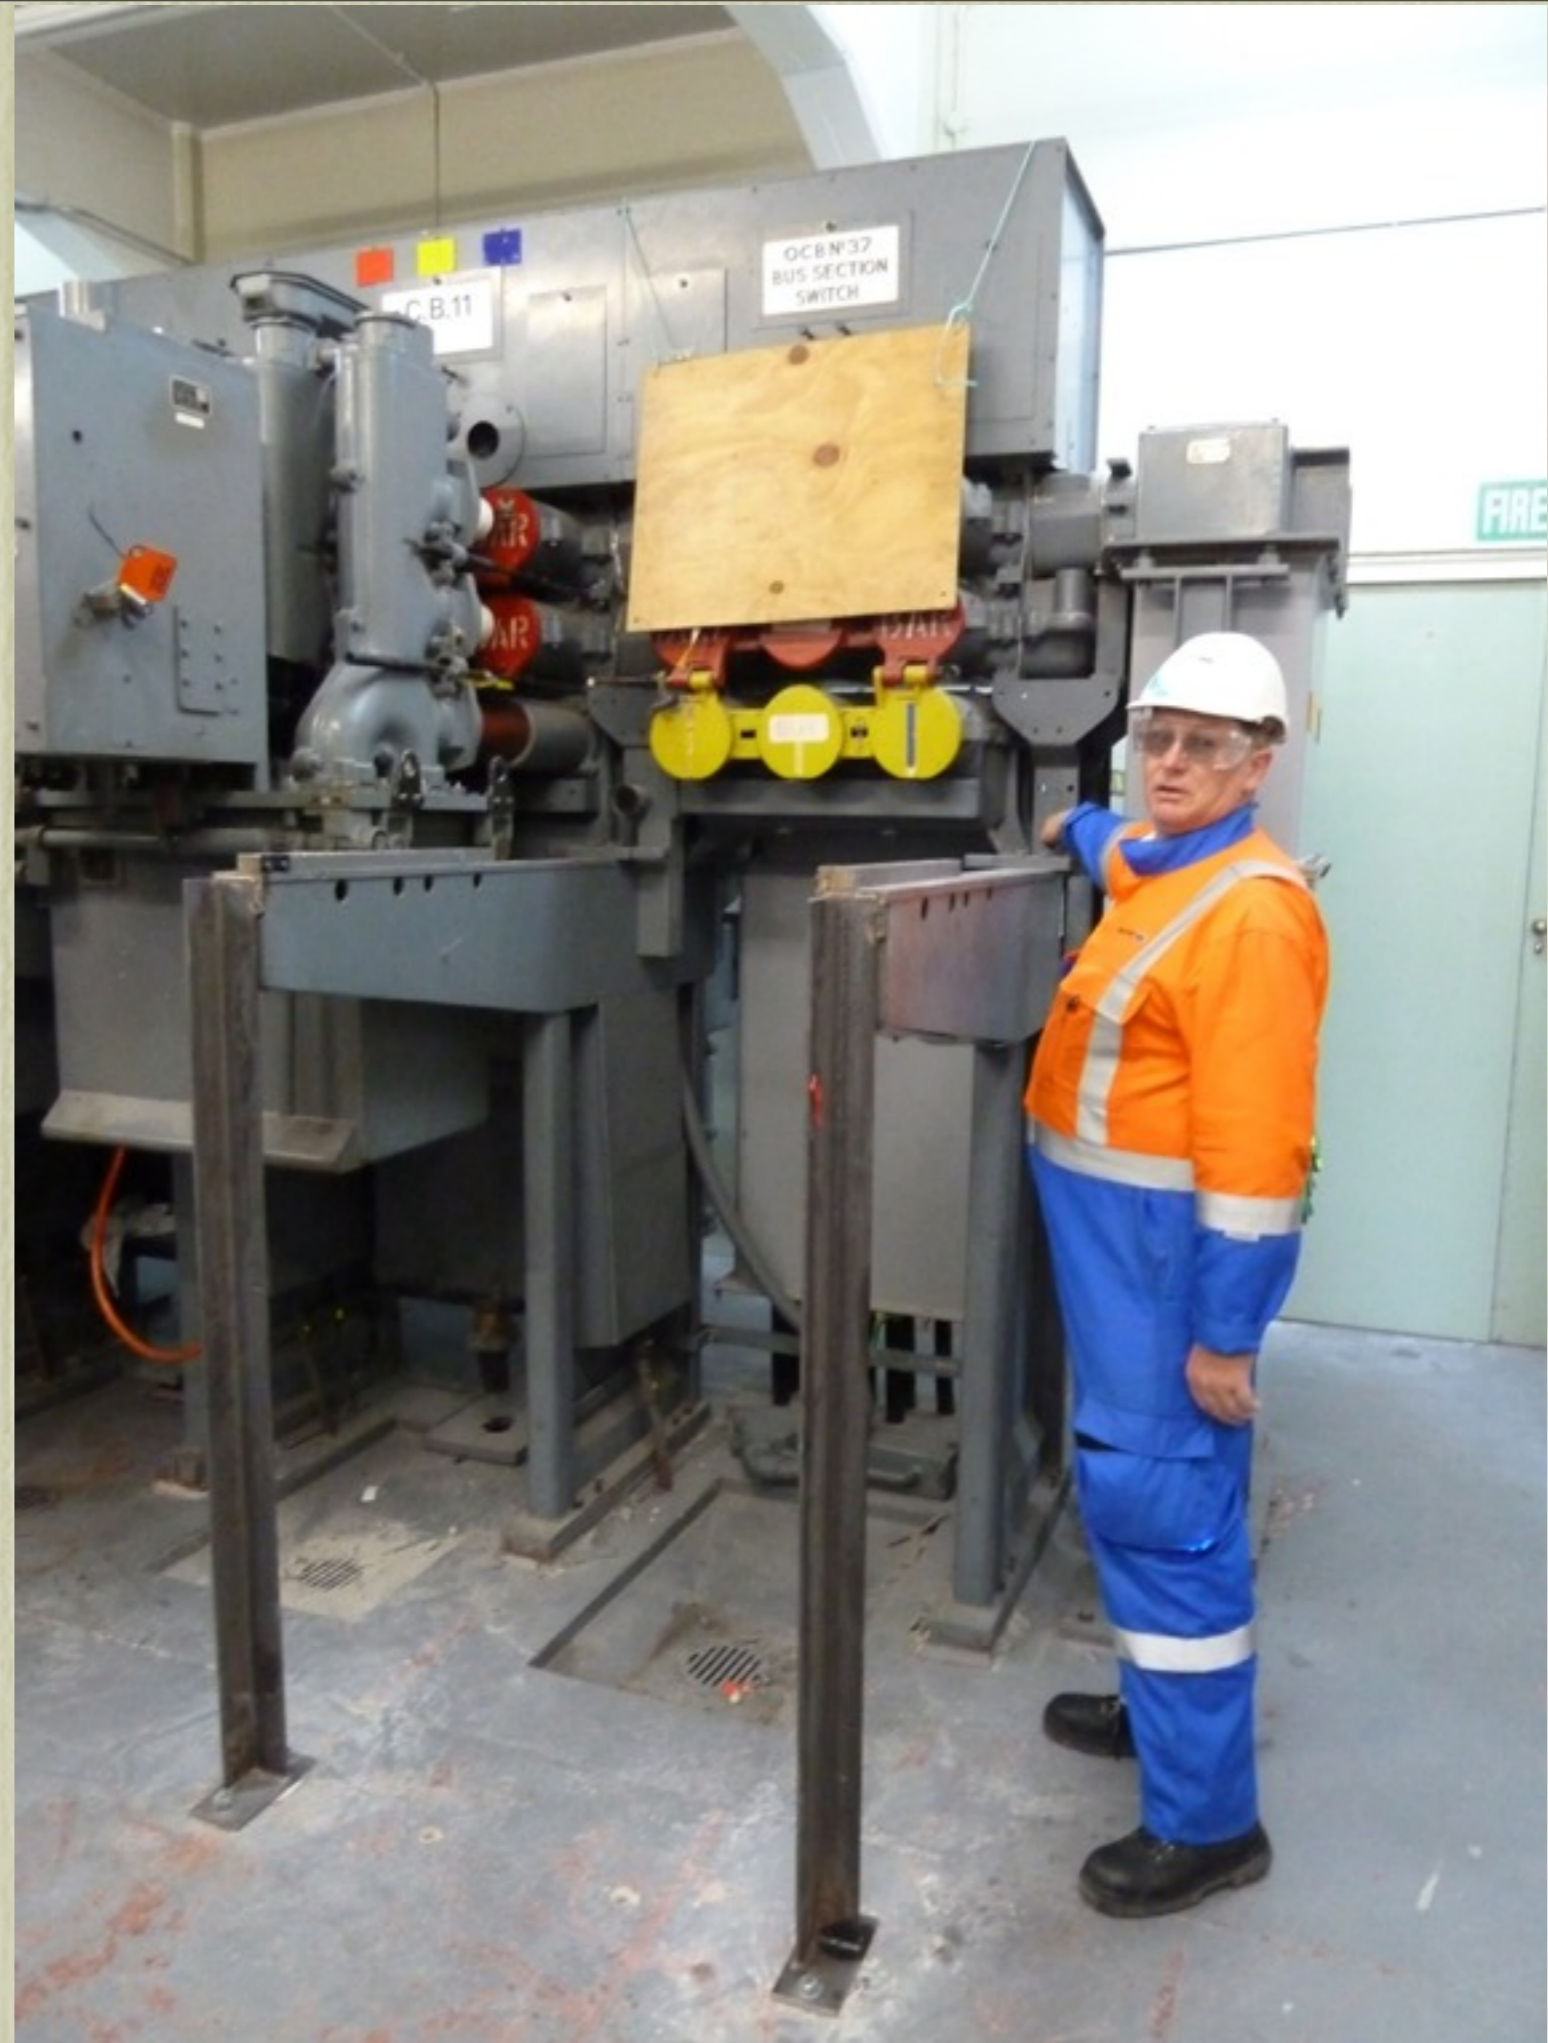
OCBs had high forces, cracked castings. One OCB in disengaged position fell to the ground. In-service OCBs remained functional, although lots of evidence of anchorage overloads

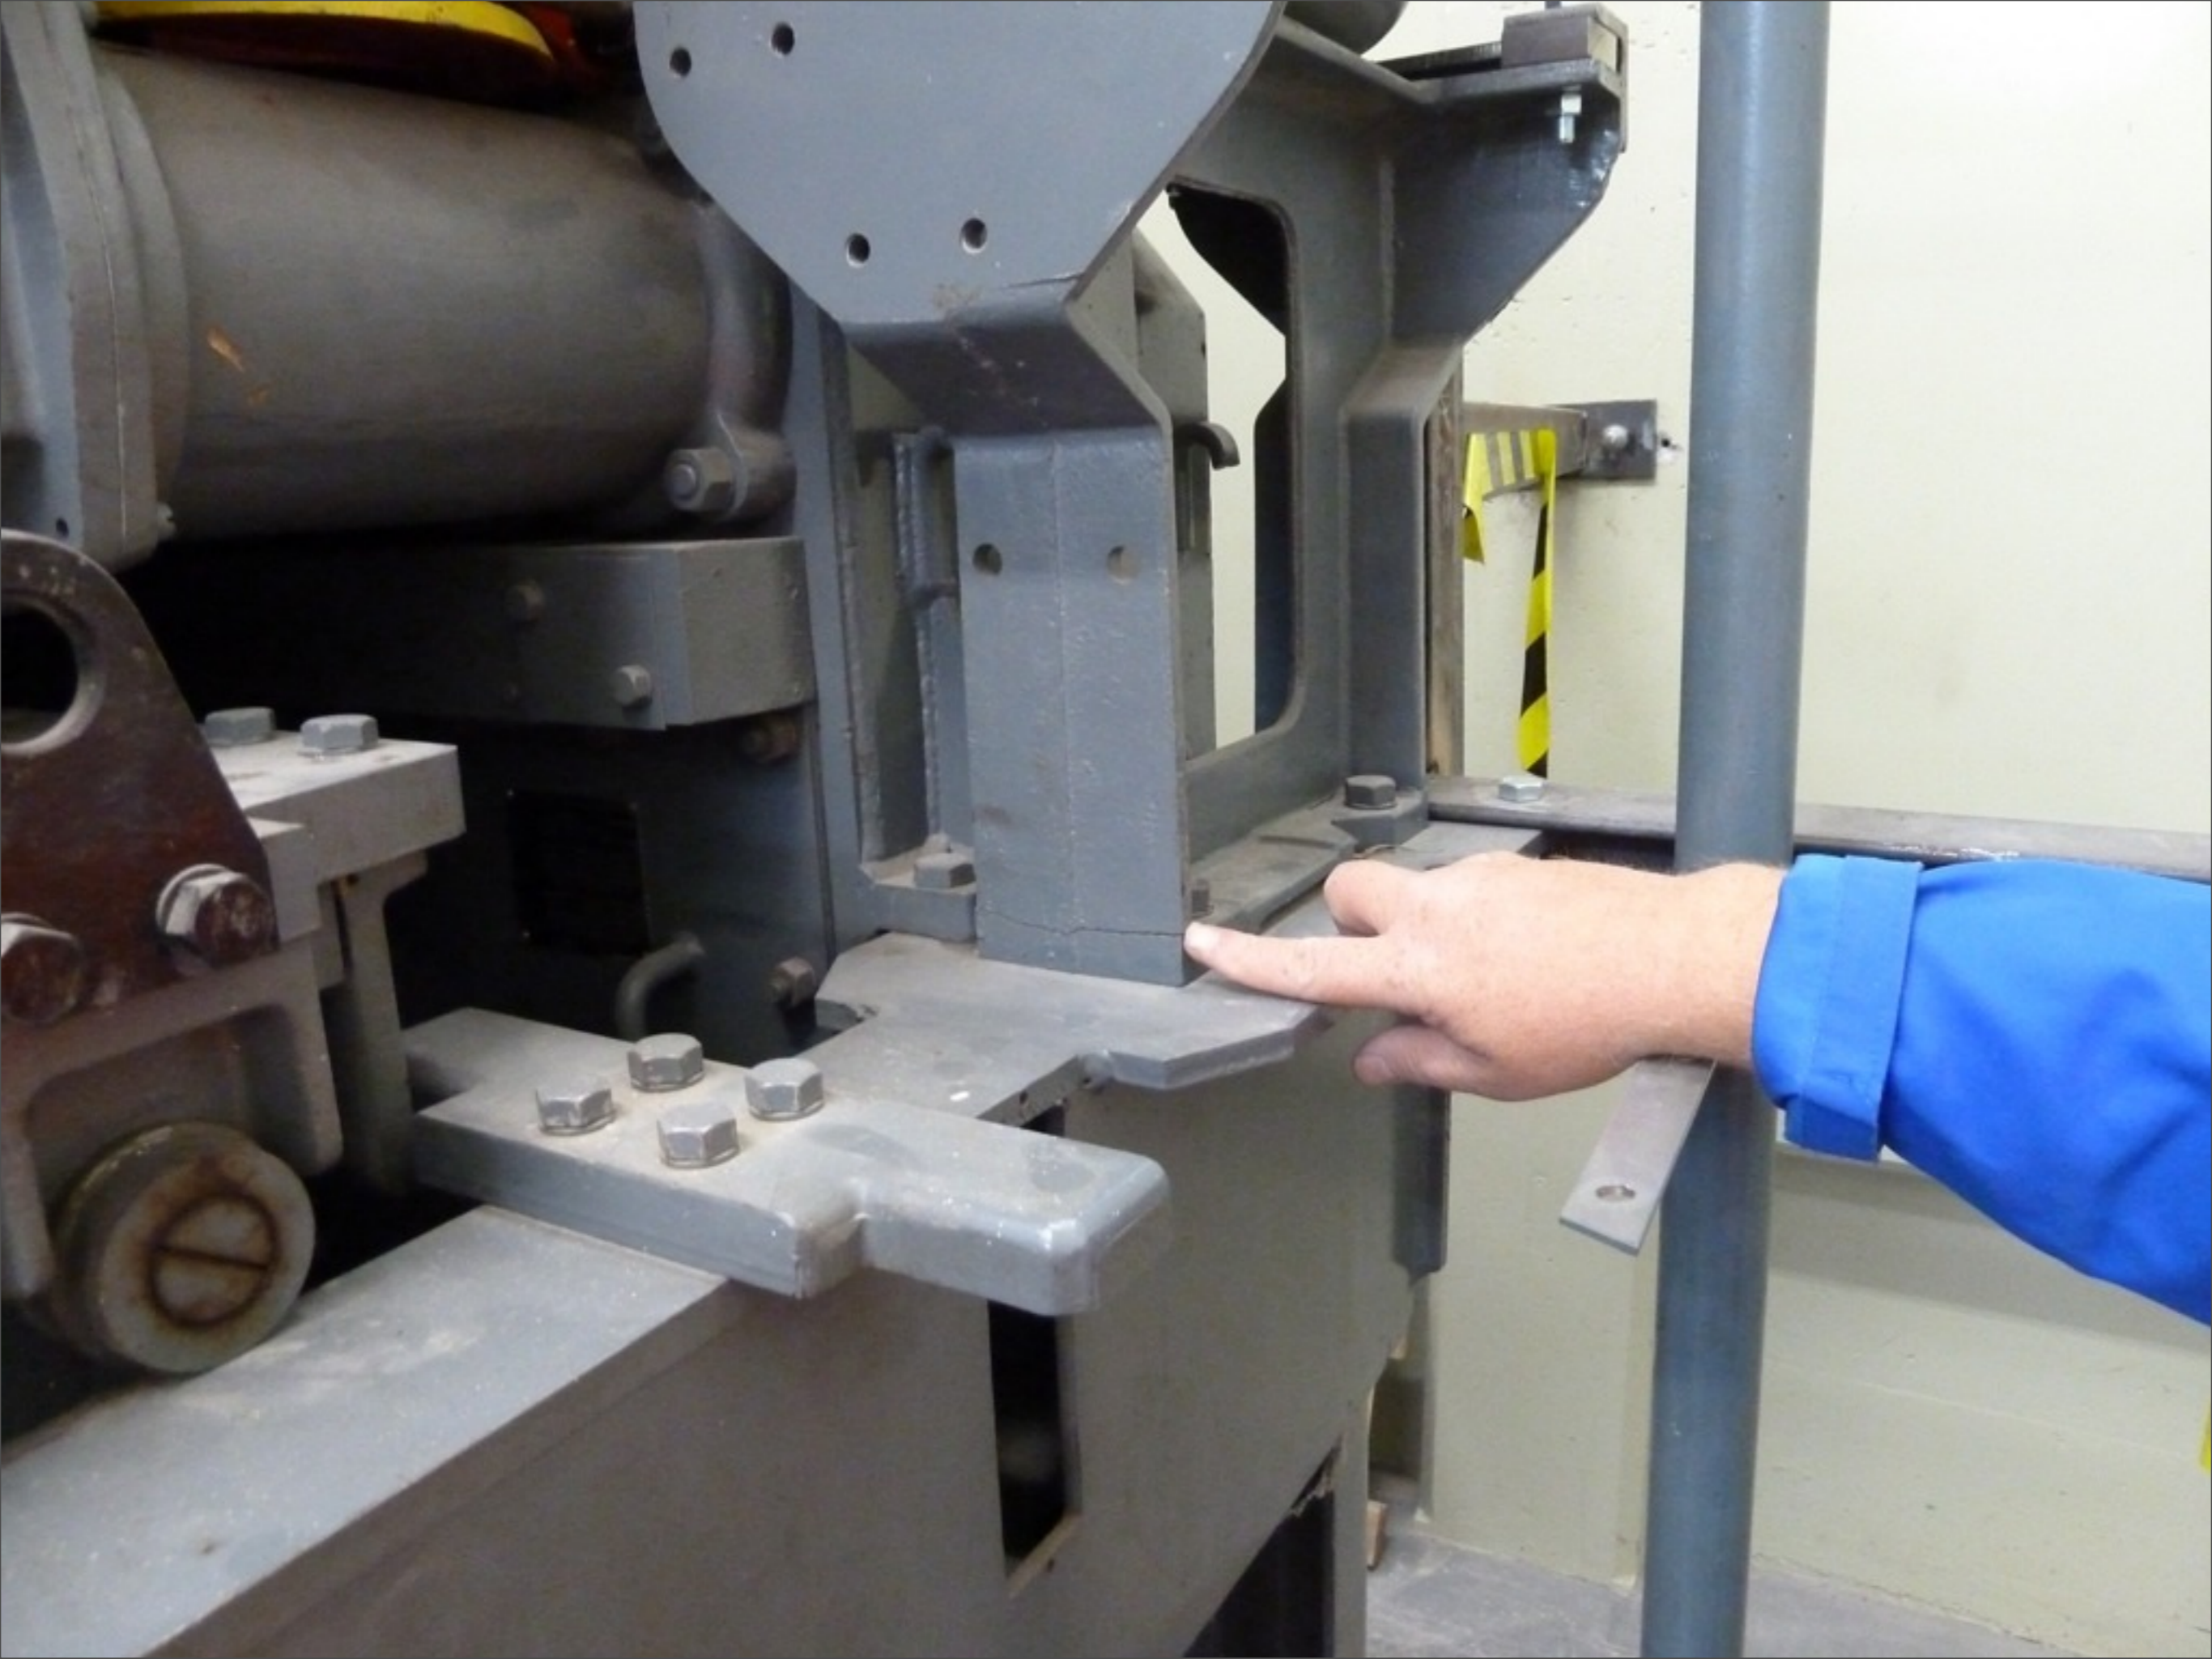
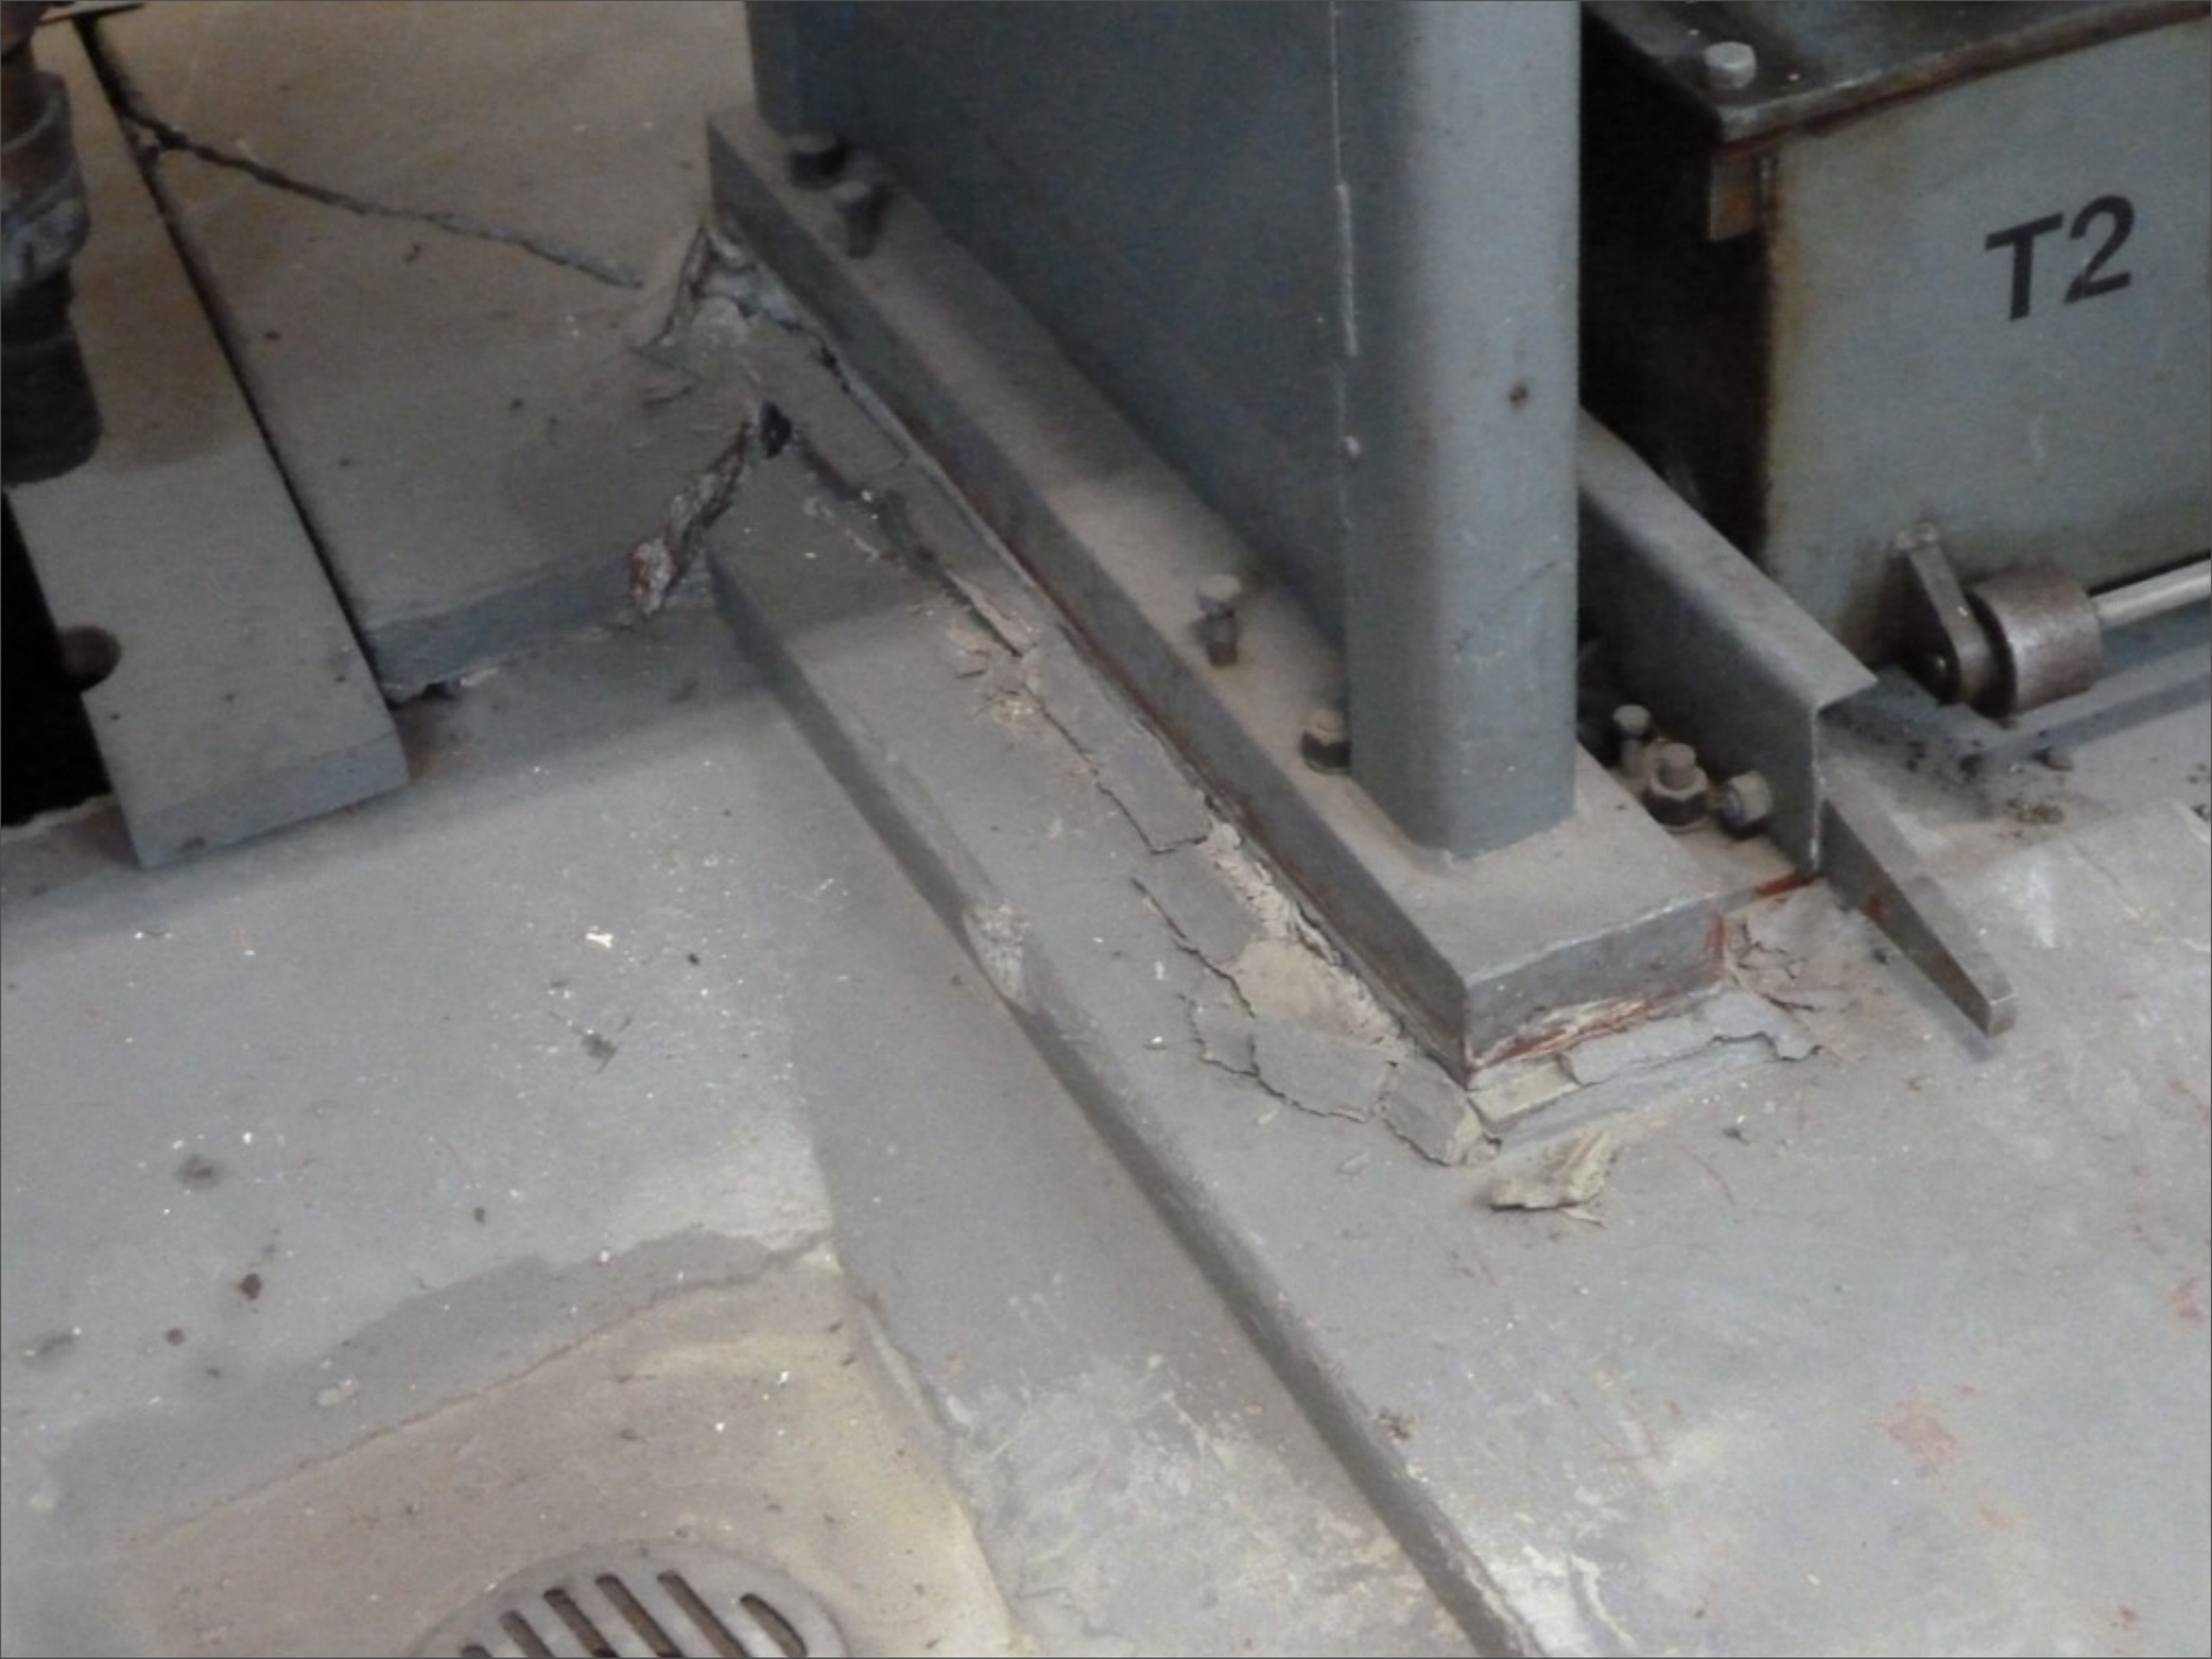
66 kV Yard, Looking South

Large sand boils surrounding substation, and about 10% of area within substation

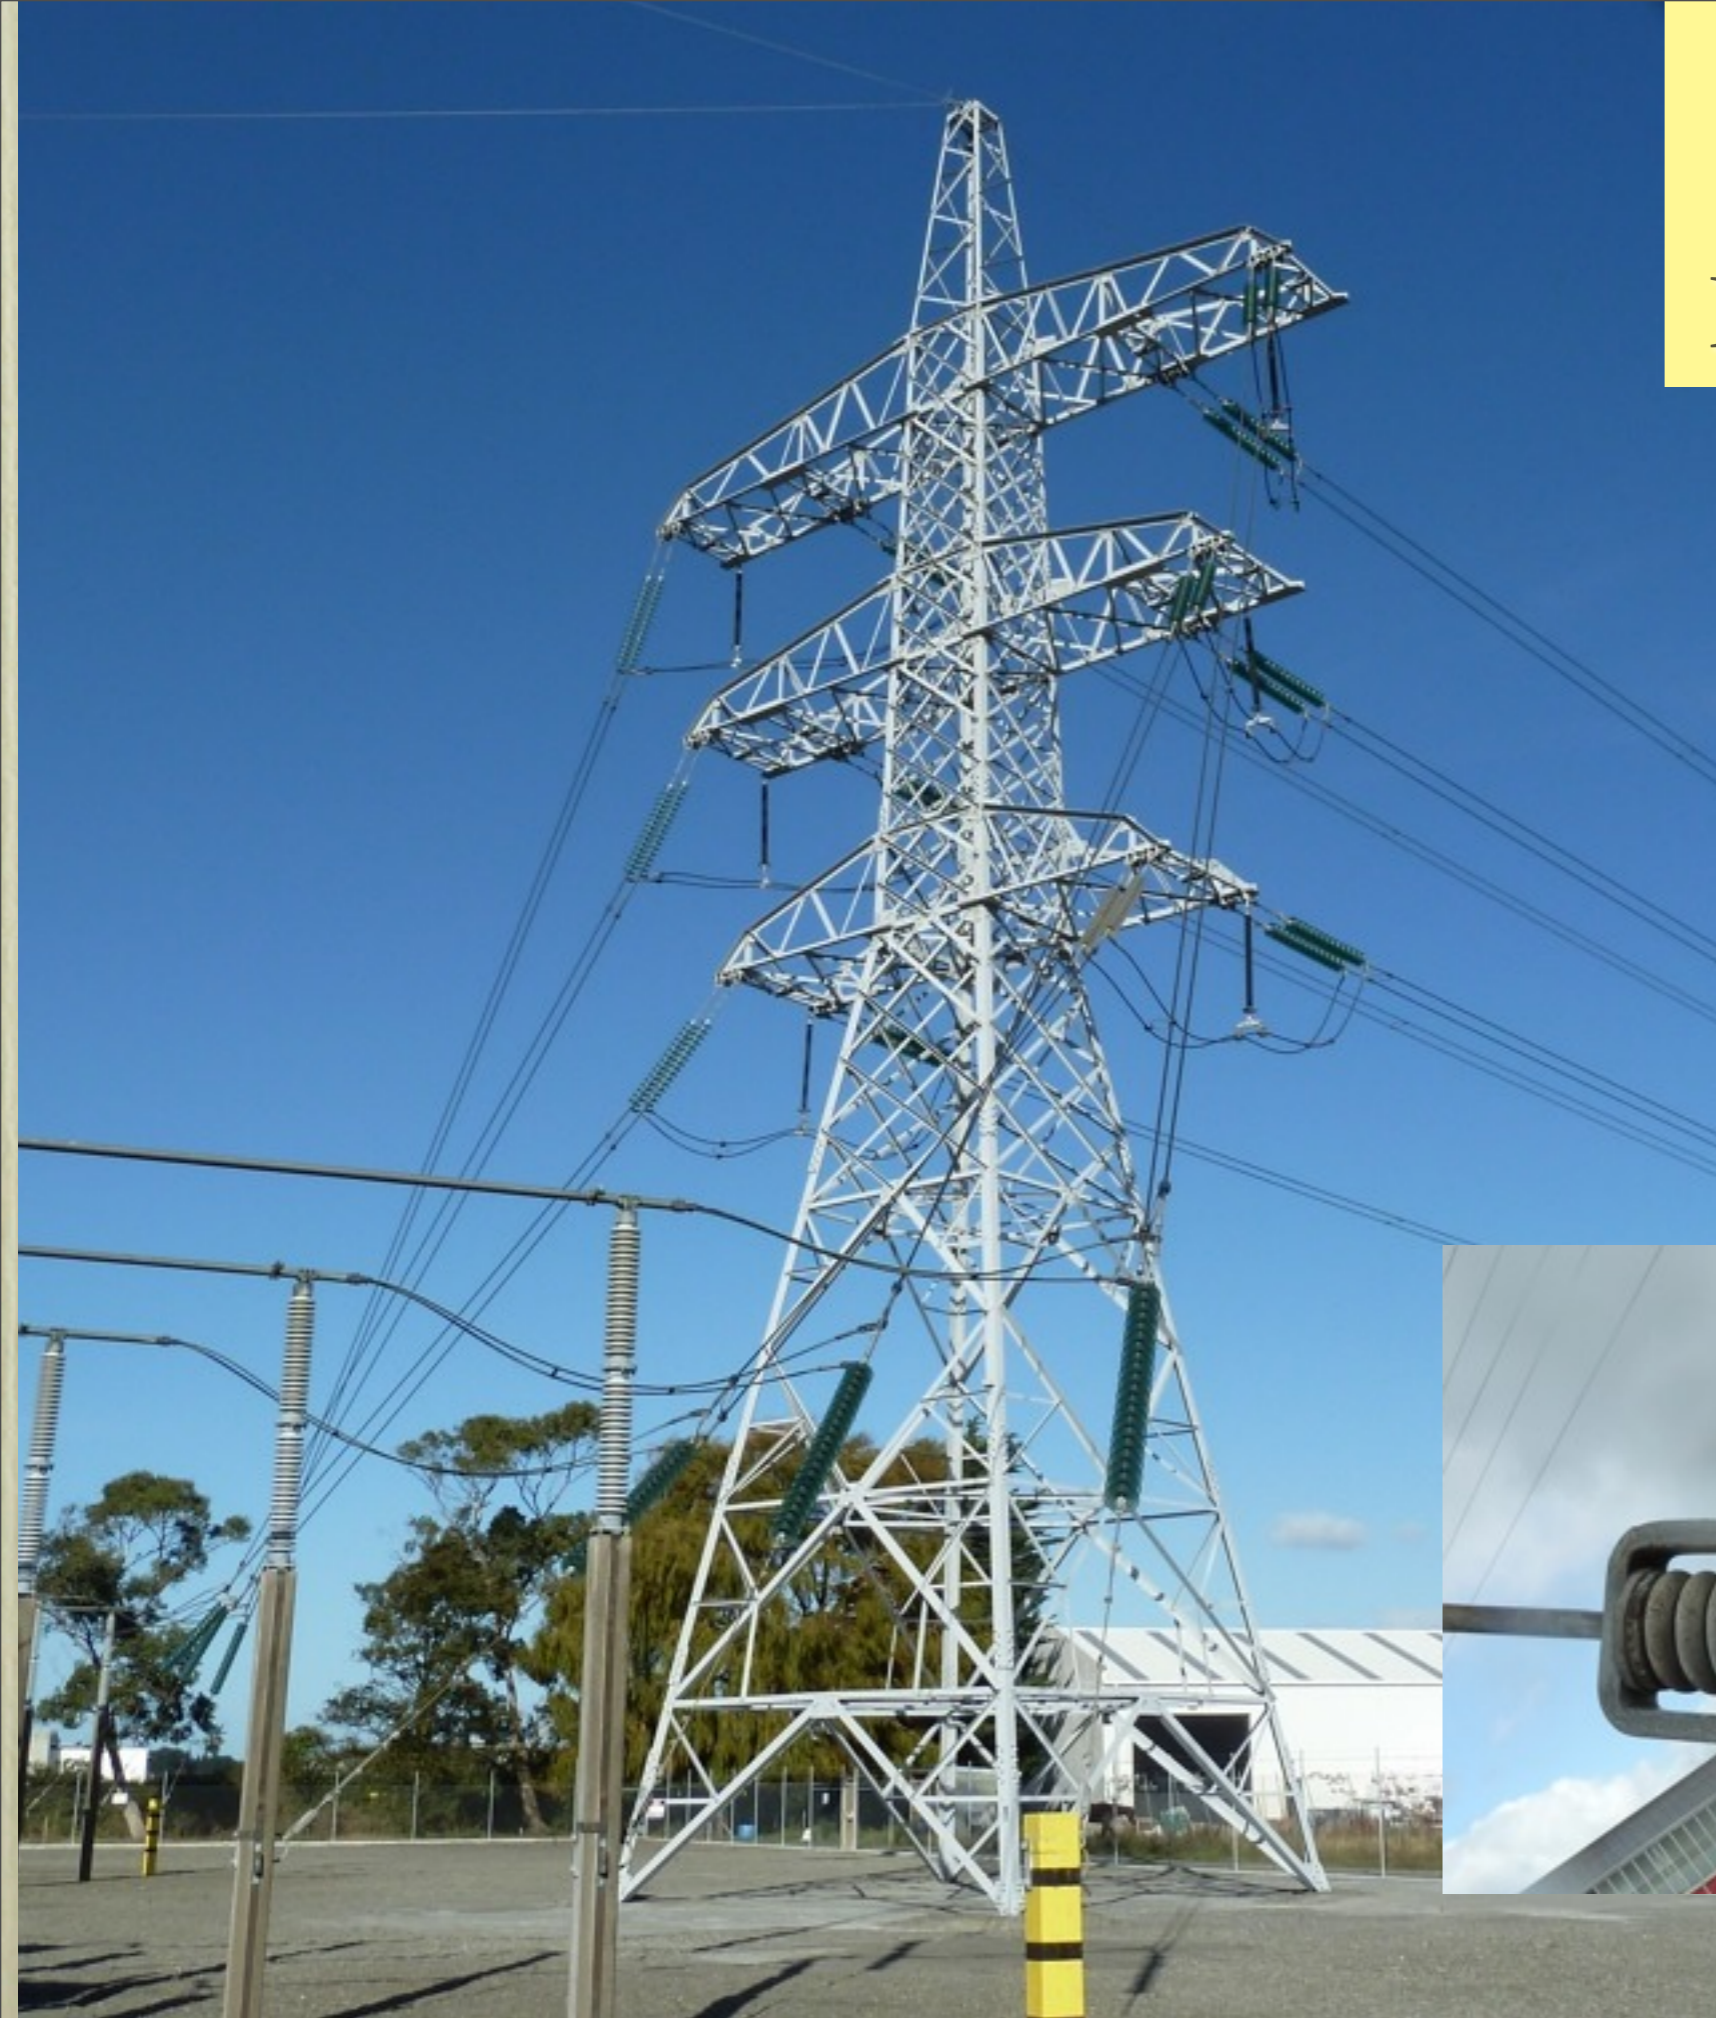
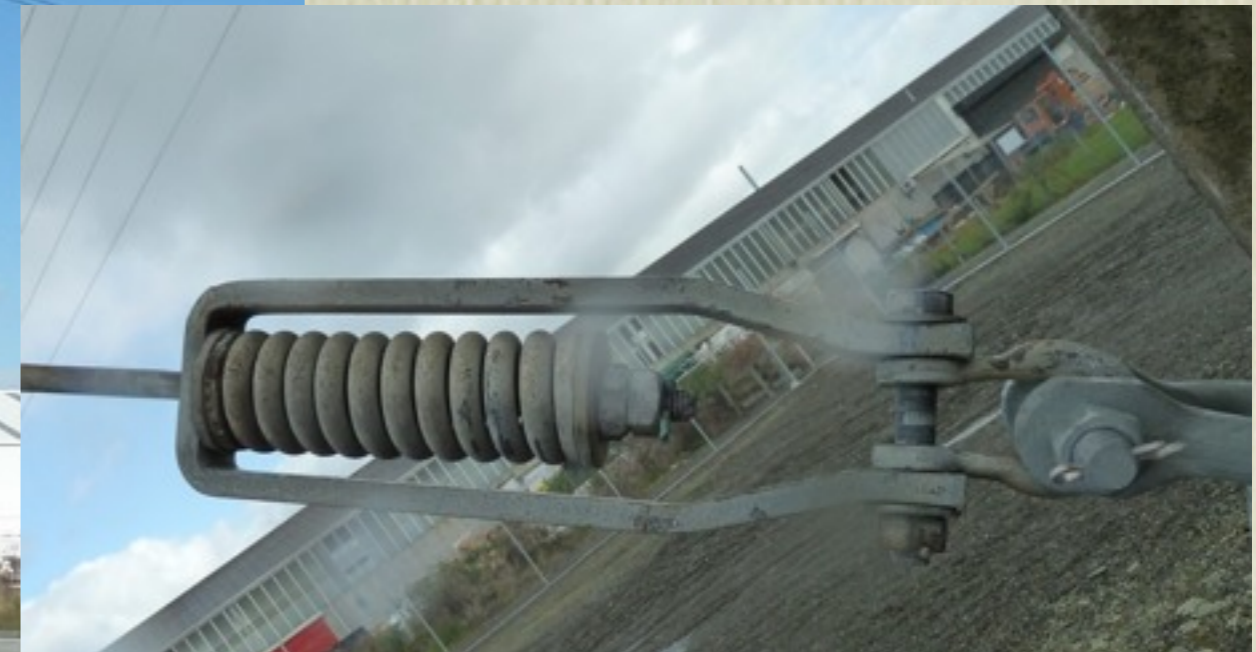
Bromley Tower - 220  
kV Double Circuit,  
Drop into 220 kV Yard

All springs "tight"
