Christchurch, Feb 22 2011 and Sept 4 2010

John Eiding  
G&E Engineering Systems Inc.  
[eidinger@geEngineeringSystems.com](mailto:eidinger@geEngineeringSystems.com)

## Impact to Electric Power Systems

ASCE - Structural Congress

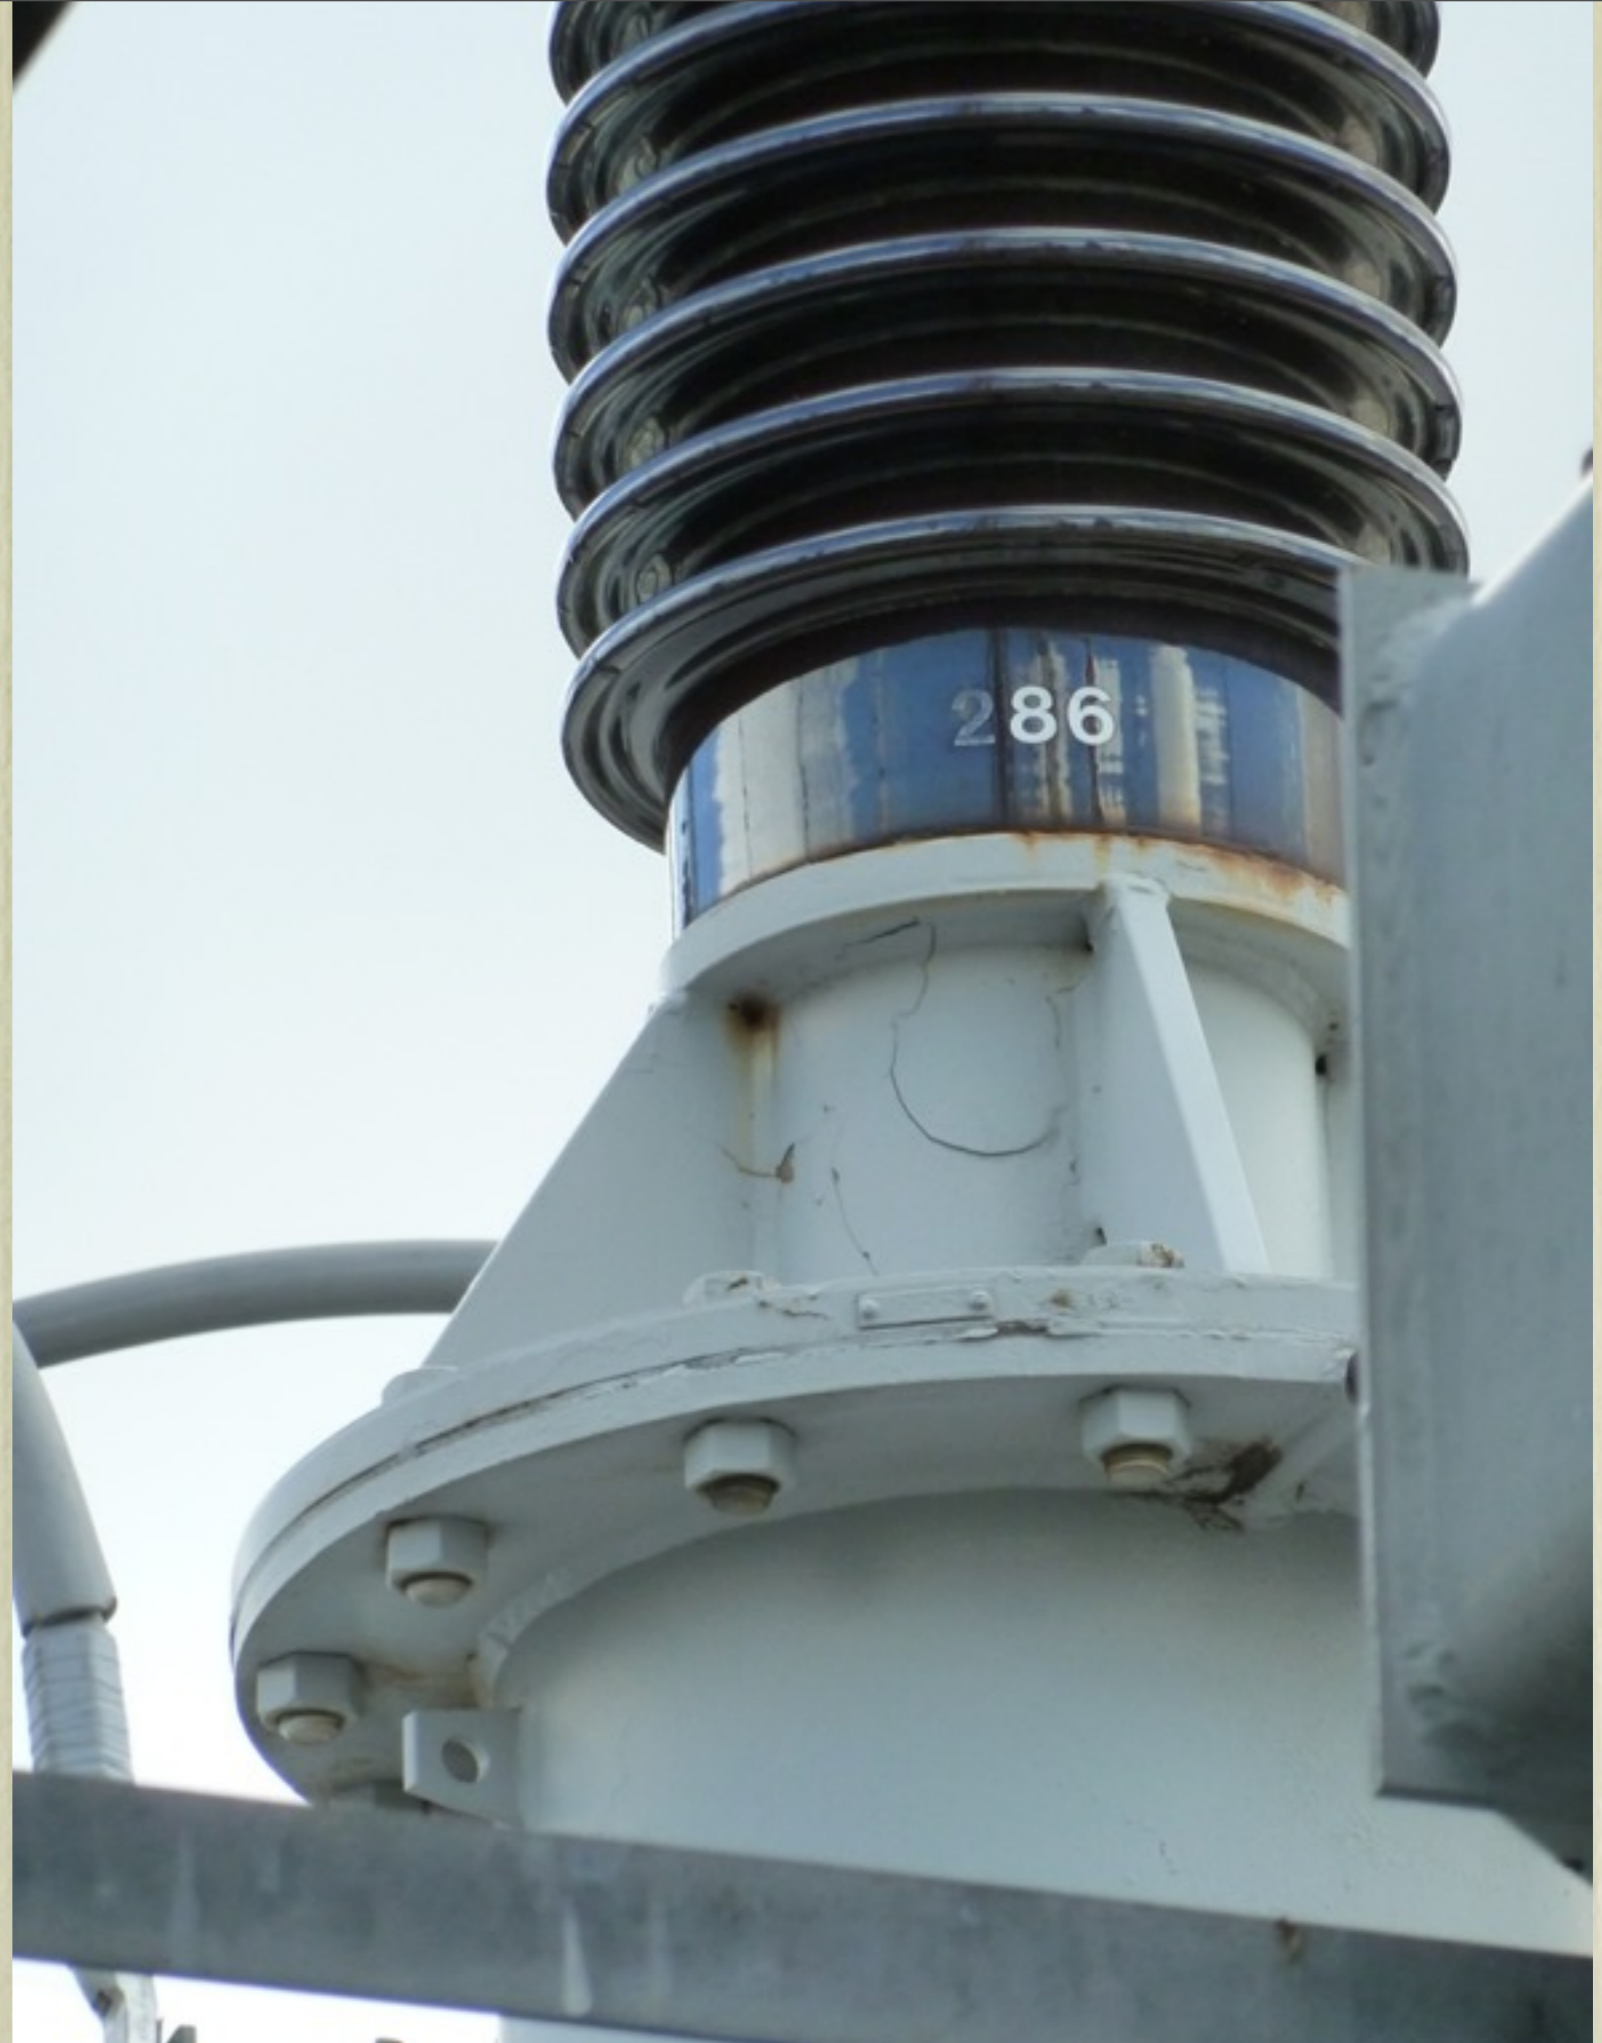
Cracked paint  
suggests yielding?

Very minor oil  
leakage

Some slippage

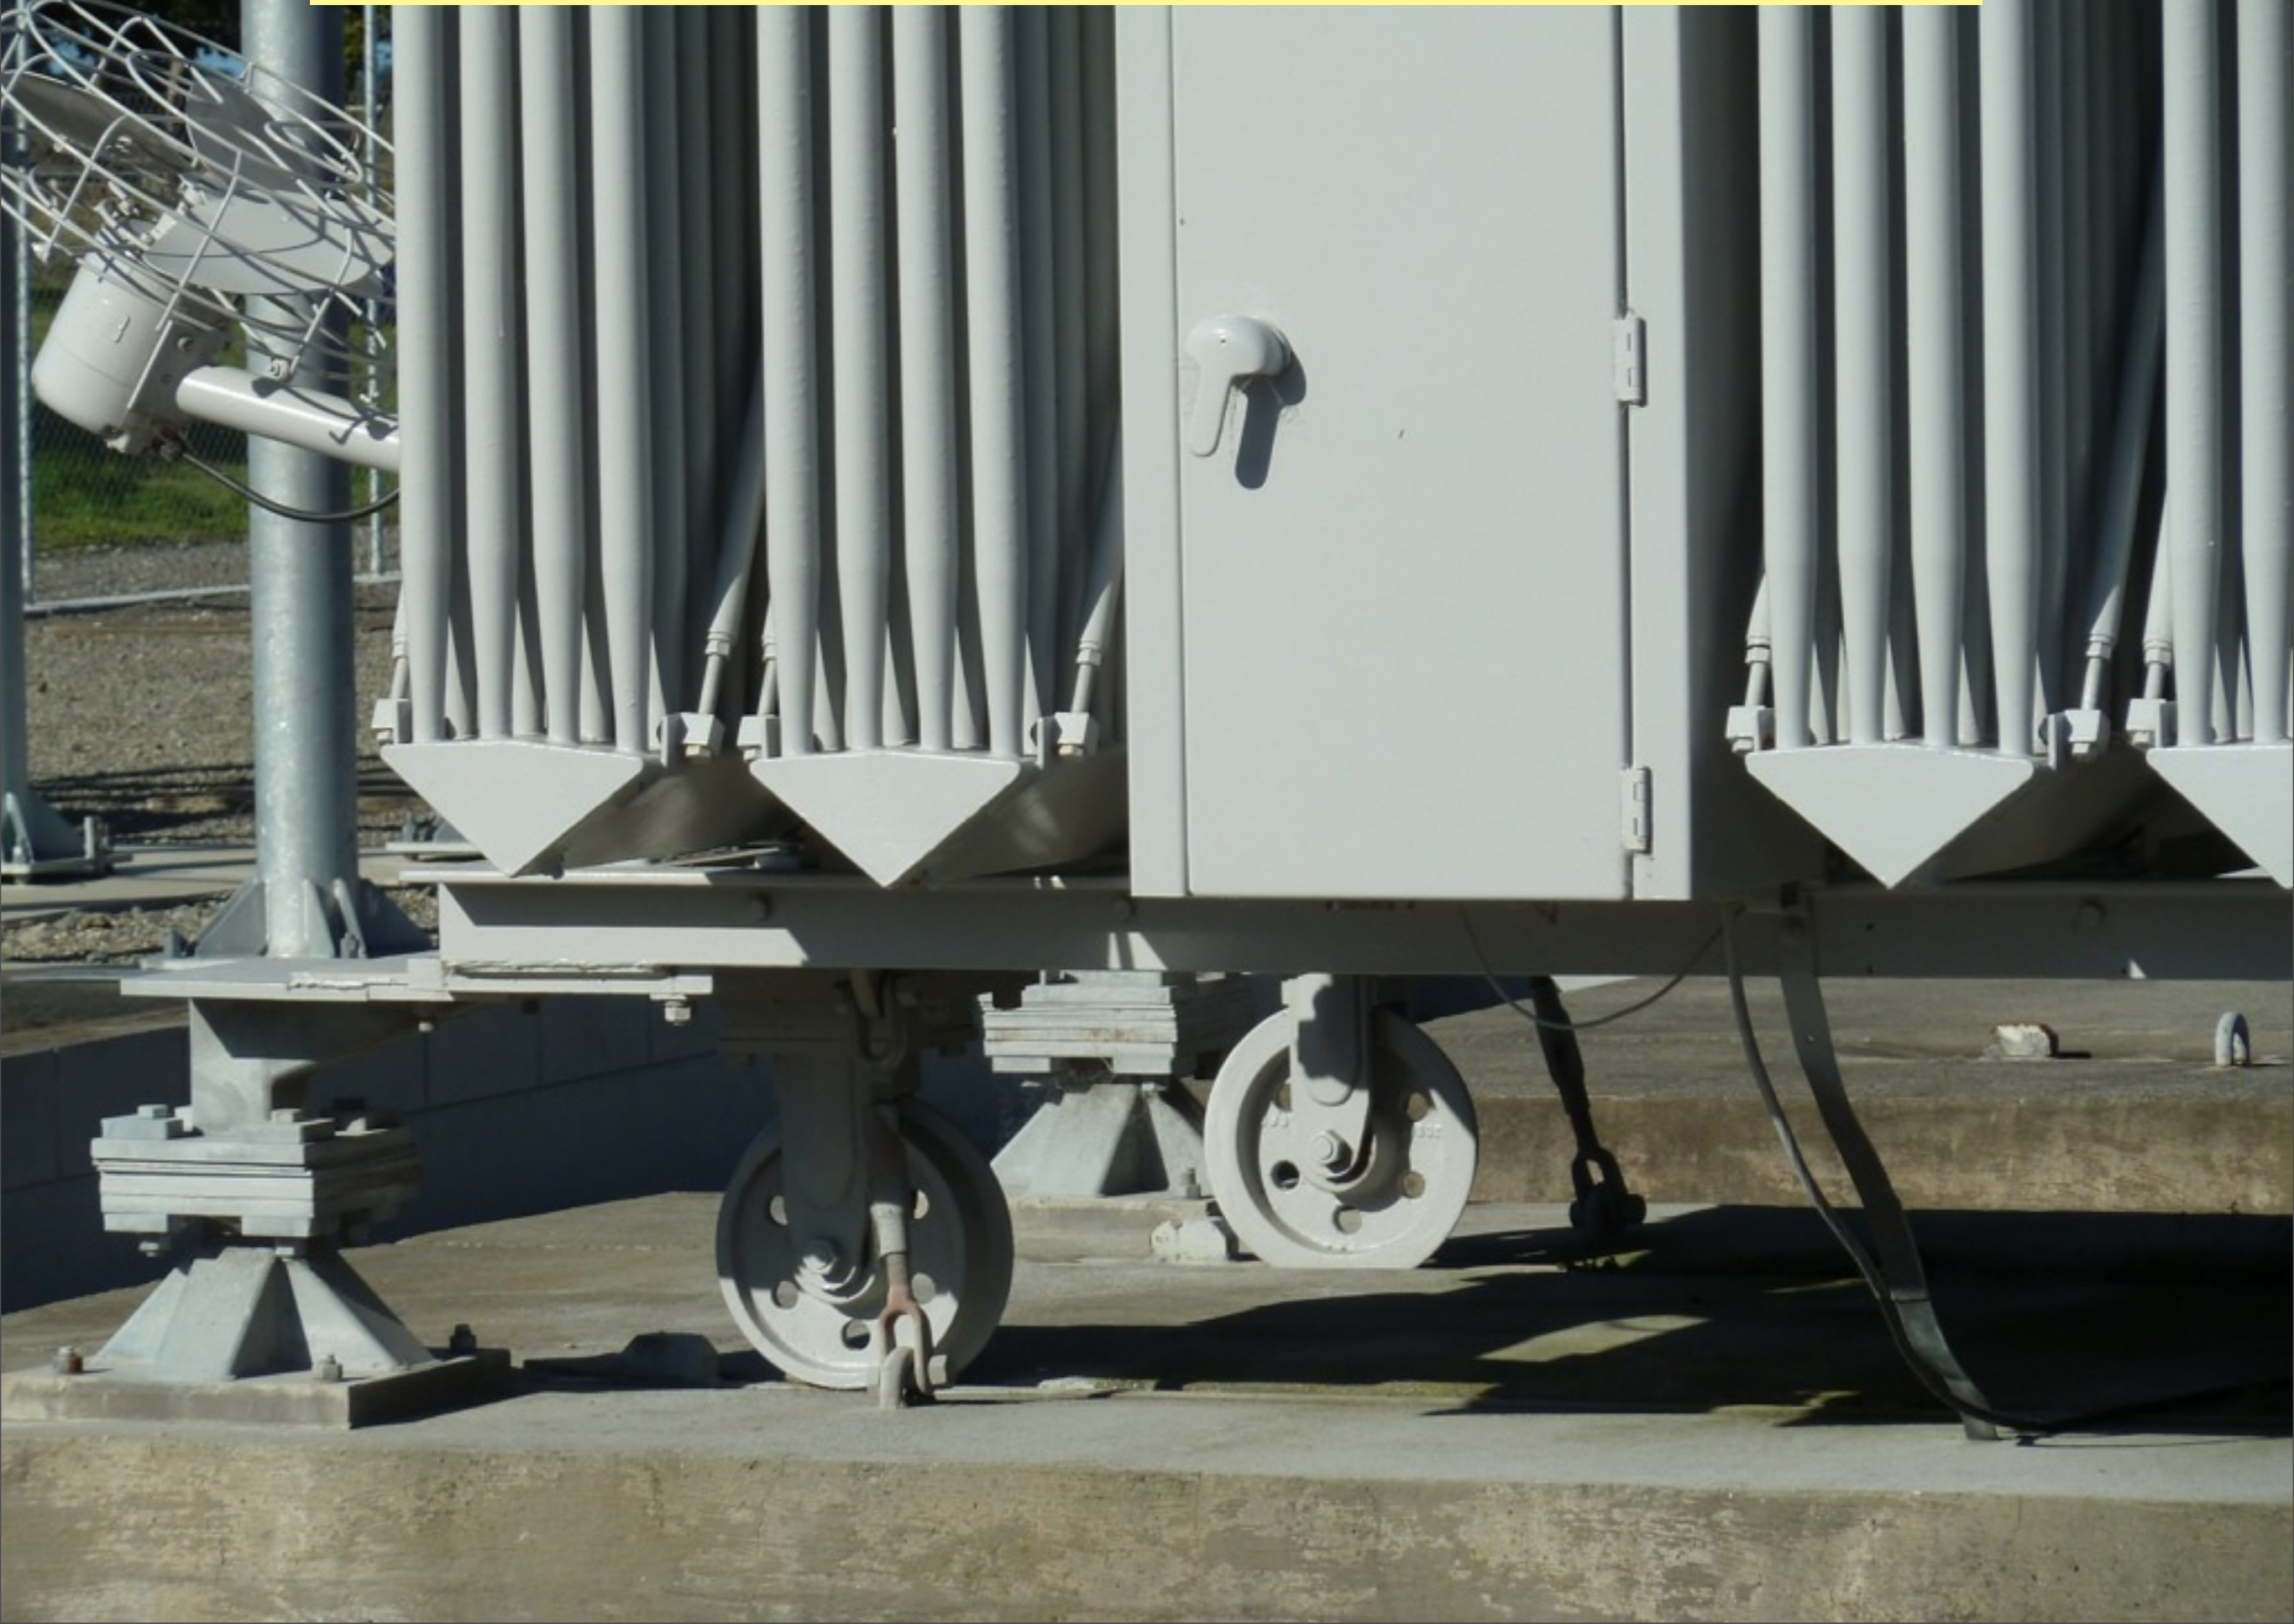
# Bolted Connections: slight slip in 220 kV yard

~20 mm slip to right

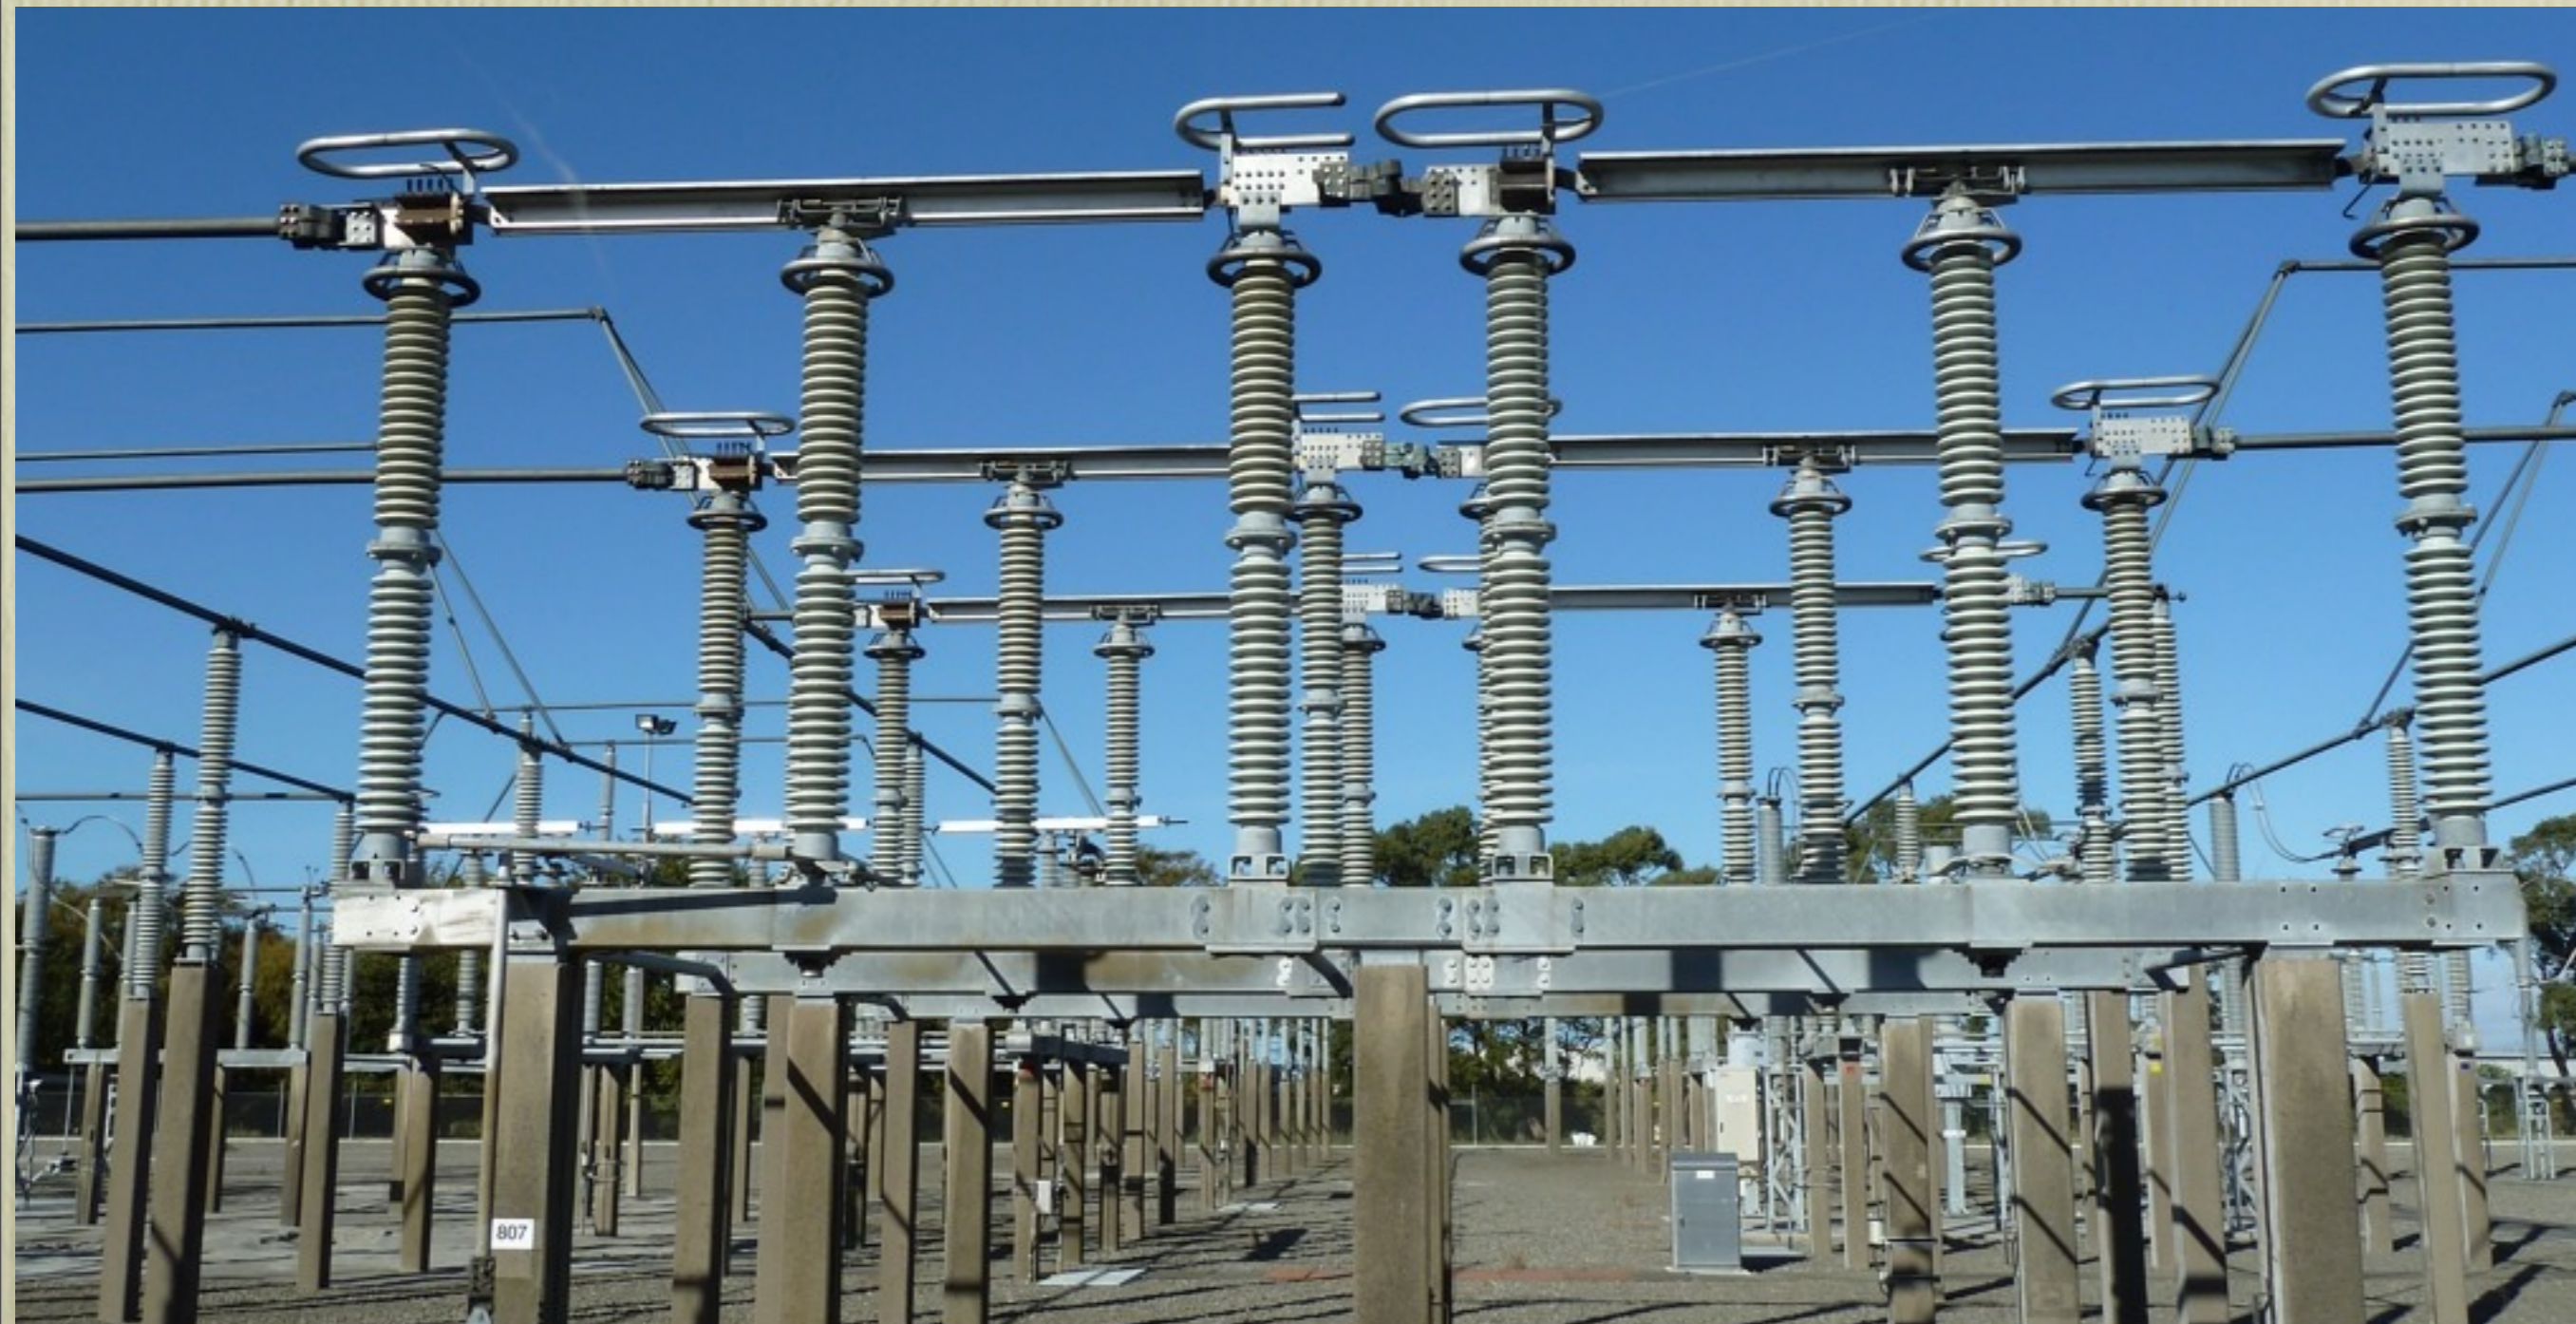
220 kV center break DS. Some contact problems, misalignments. No contact burns. Needed to be manually reset.

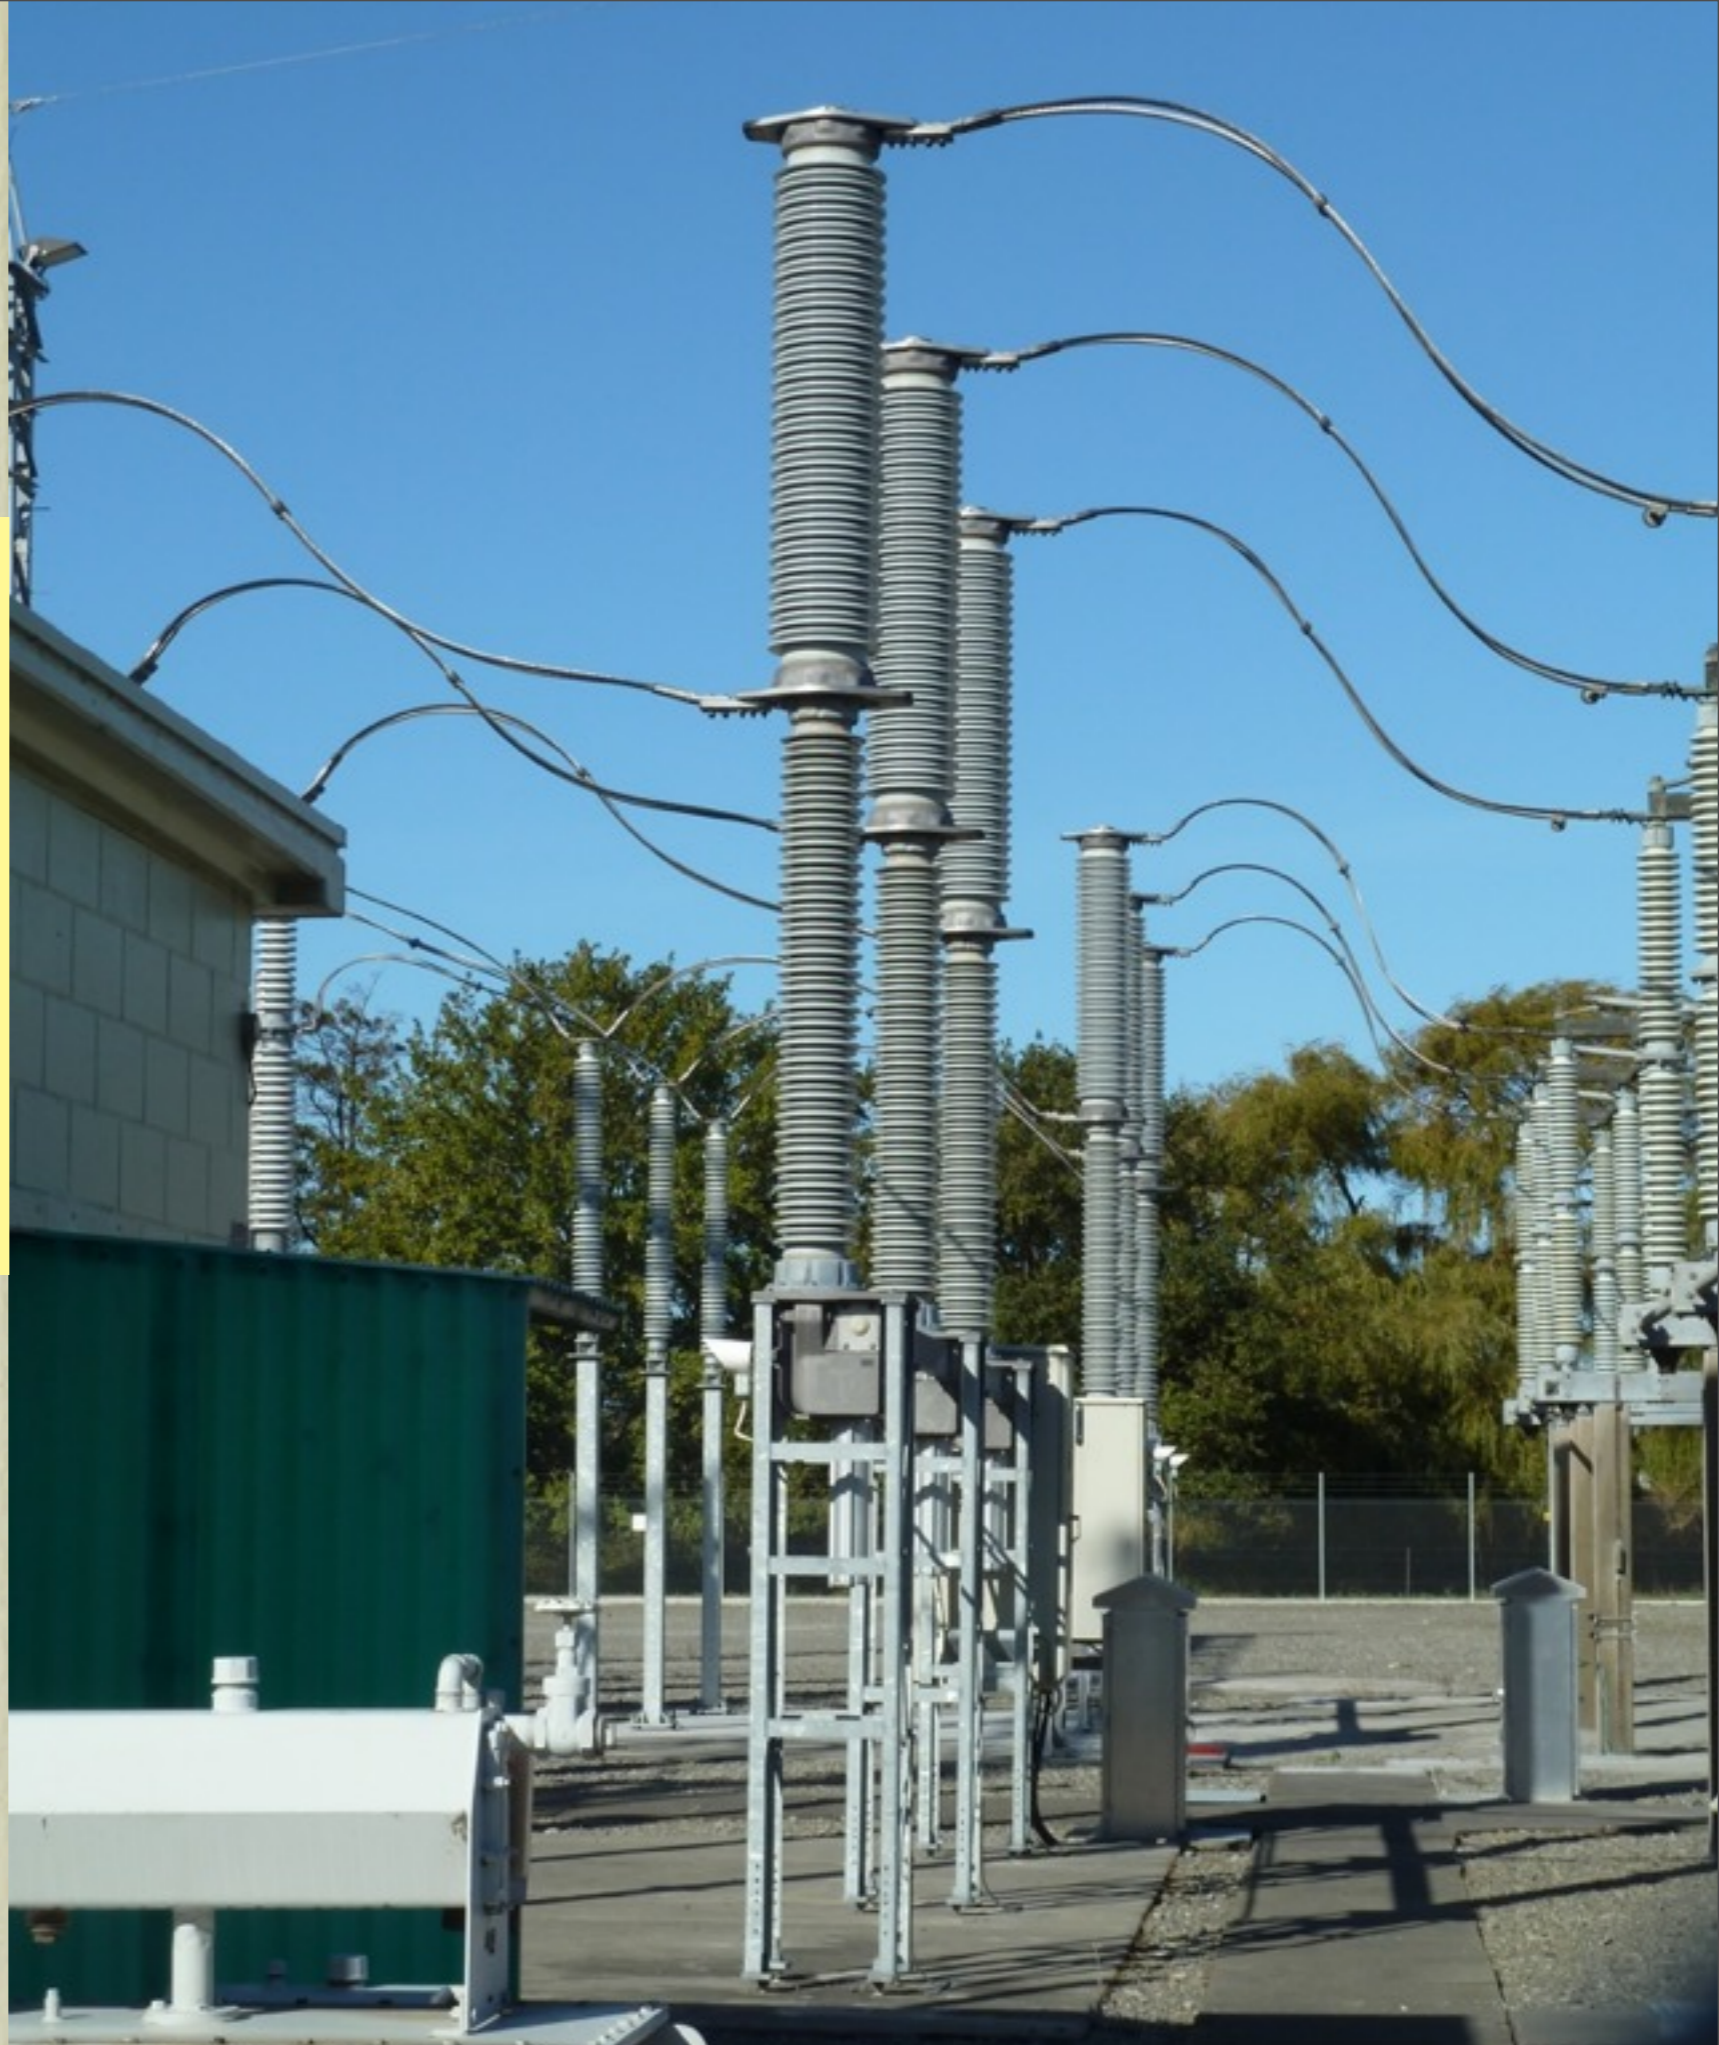
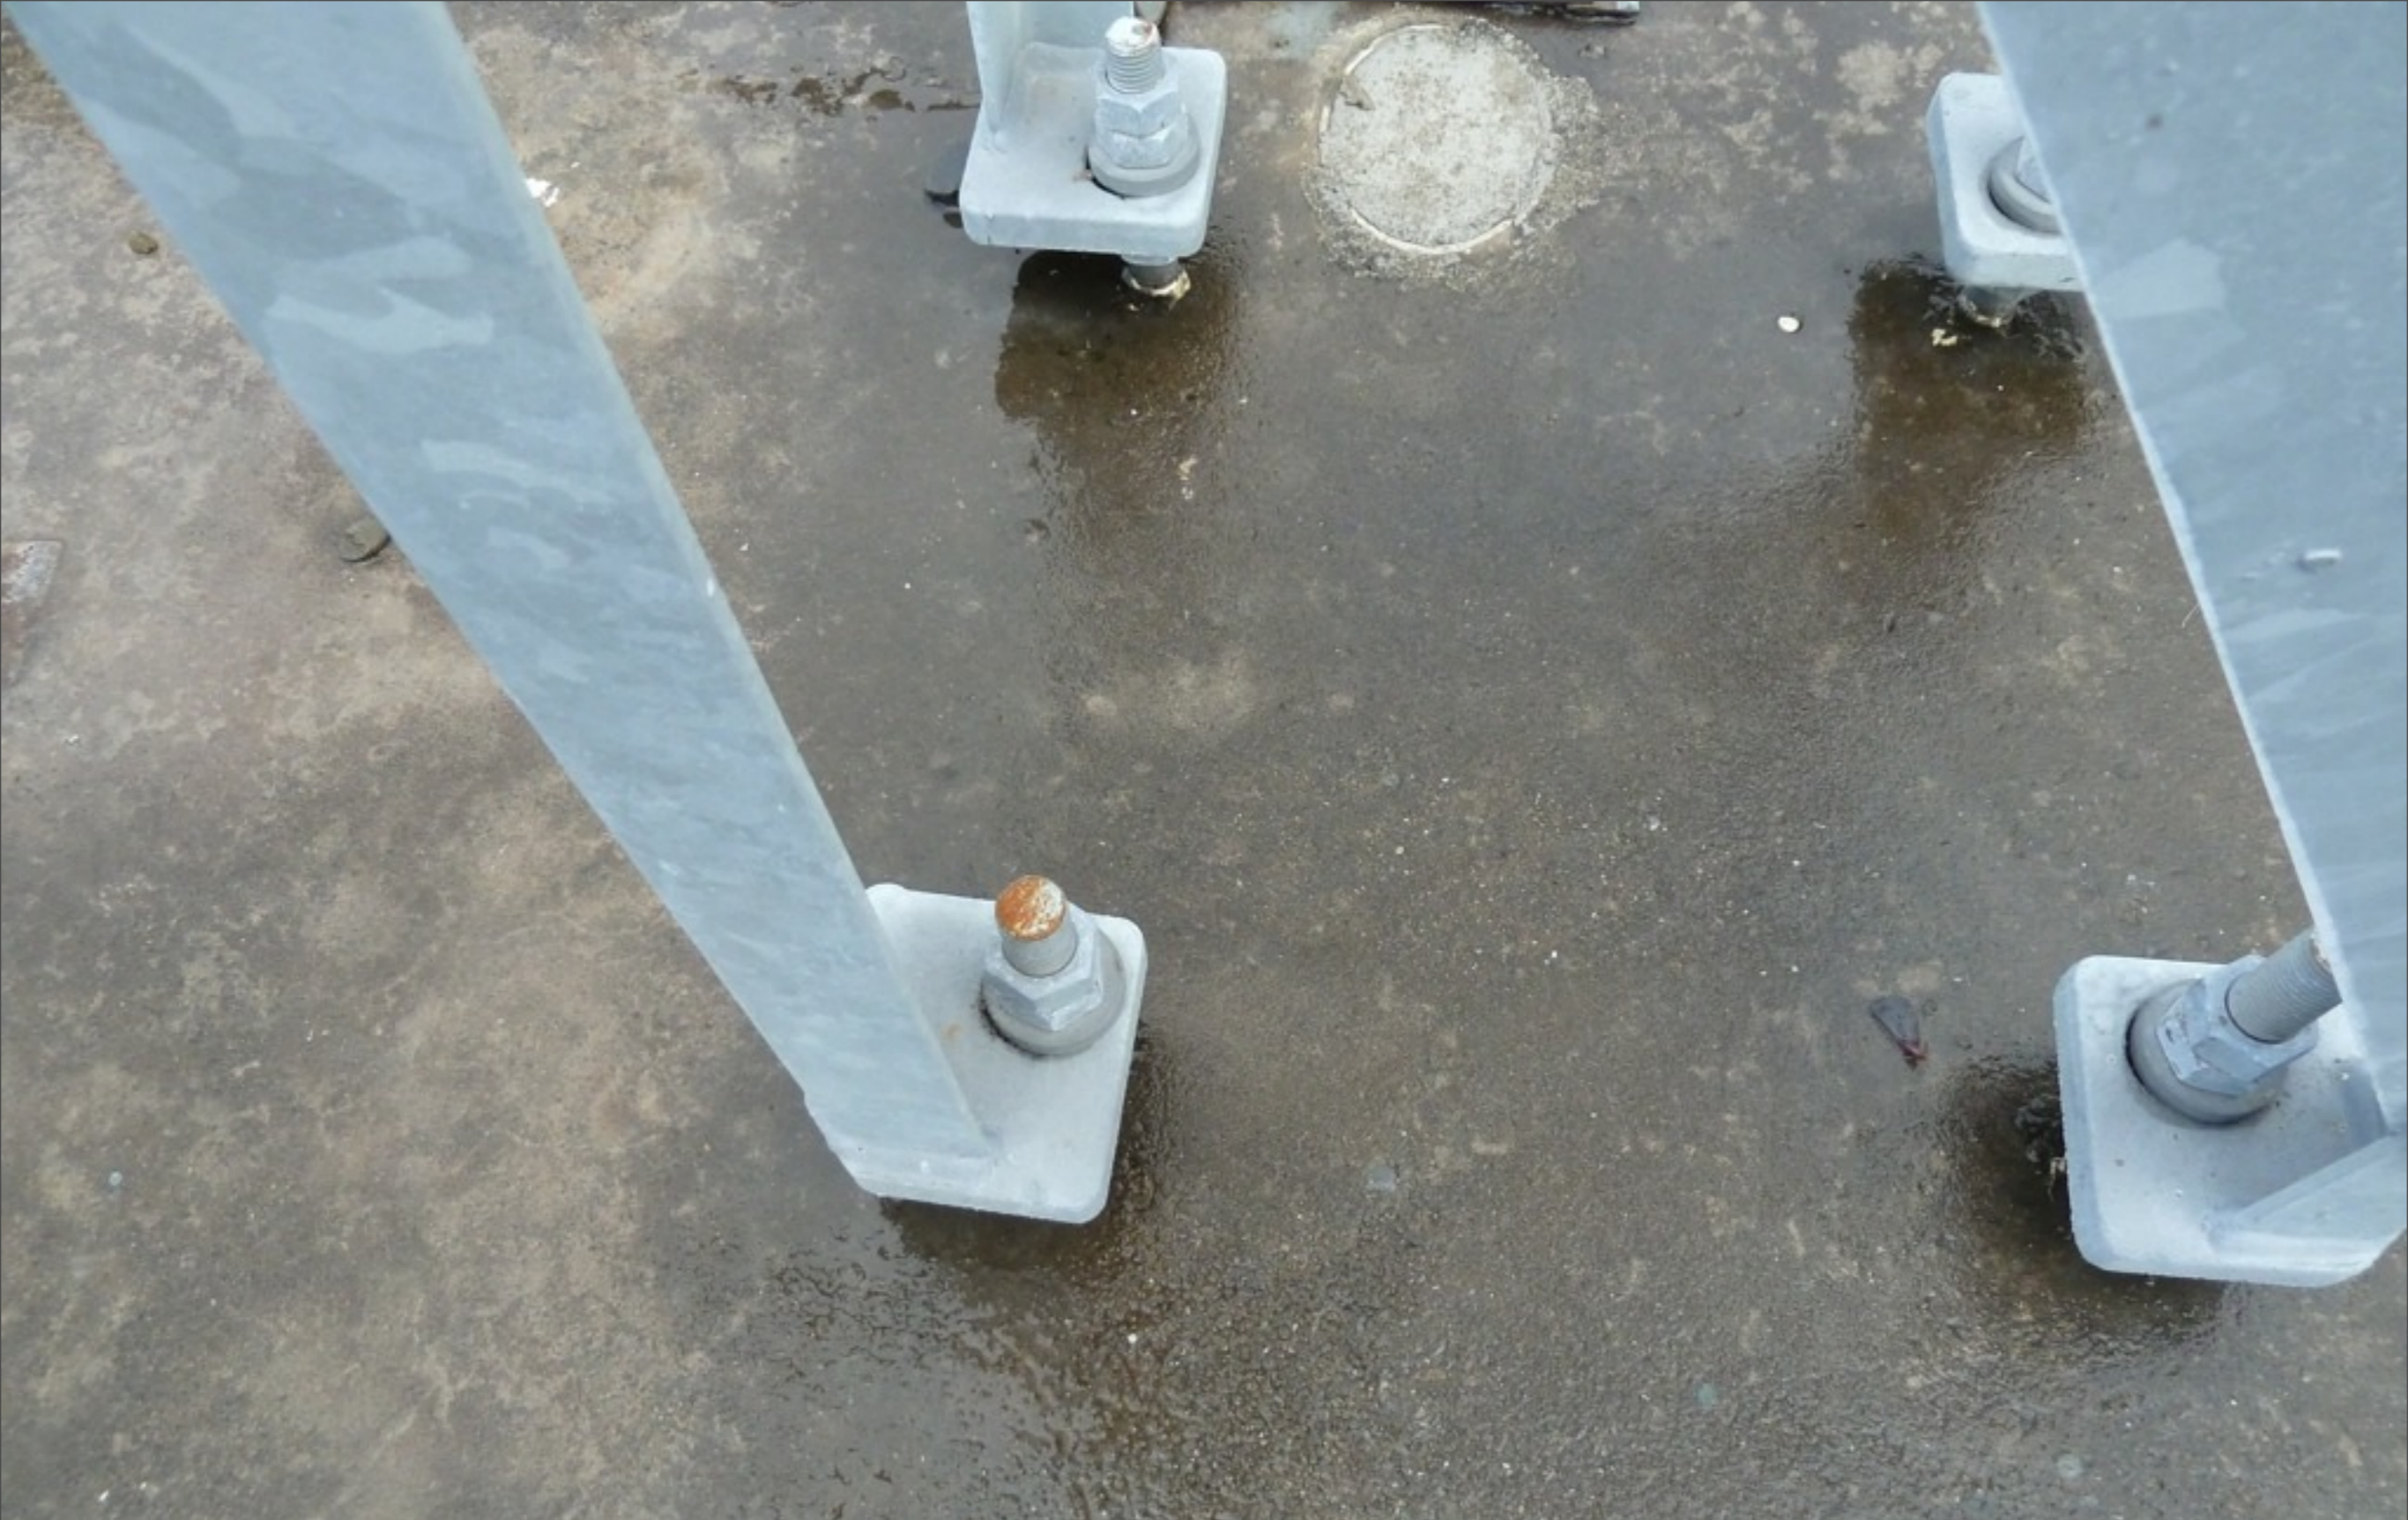
LTB245E1  
Years: 2002, 2005

No IEEE 693 posting

Newer installations do not use grout pads. Up to 1 inch clear height for bolts
