Christchurch, Feb 22 2011 and Sept 4 2010

John Eiding  
G&E Engineering Systems Inc.  
[eidinger@geEngineeringSystems.com](mailto:eidinger@geEngineeringSystems.com)

## Impact to Electric Power Systems

ASCE - Structural Congress

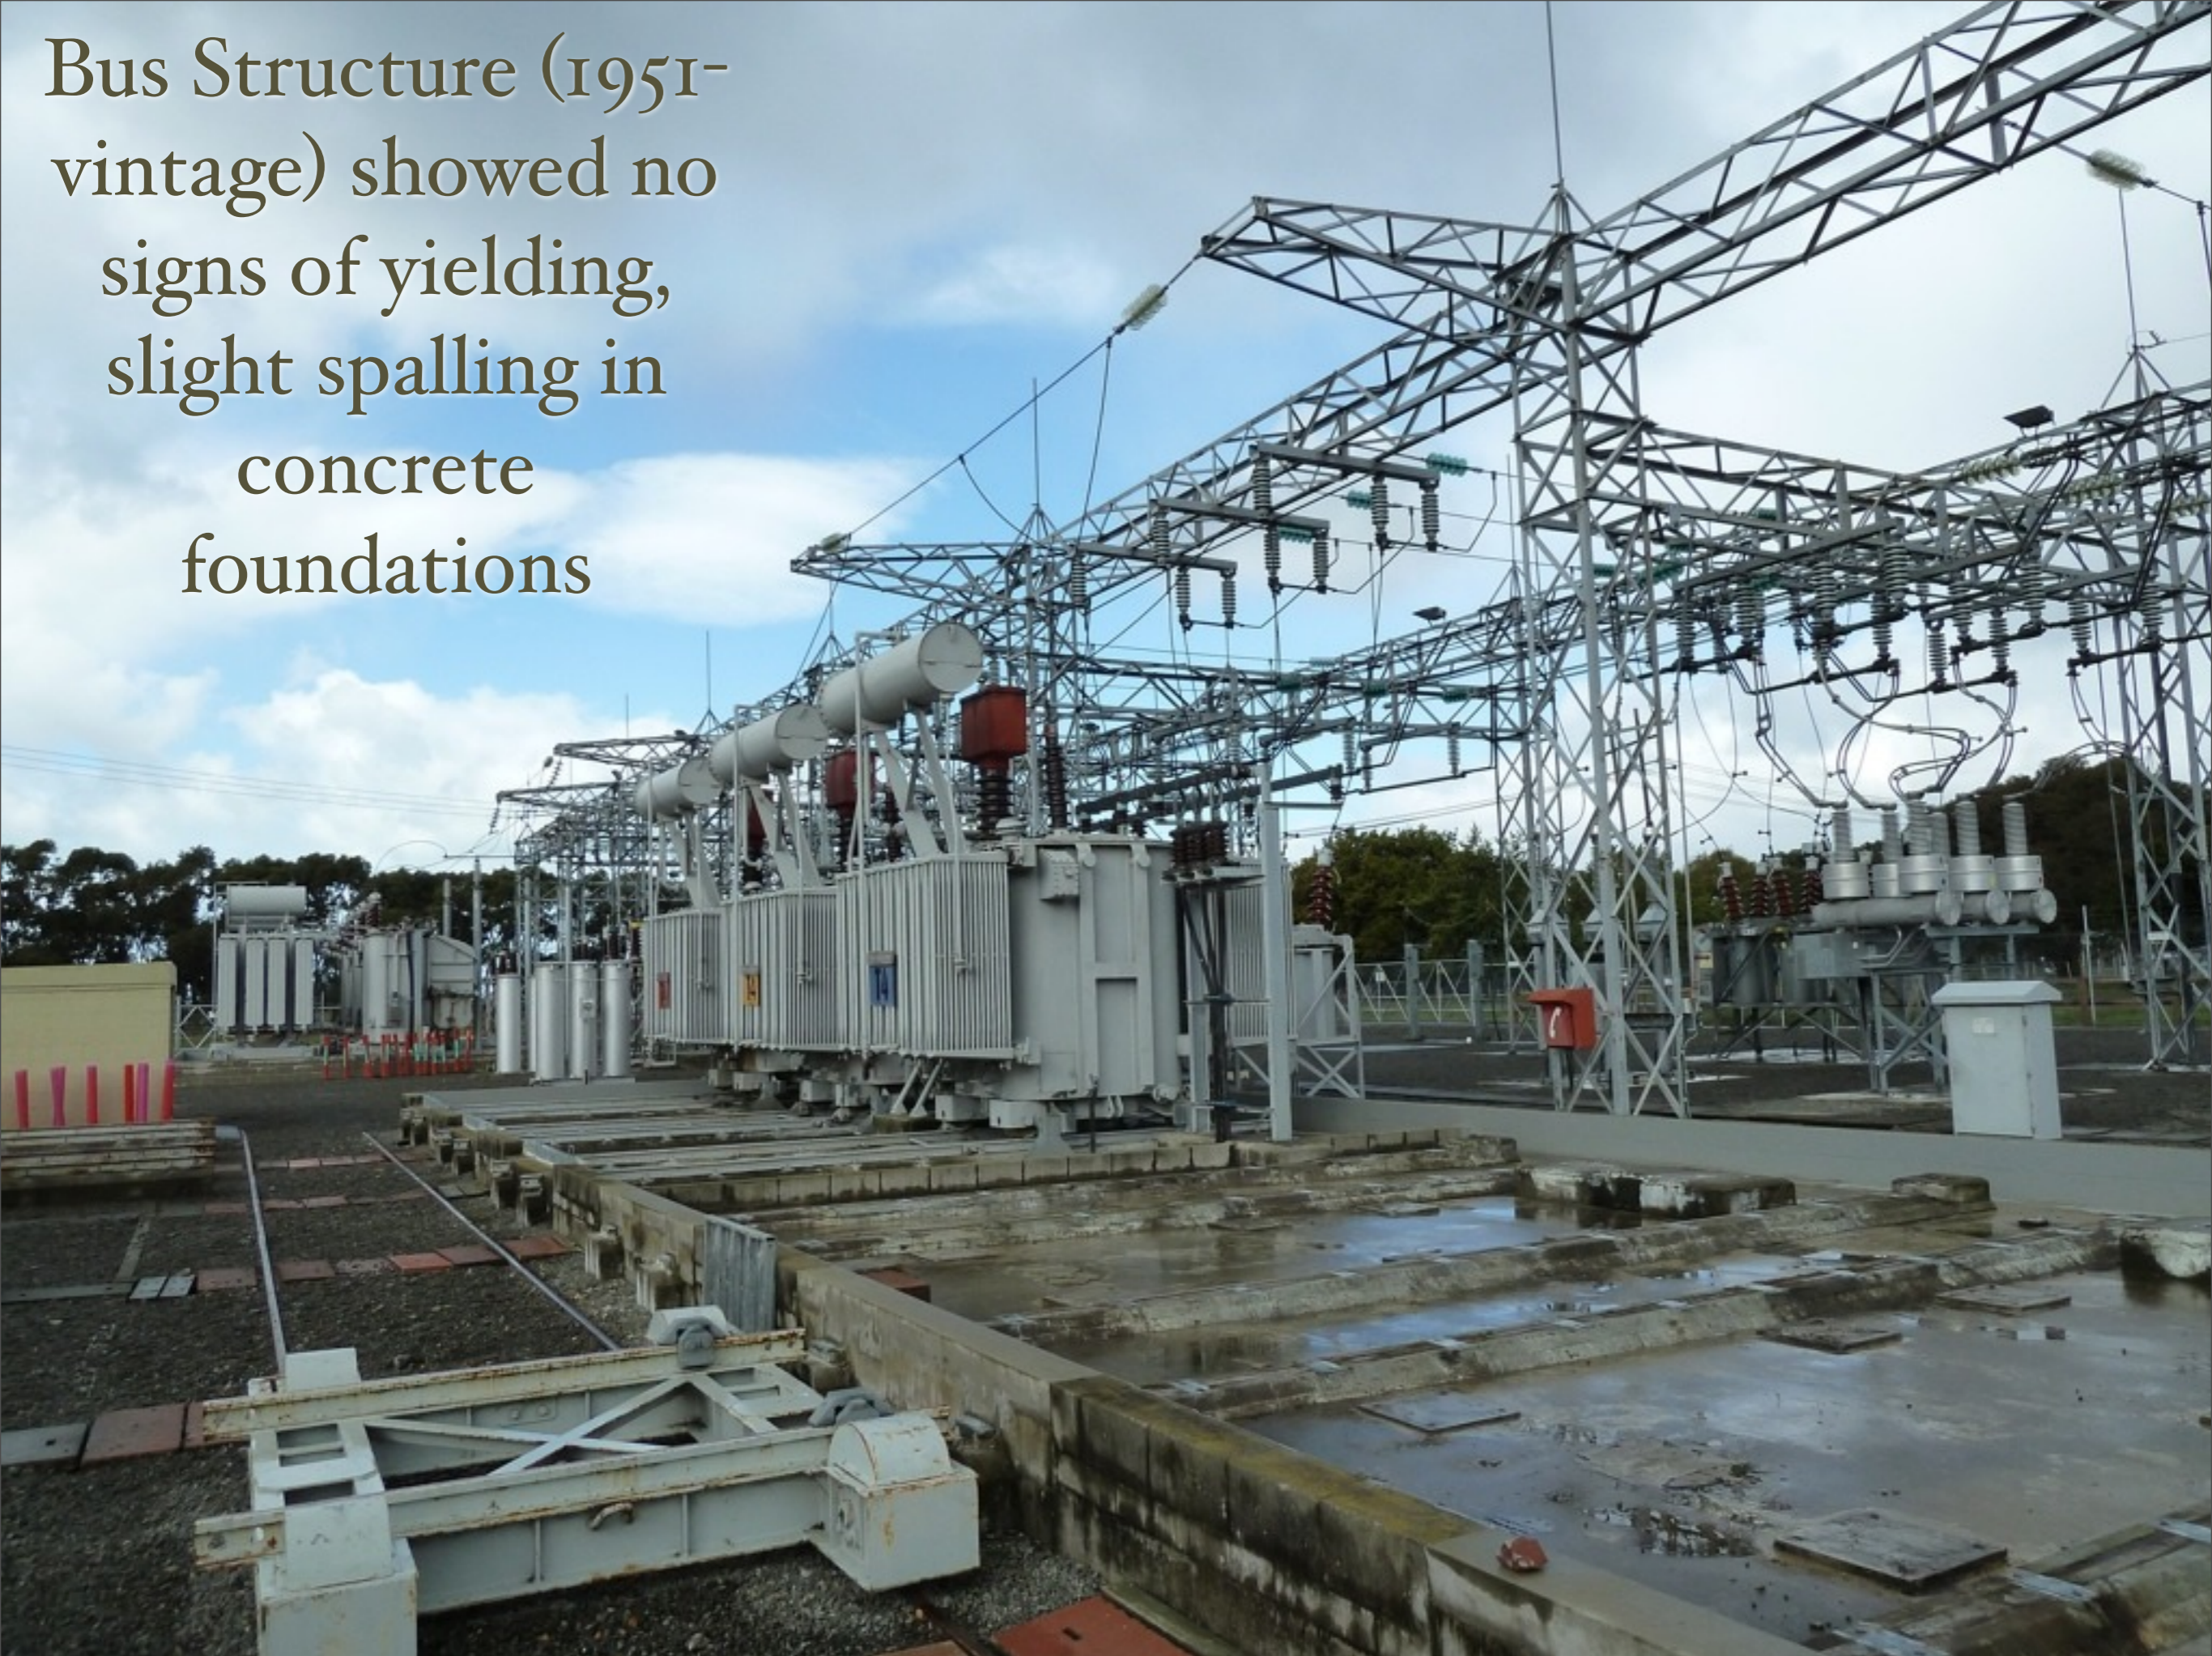
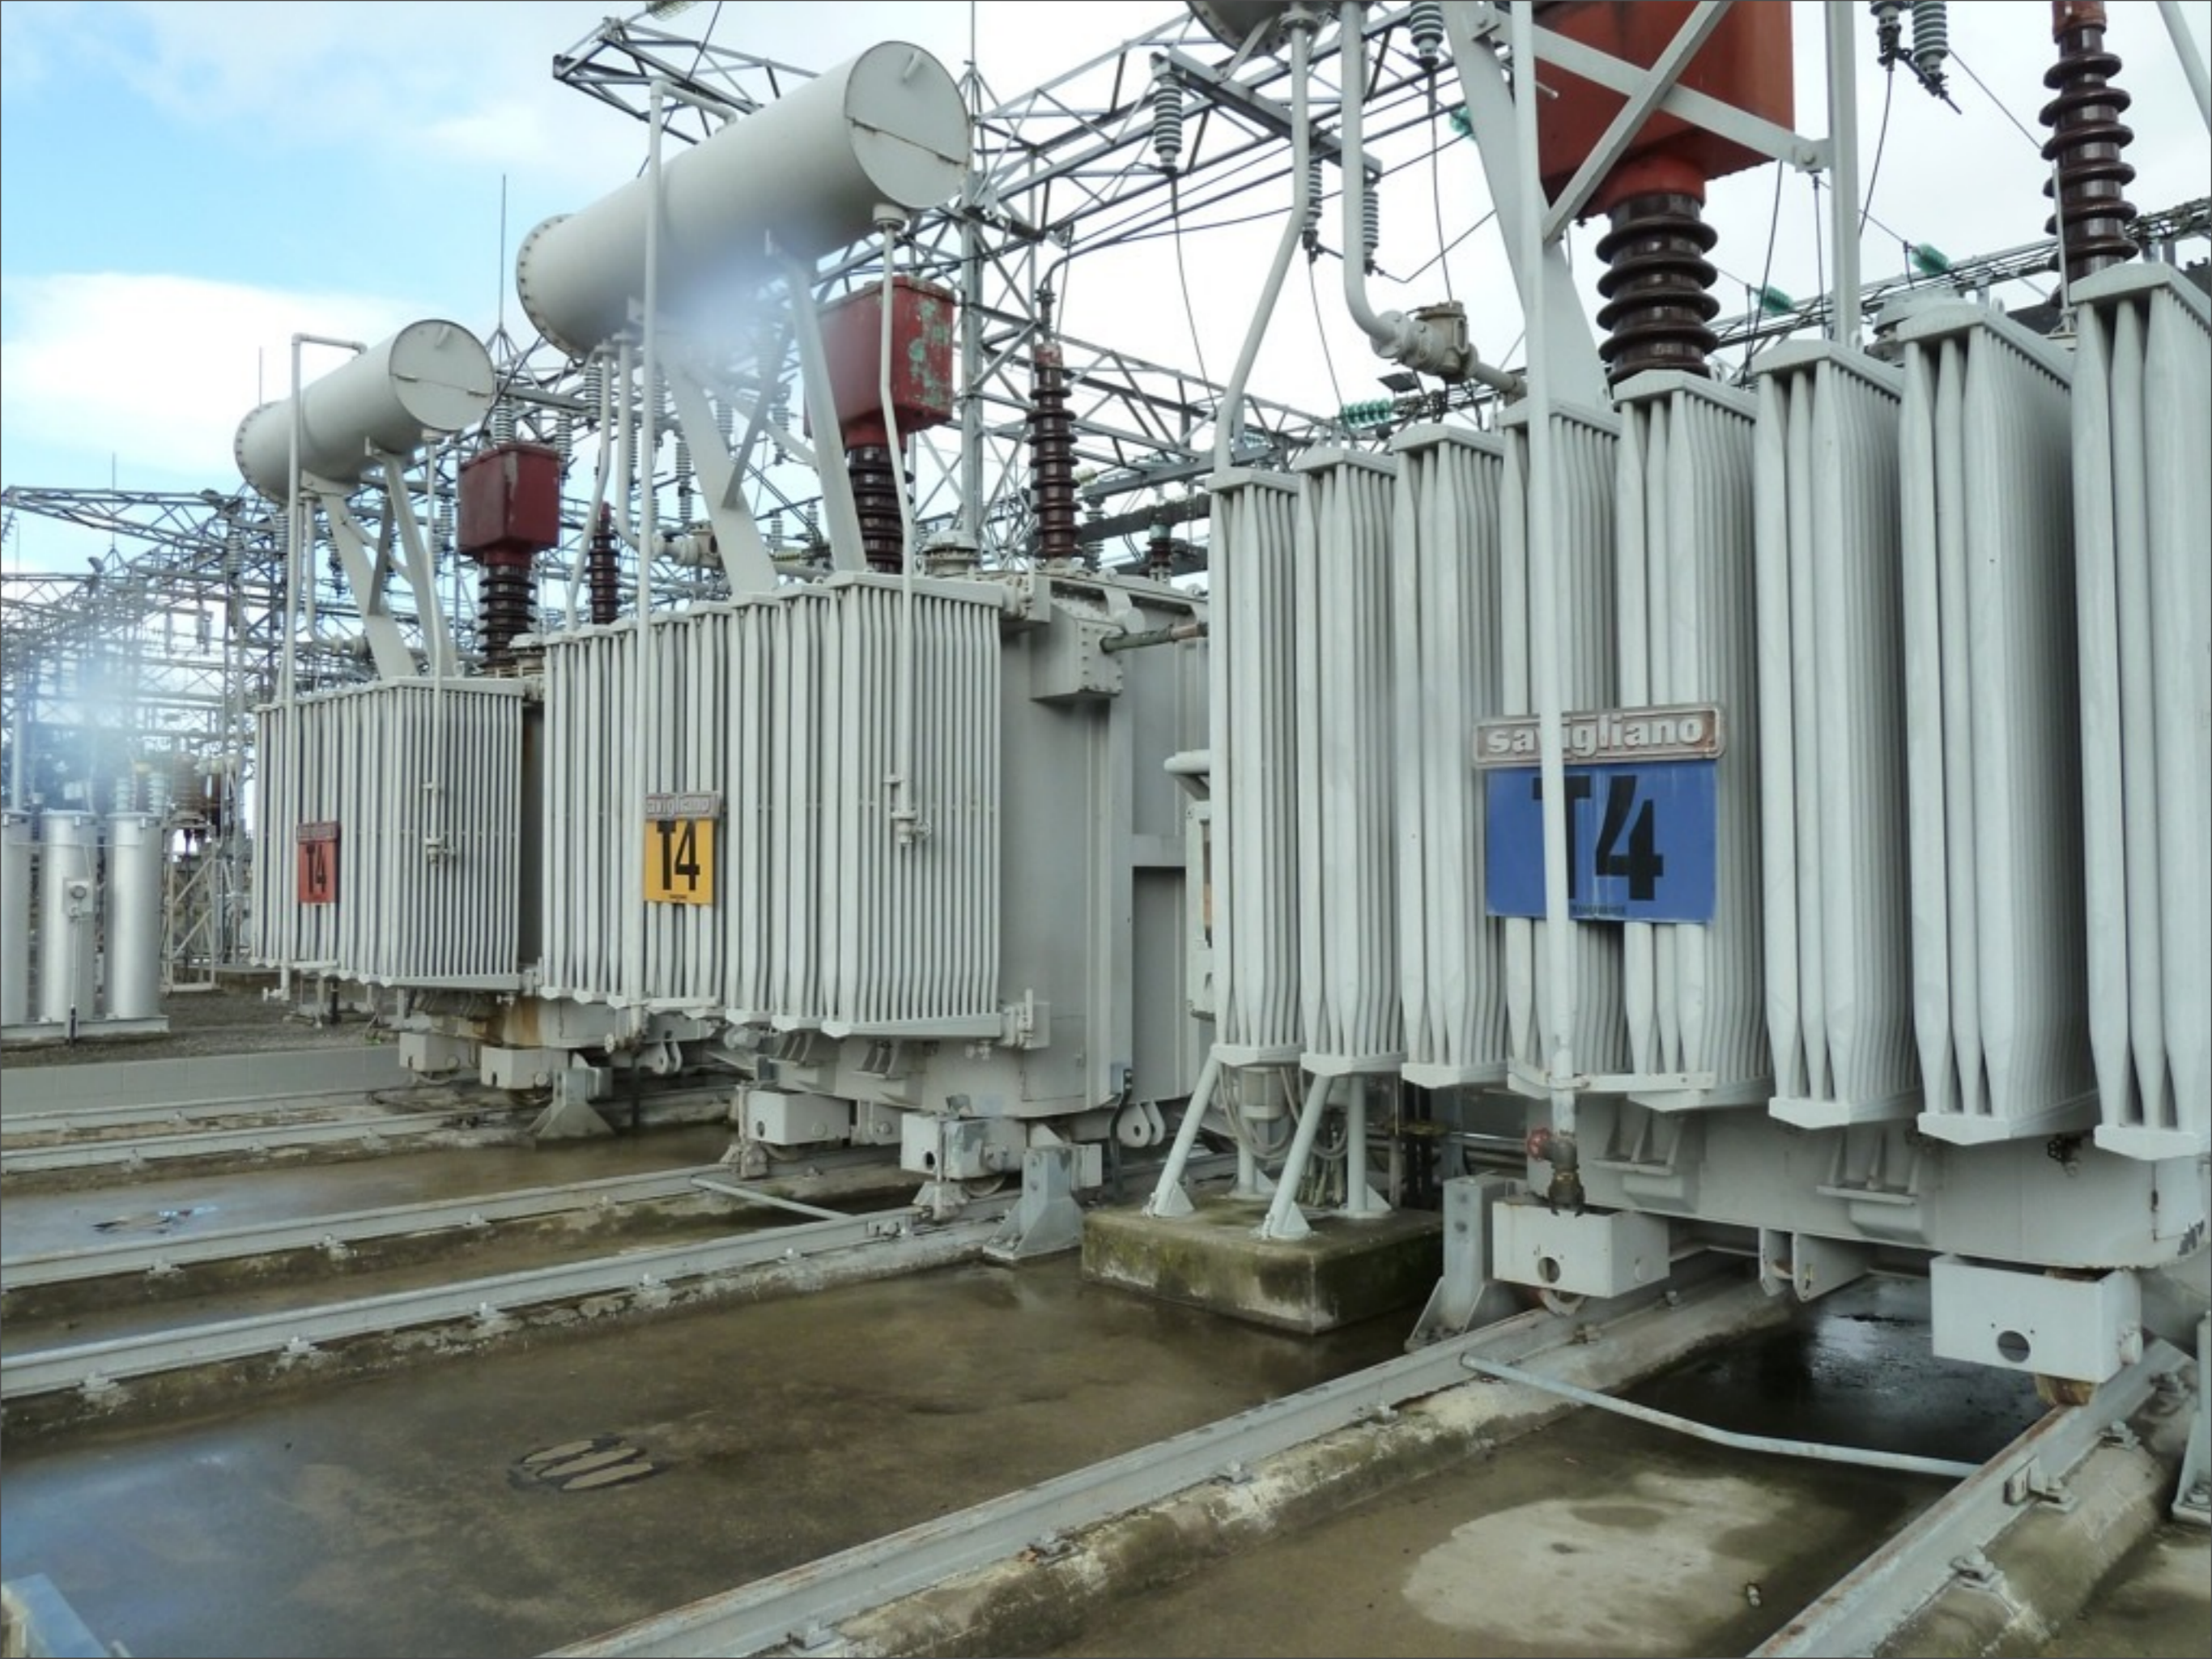
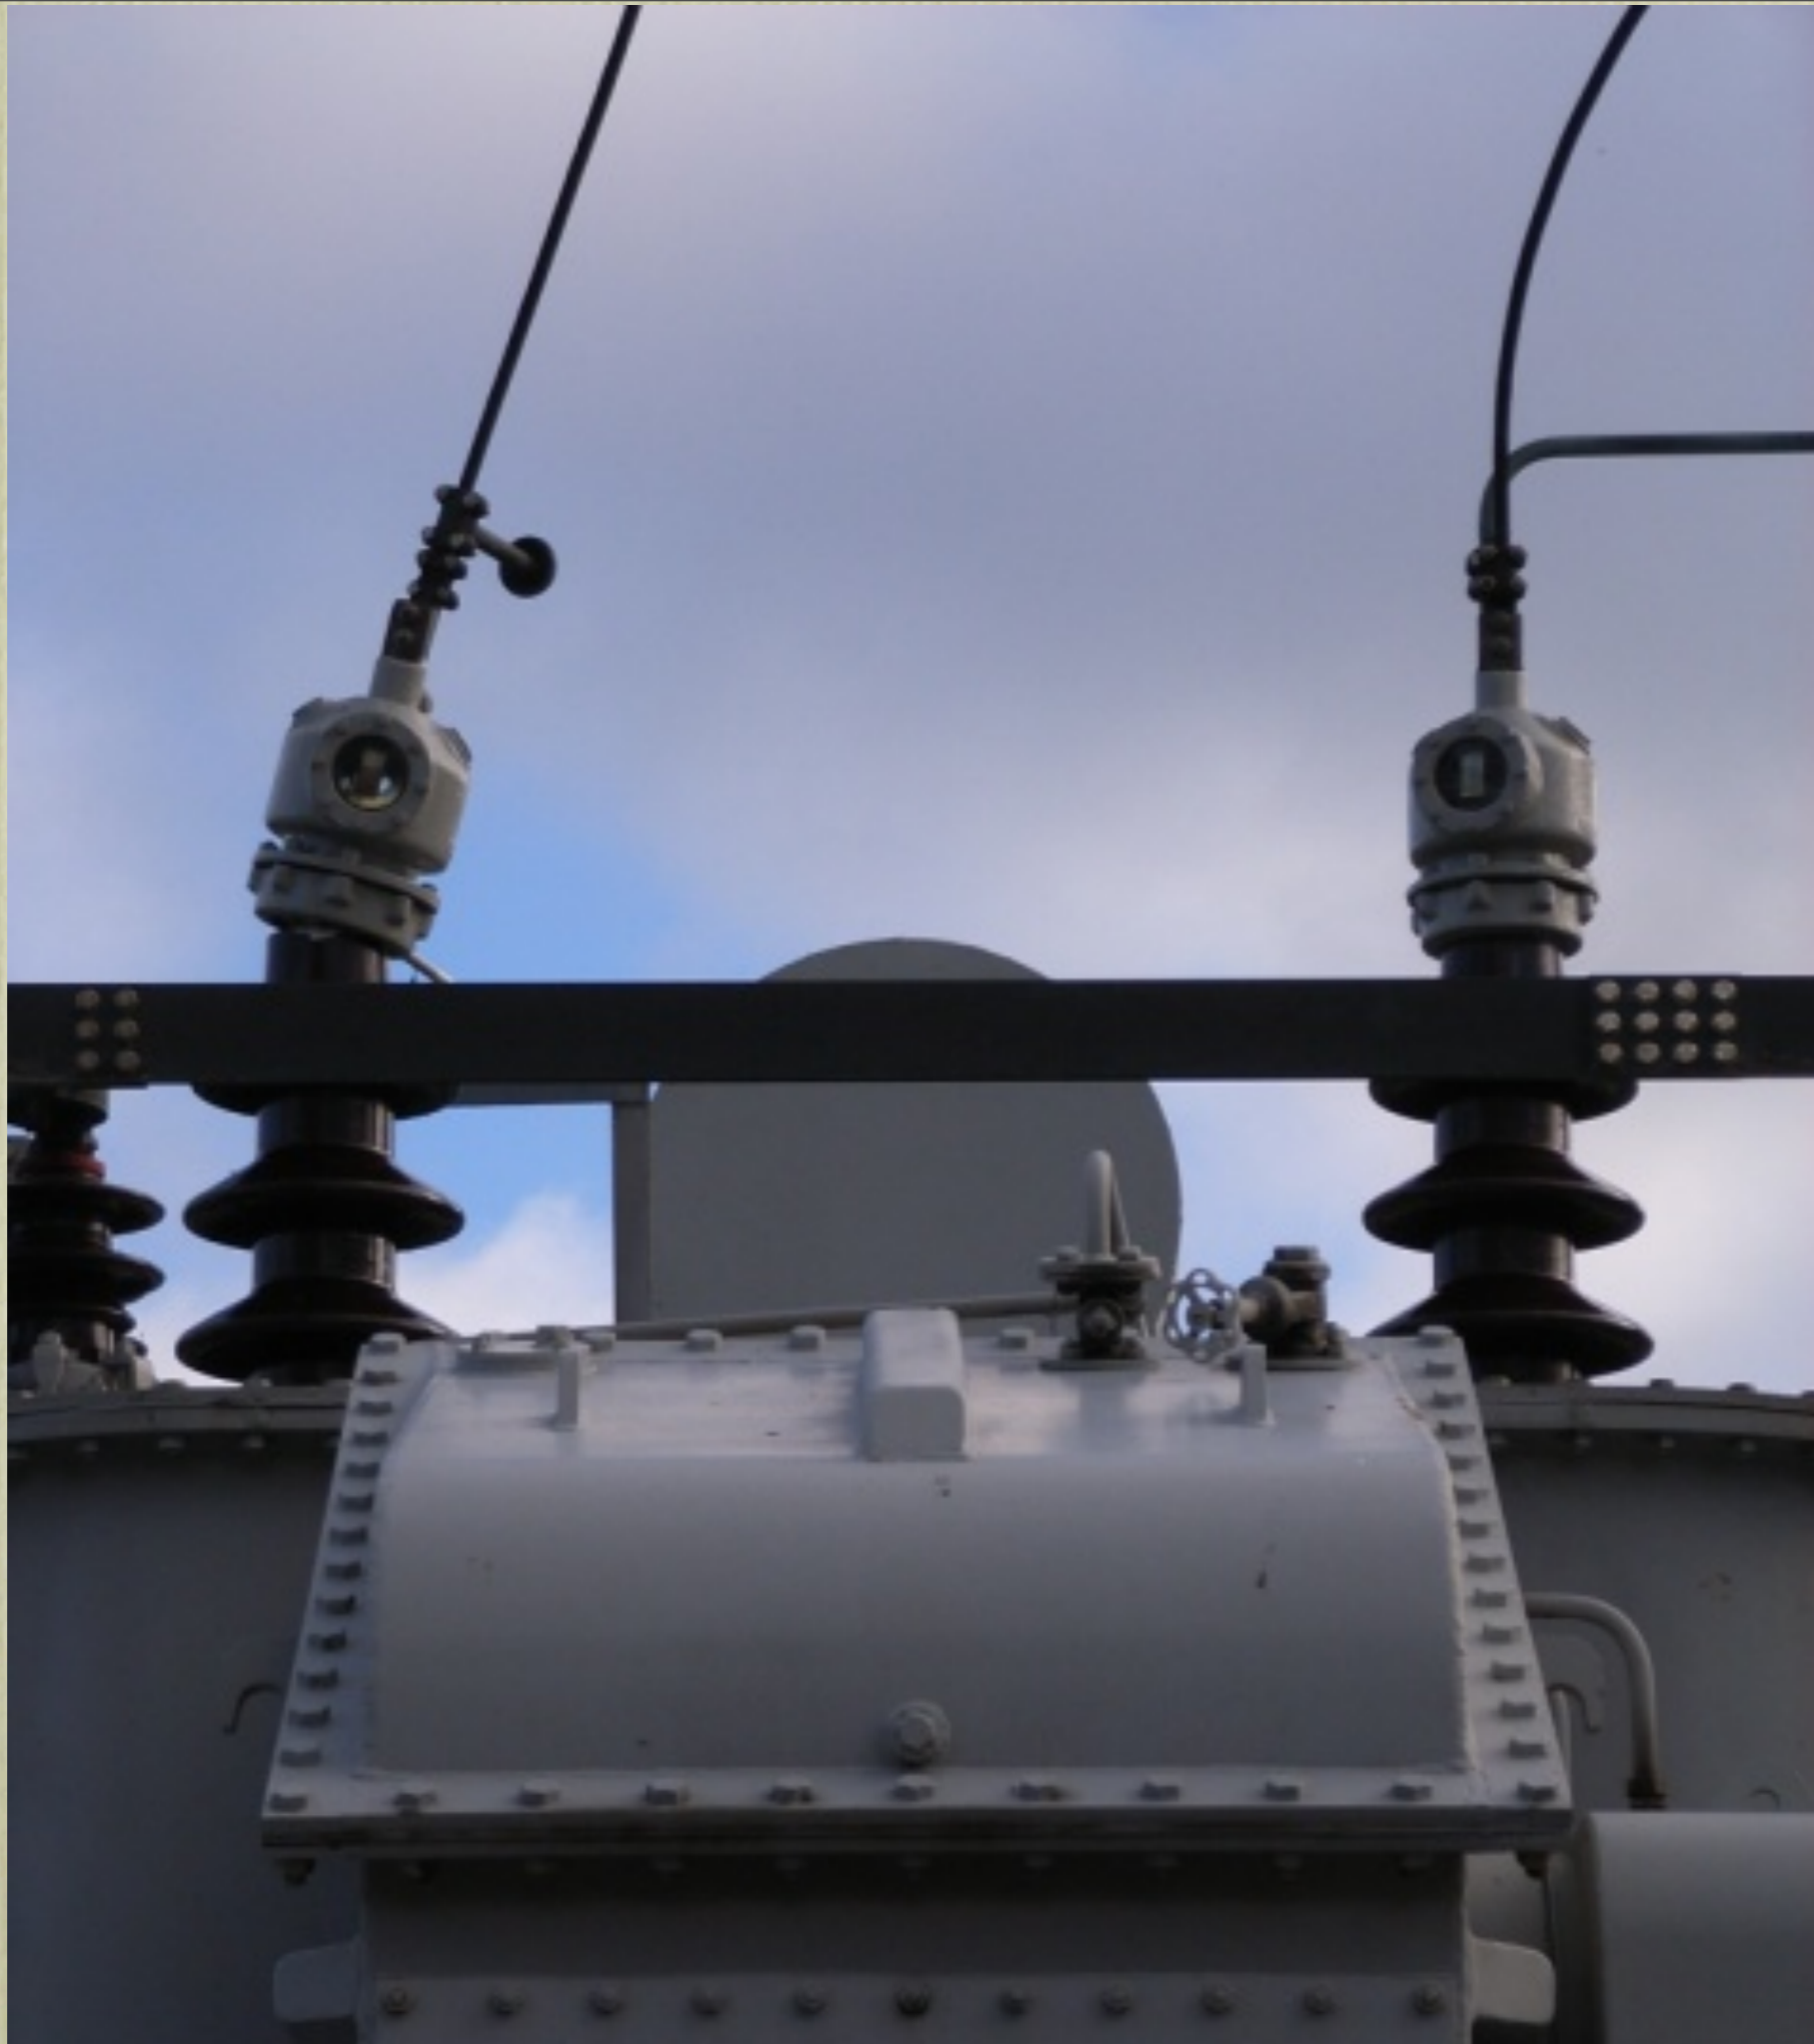
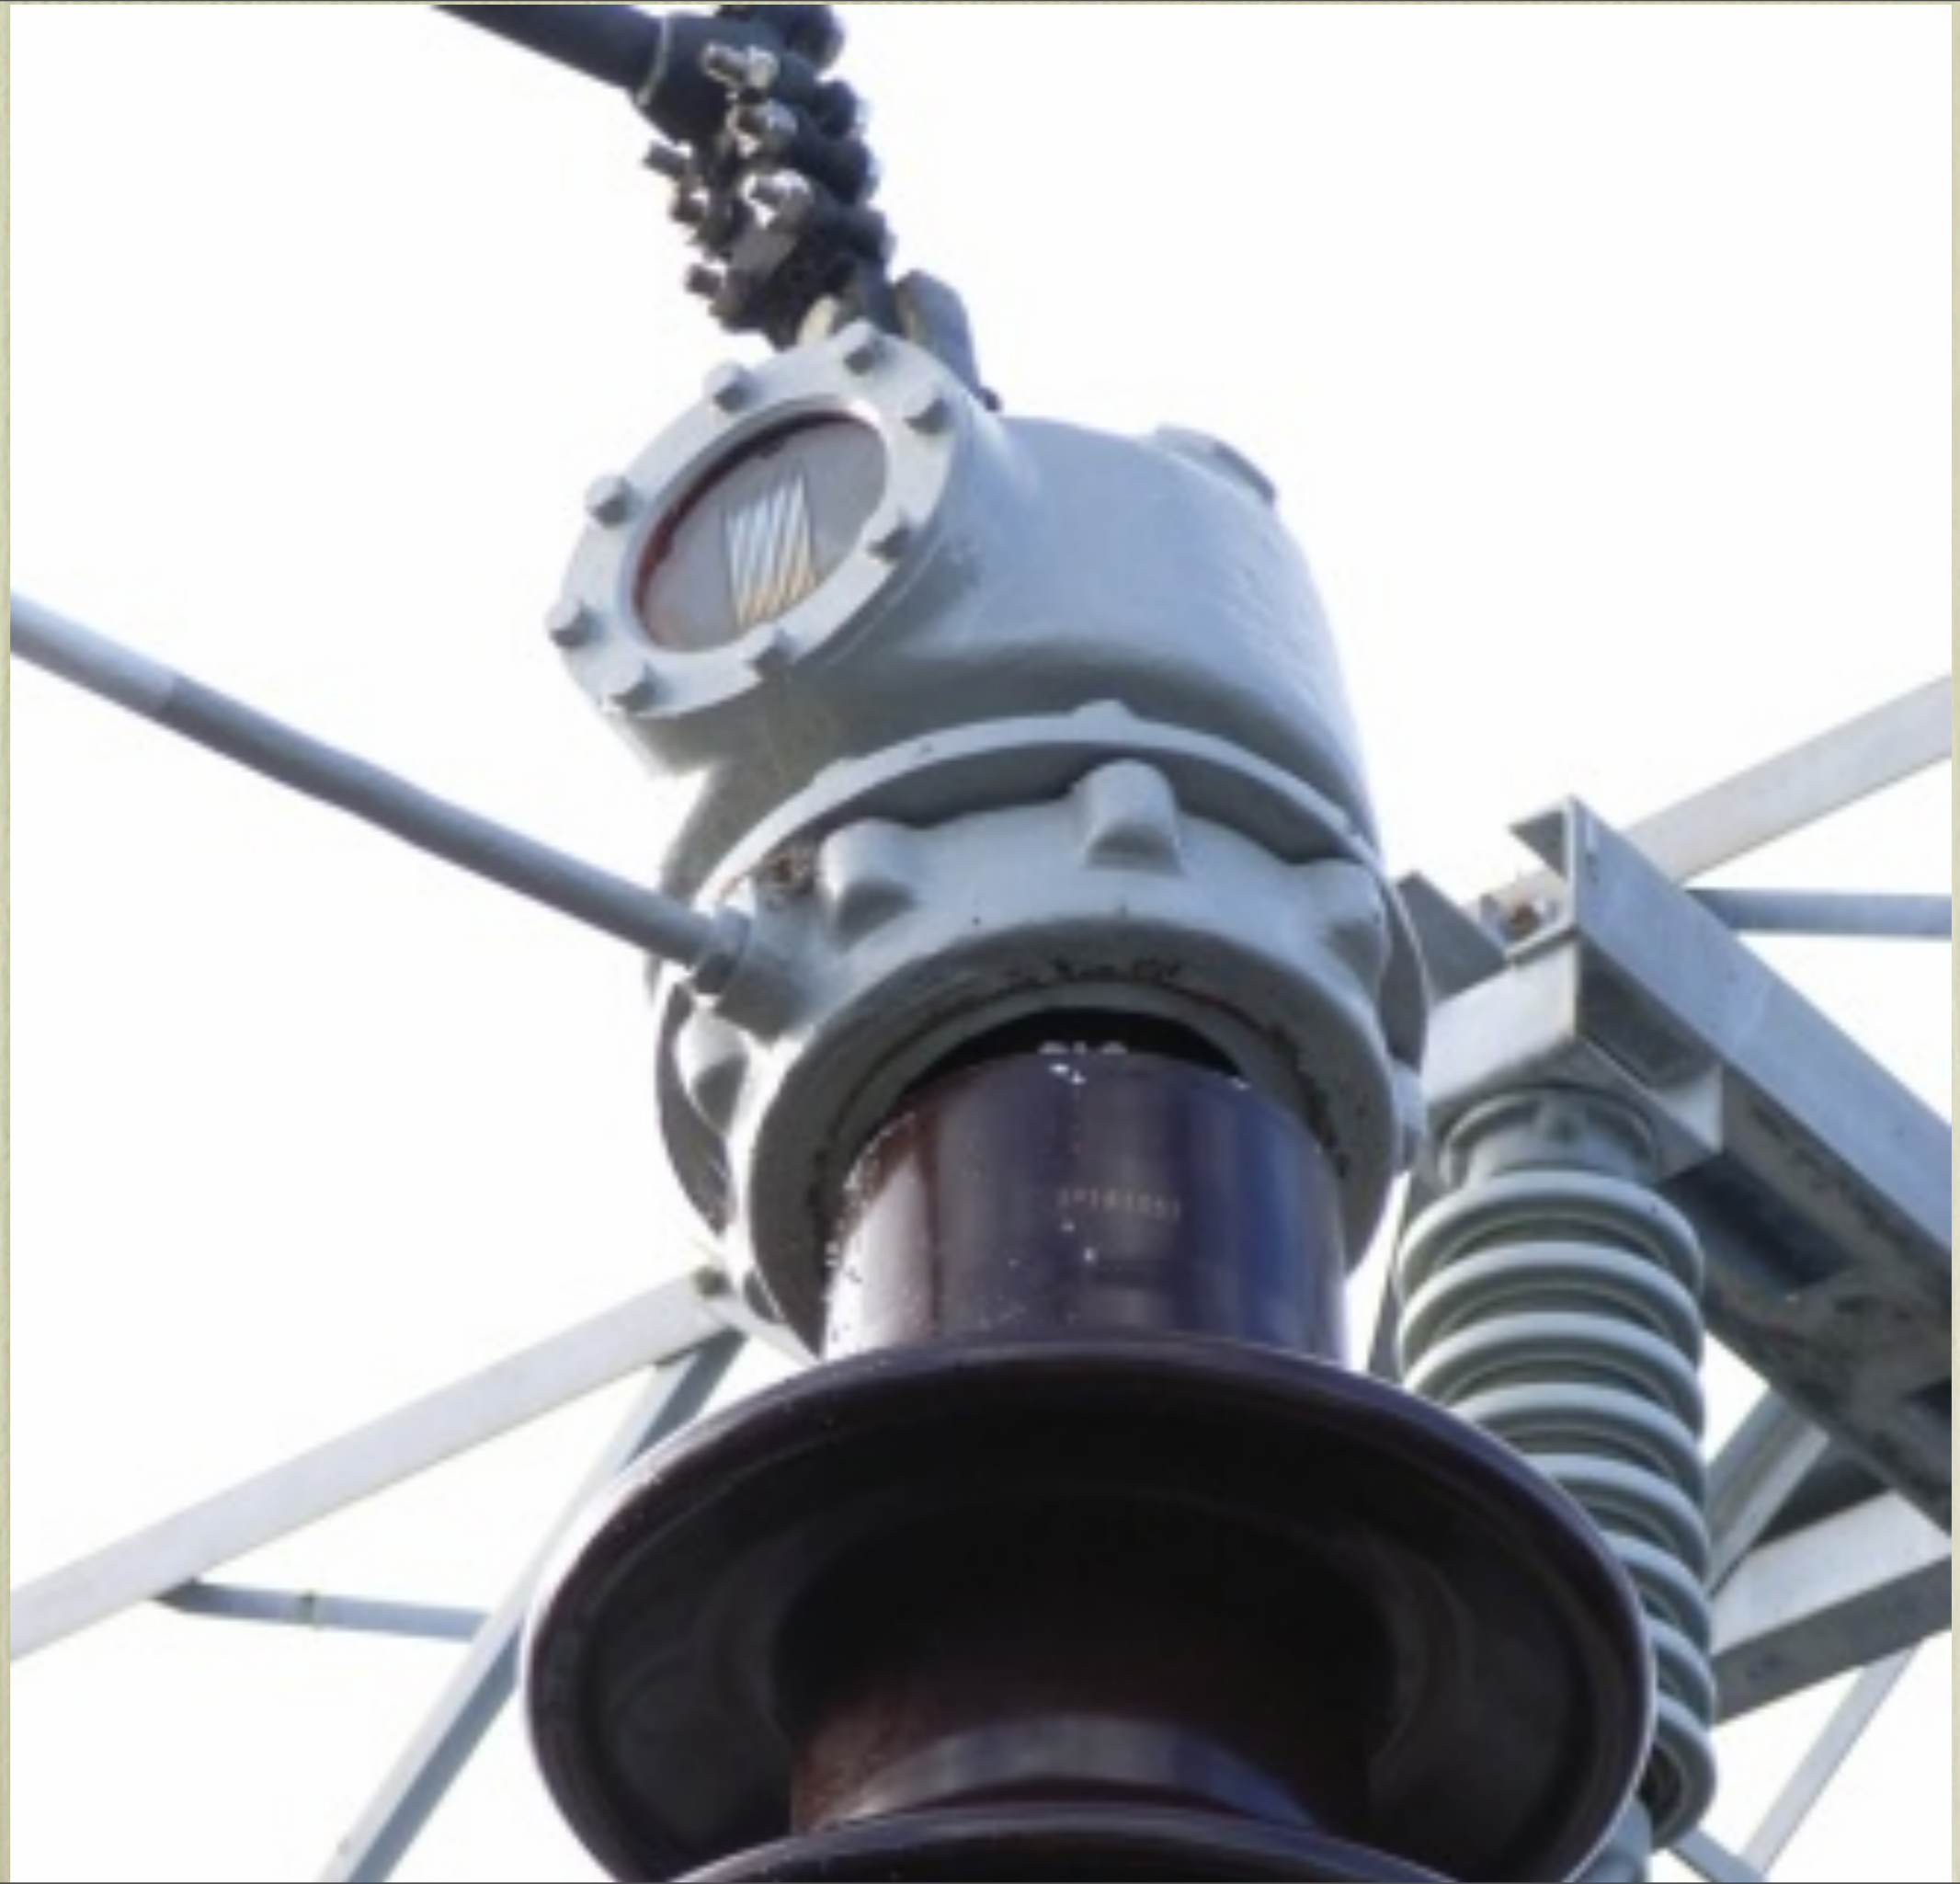
Bus Structure (1951-  
vintage) showed no  
signs of yielding,  
slight spalling in  
concrete  
foundations

Oil Tanks for  
Buried 66 kV  
Cables. 2 of 3 were  
tilted on their  
foundations, one  
spalled concrete  
foundation

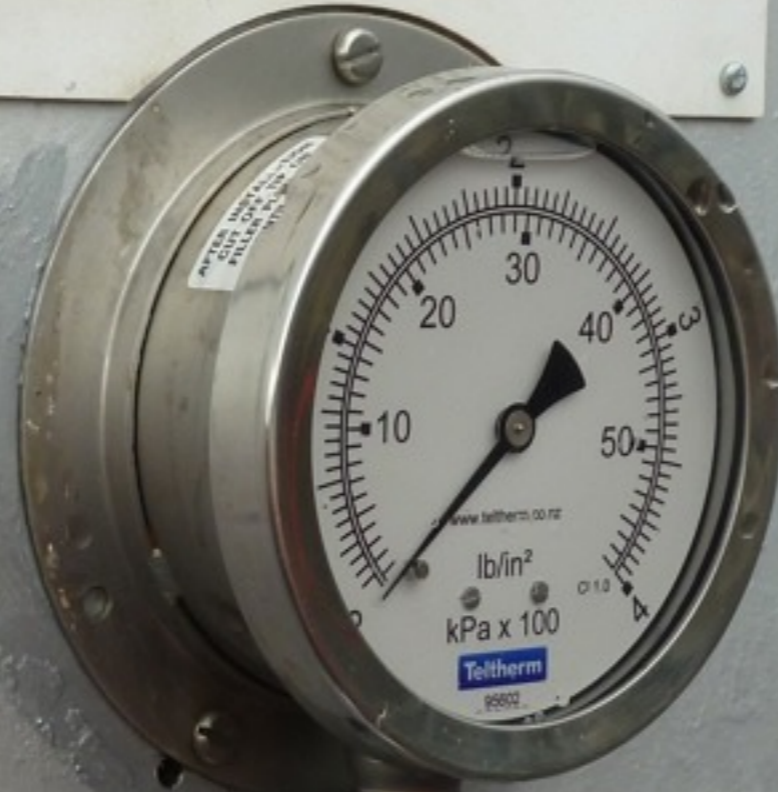
DALLINGTON No.2

0 psi pressure to buried oil-filled cables  
(3 cables from this substation)

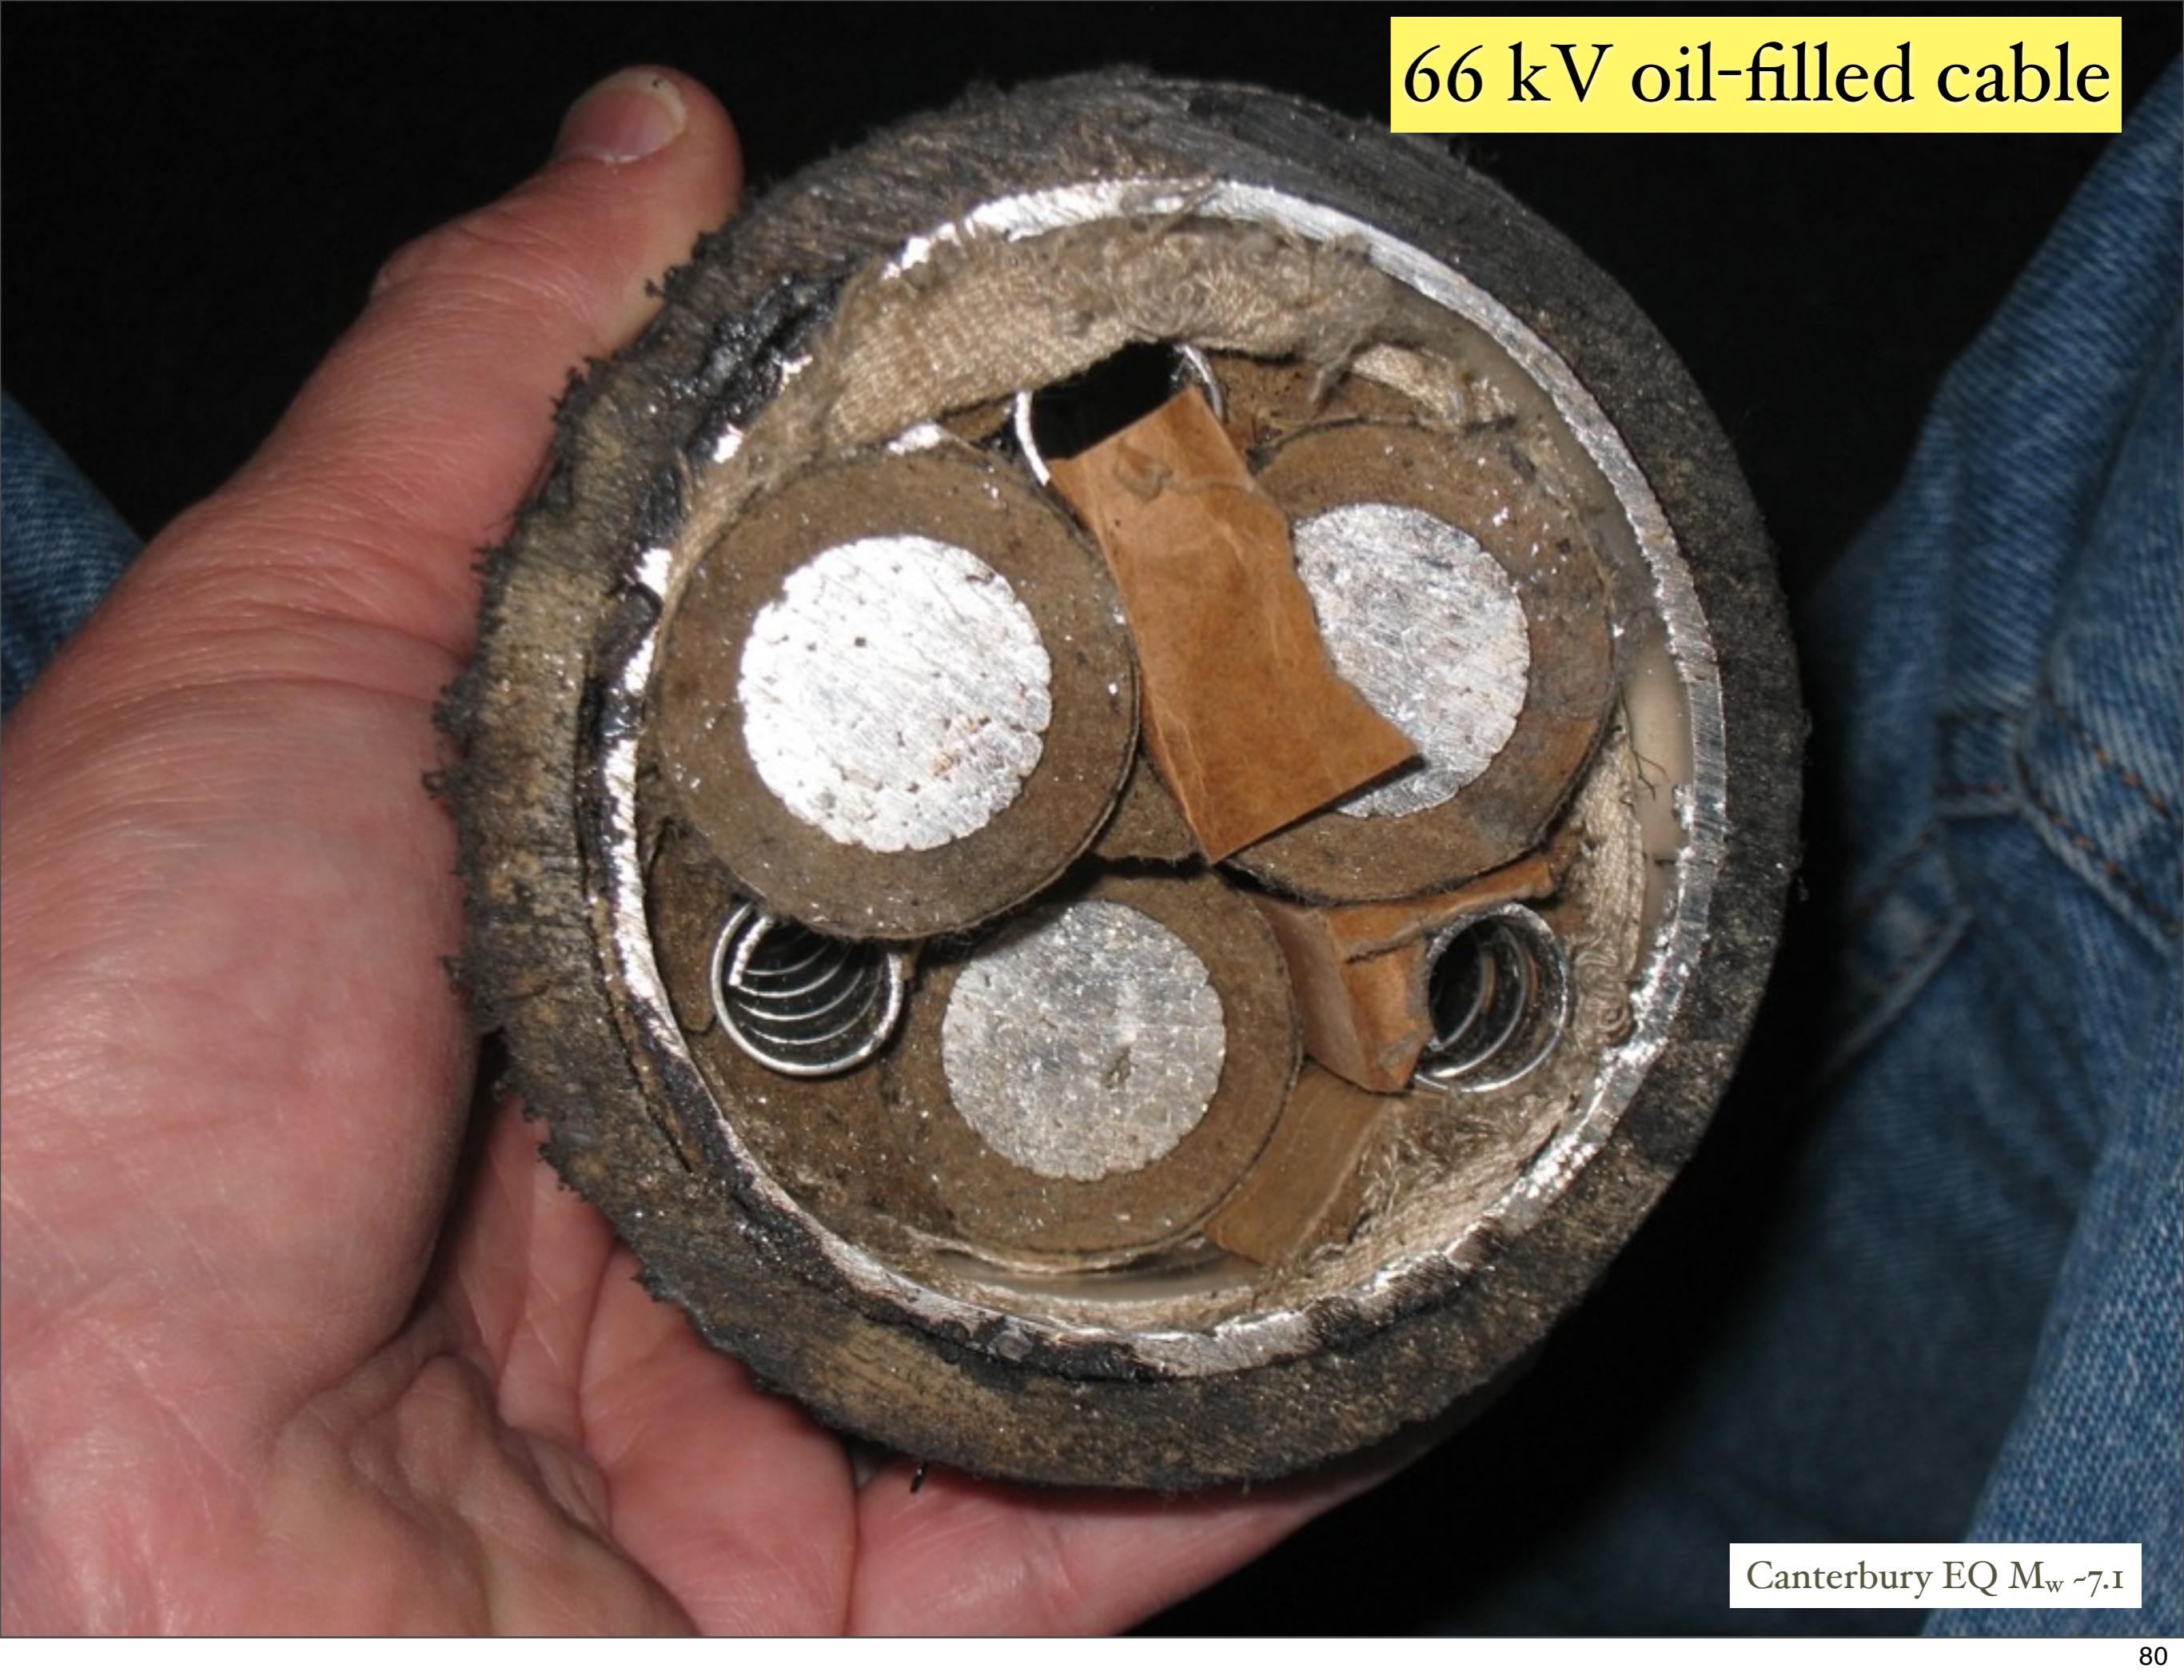
66 kV oil-filled cable

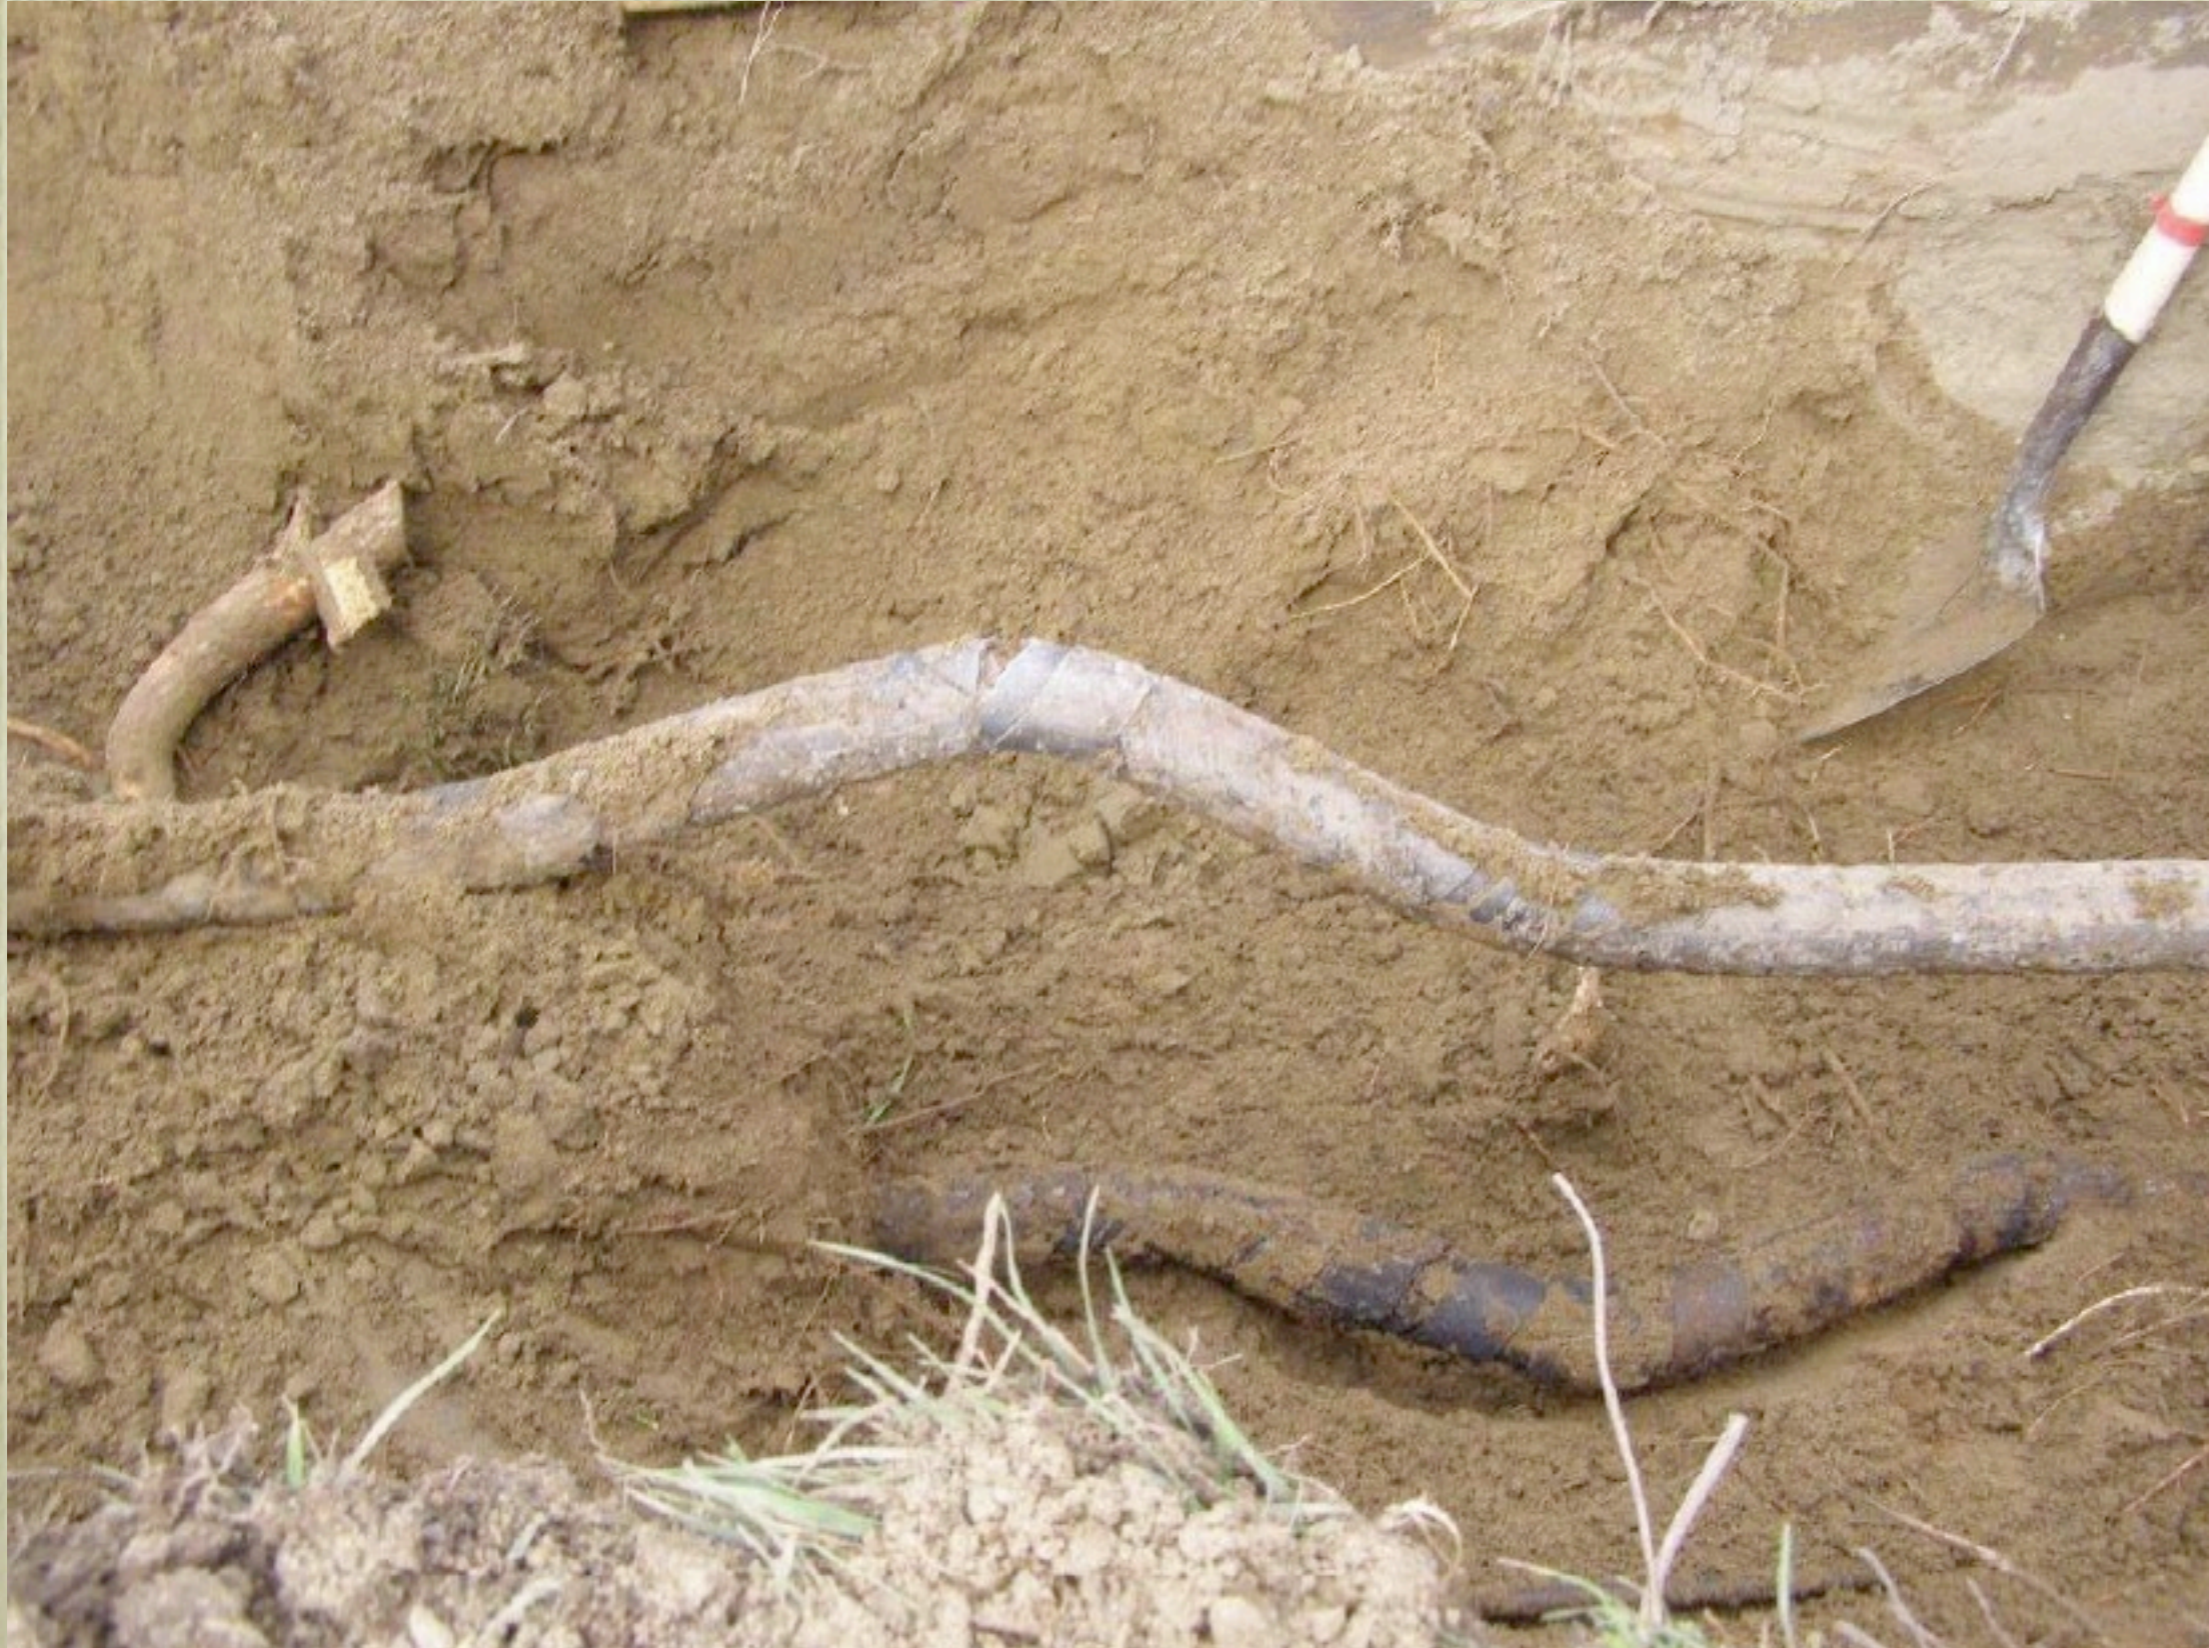
# Typical 11 kV cable damage
