Christchurch, Feb 22 2011 and Sept 4 2010

John Eiding  
G&E Engineering Systems Inc.  
[eidinger@geEngineeringSystems.com](mailto:eidinger@geEngineeringSystems.com)

## Impact to Electric Power Systems

ASCE - Structural Congress

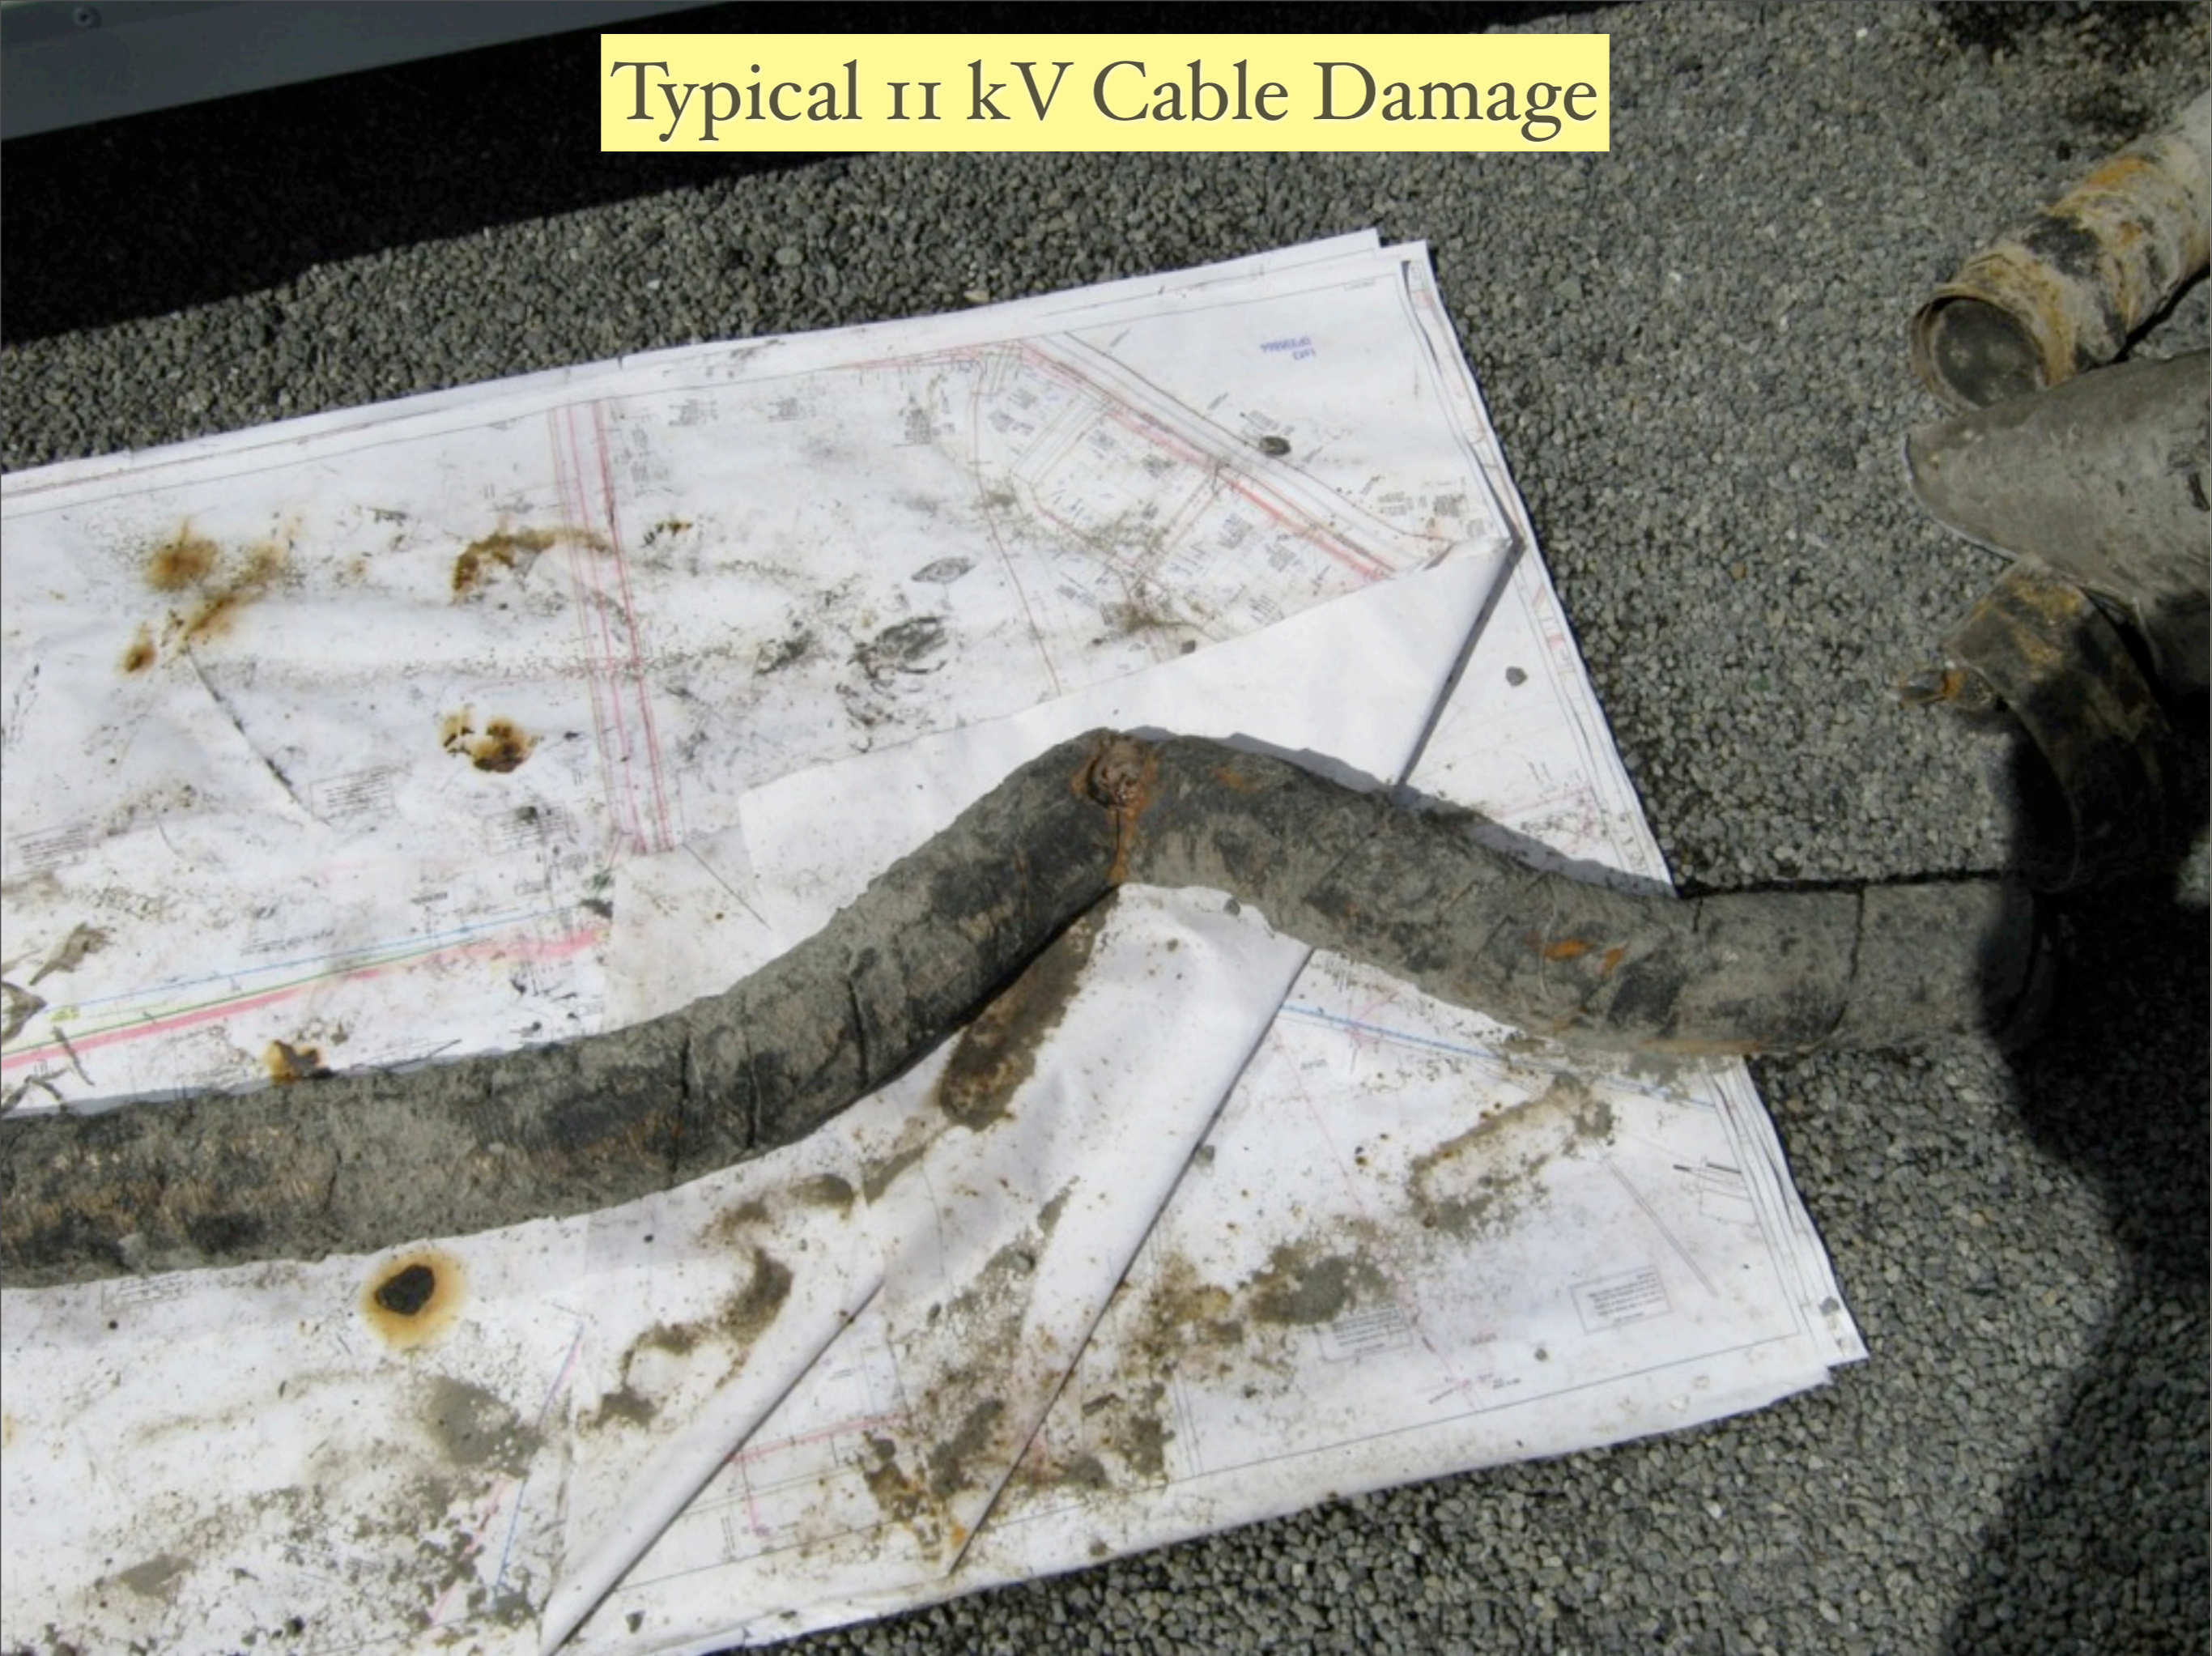
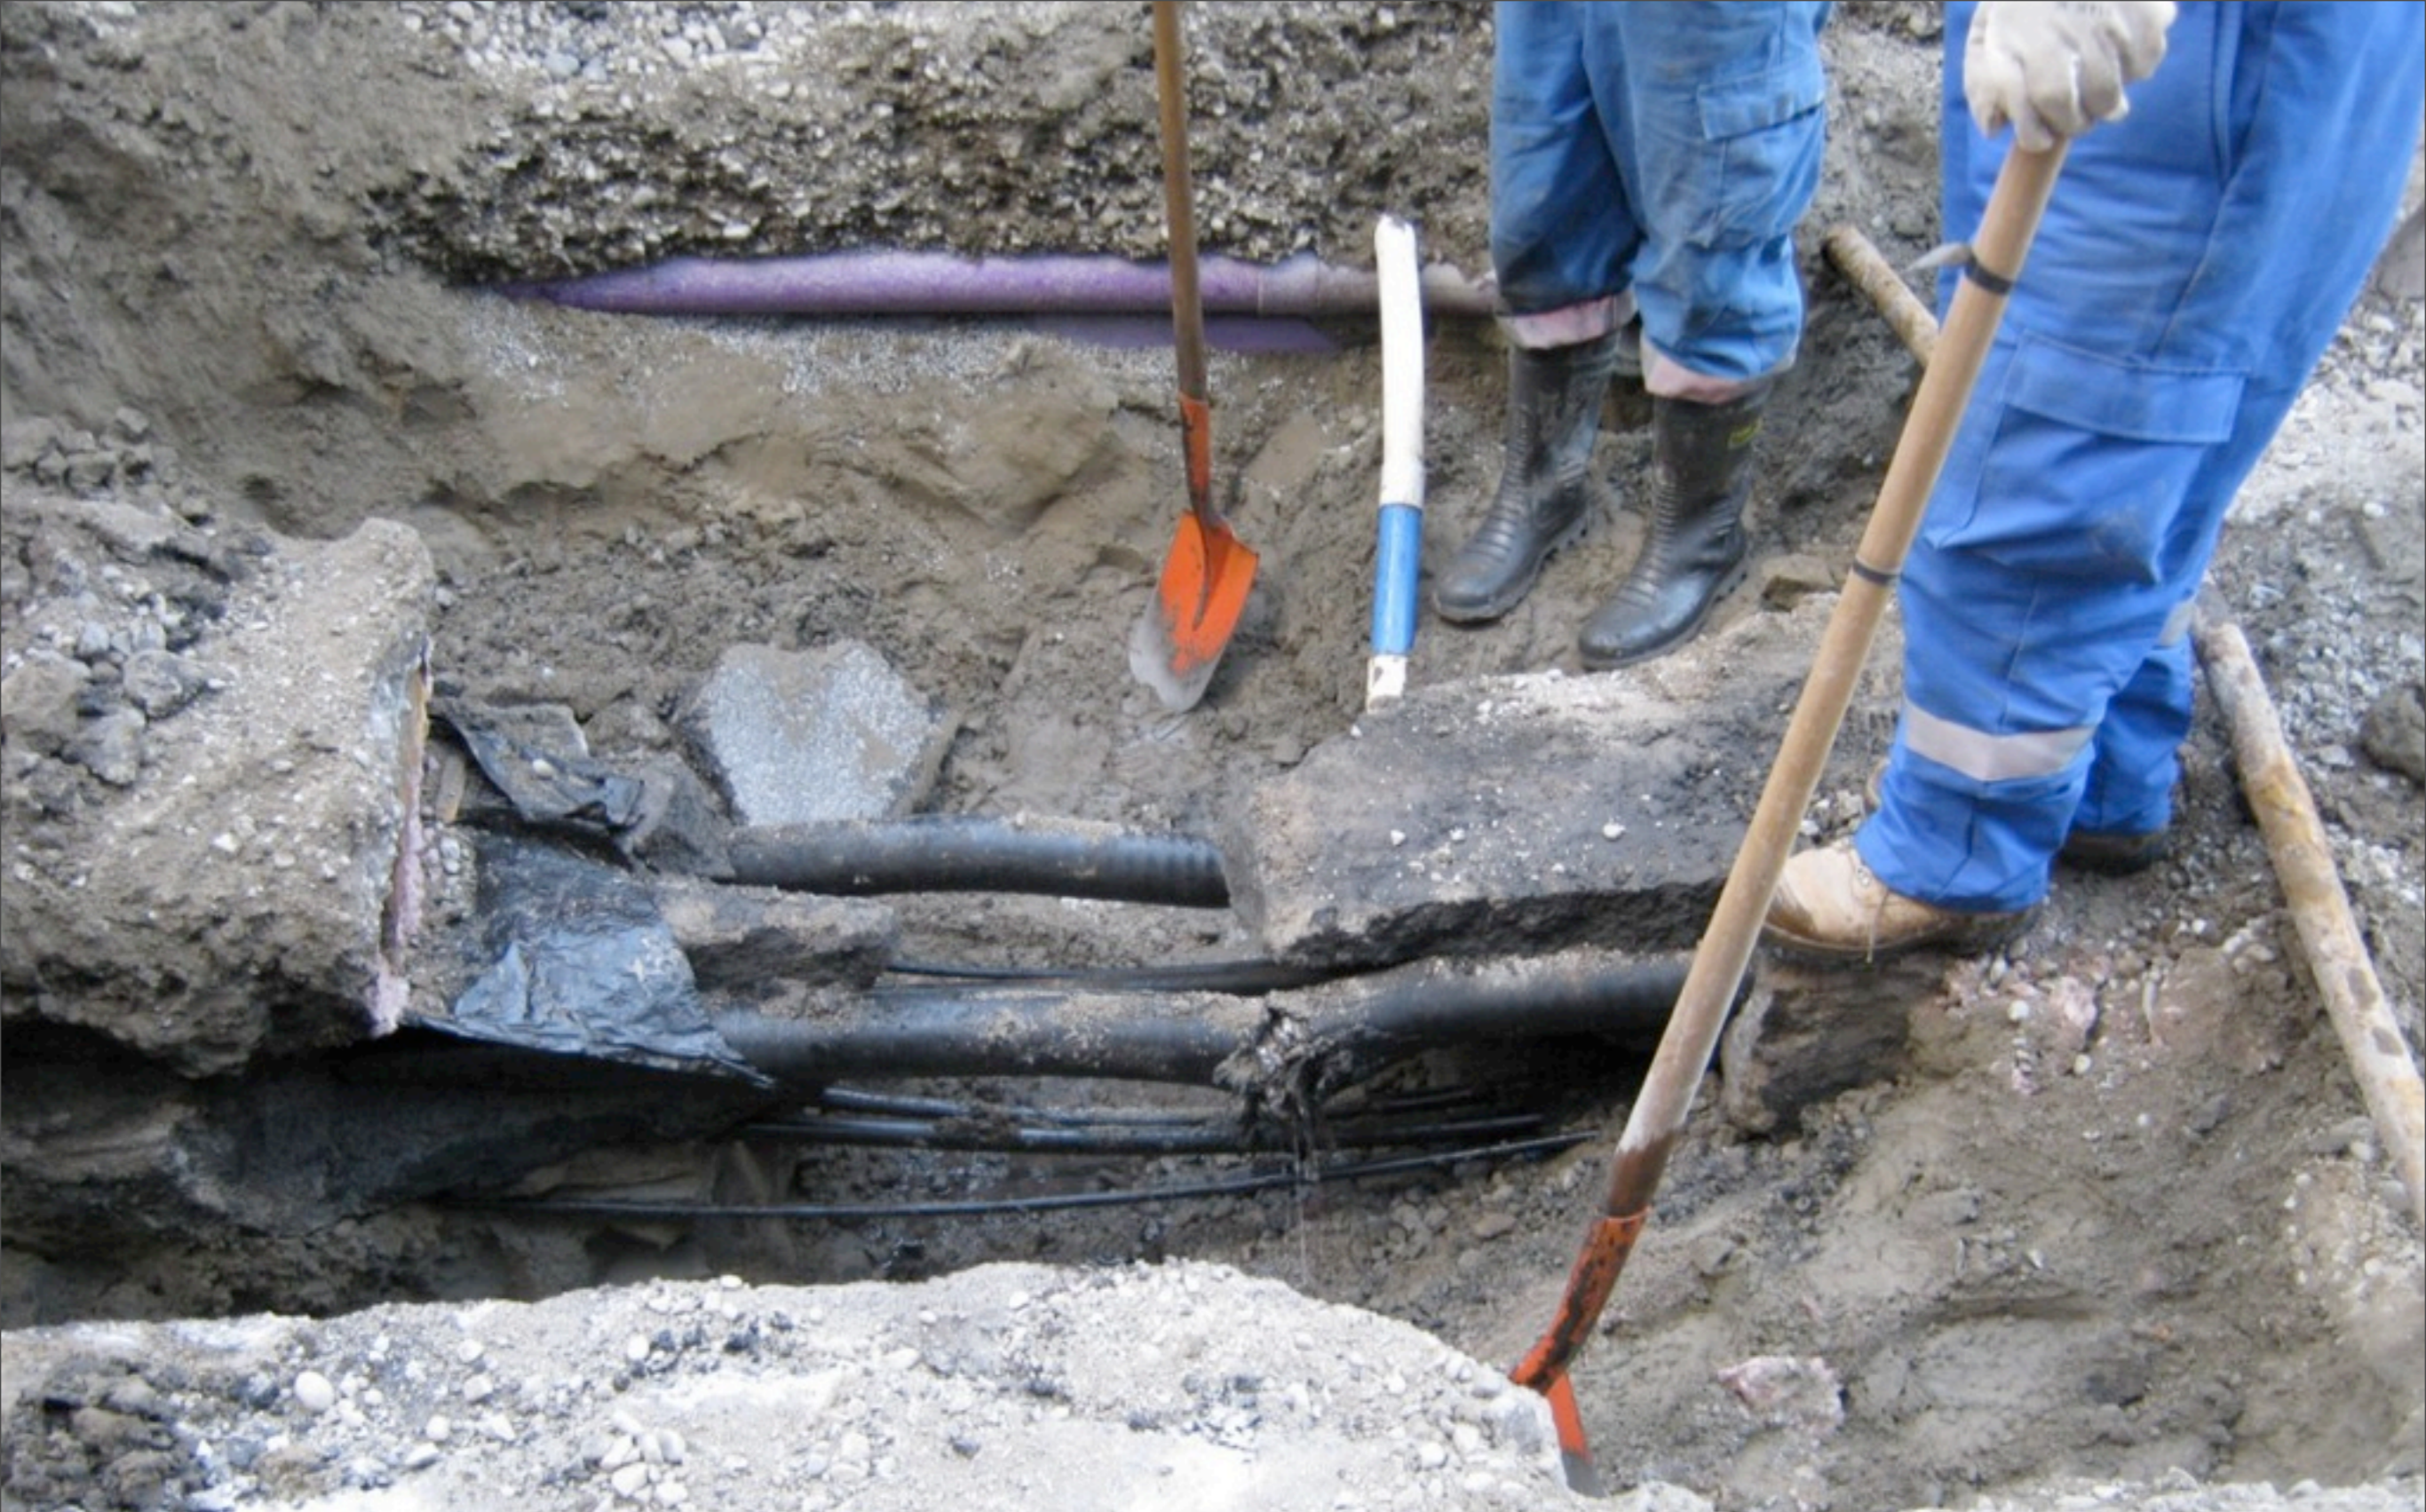
# Typical 11 kV Cable Damage

Armagh Street - failed 66 kV cables (multiple)  
Similar damage for Brighton, Dallington

66 kV Cable - Buckled, but remains operational (for now)

- Build overhead “temporary” 66 kV cables:
  - 3 km to Brighton
  - 4.5 km to Dallington
  - 1.5 km to Keys. New substation at Keys

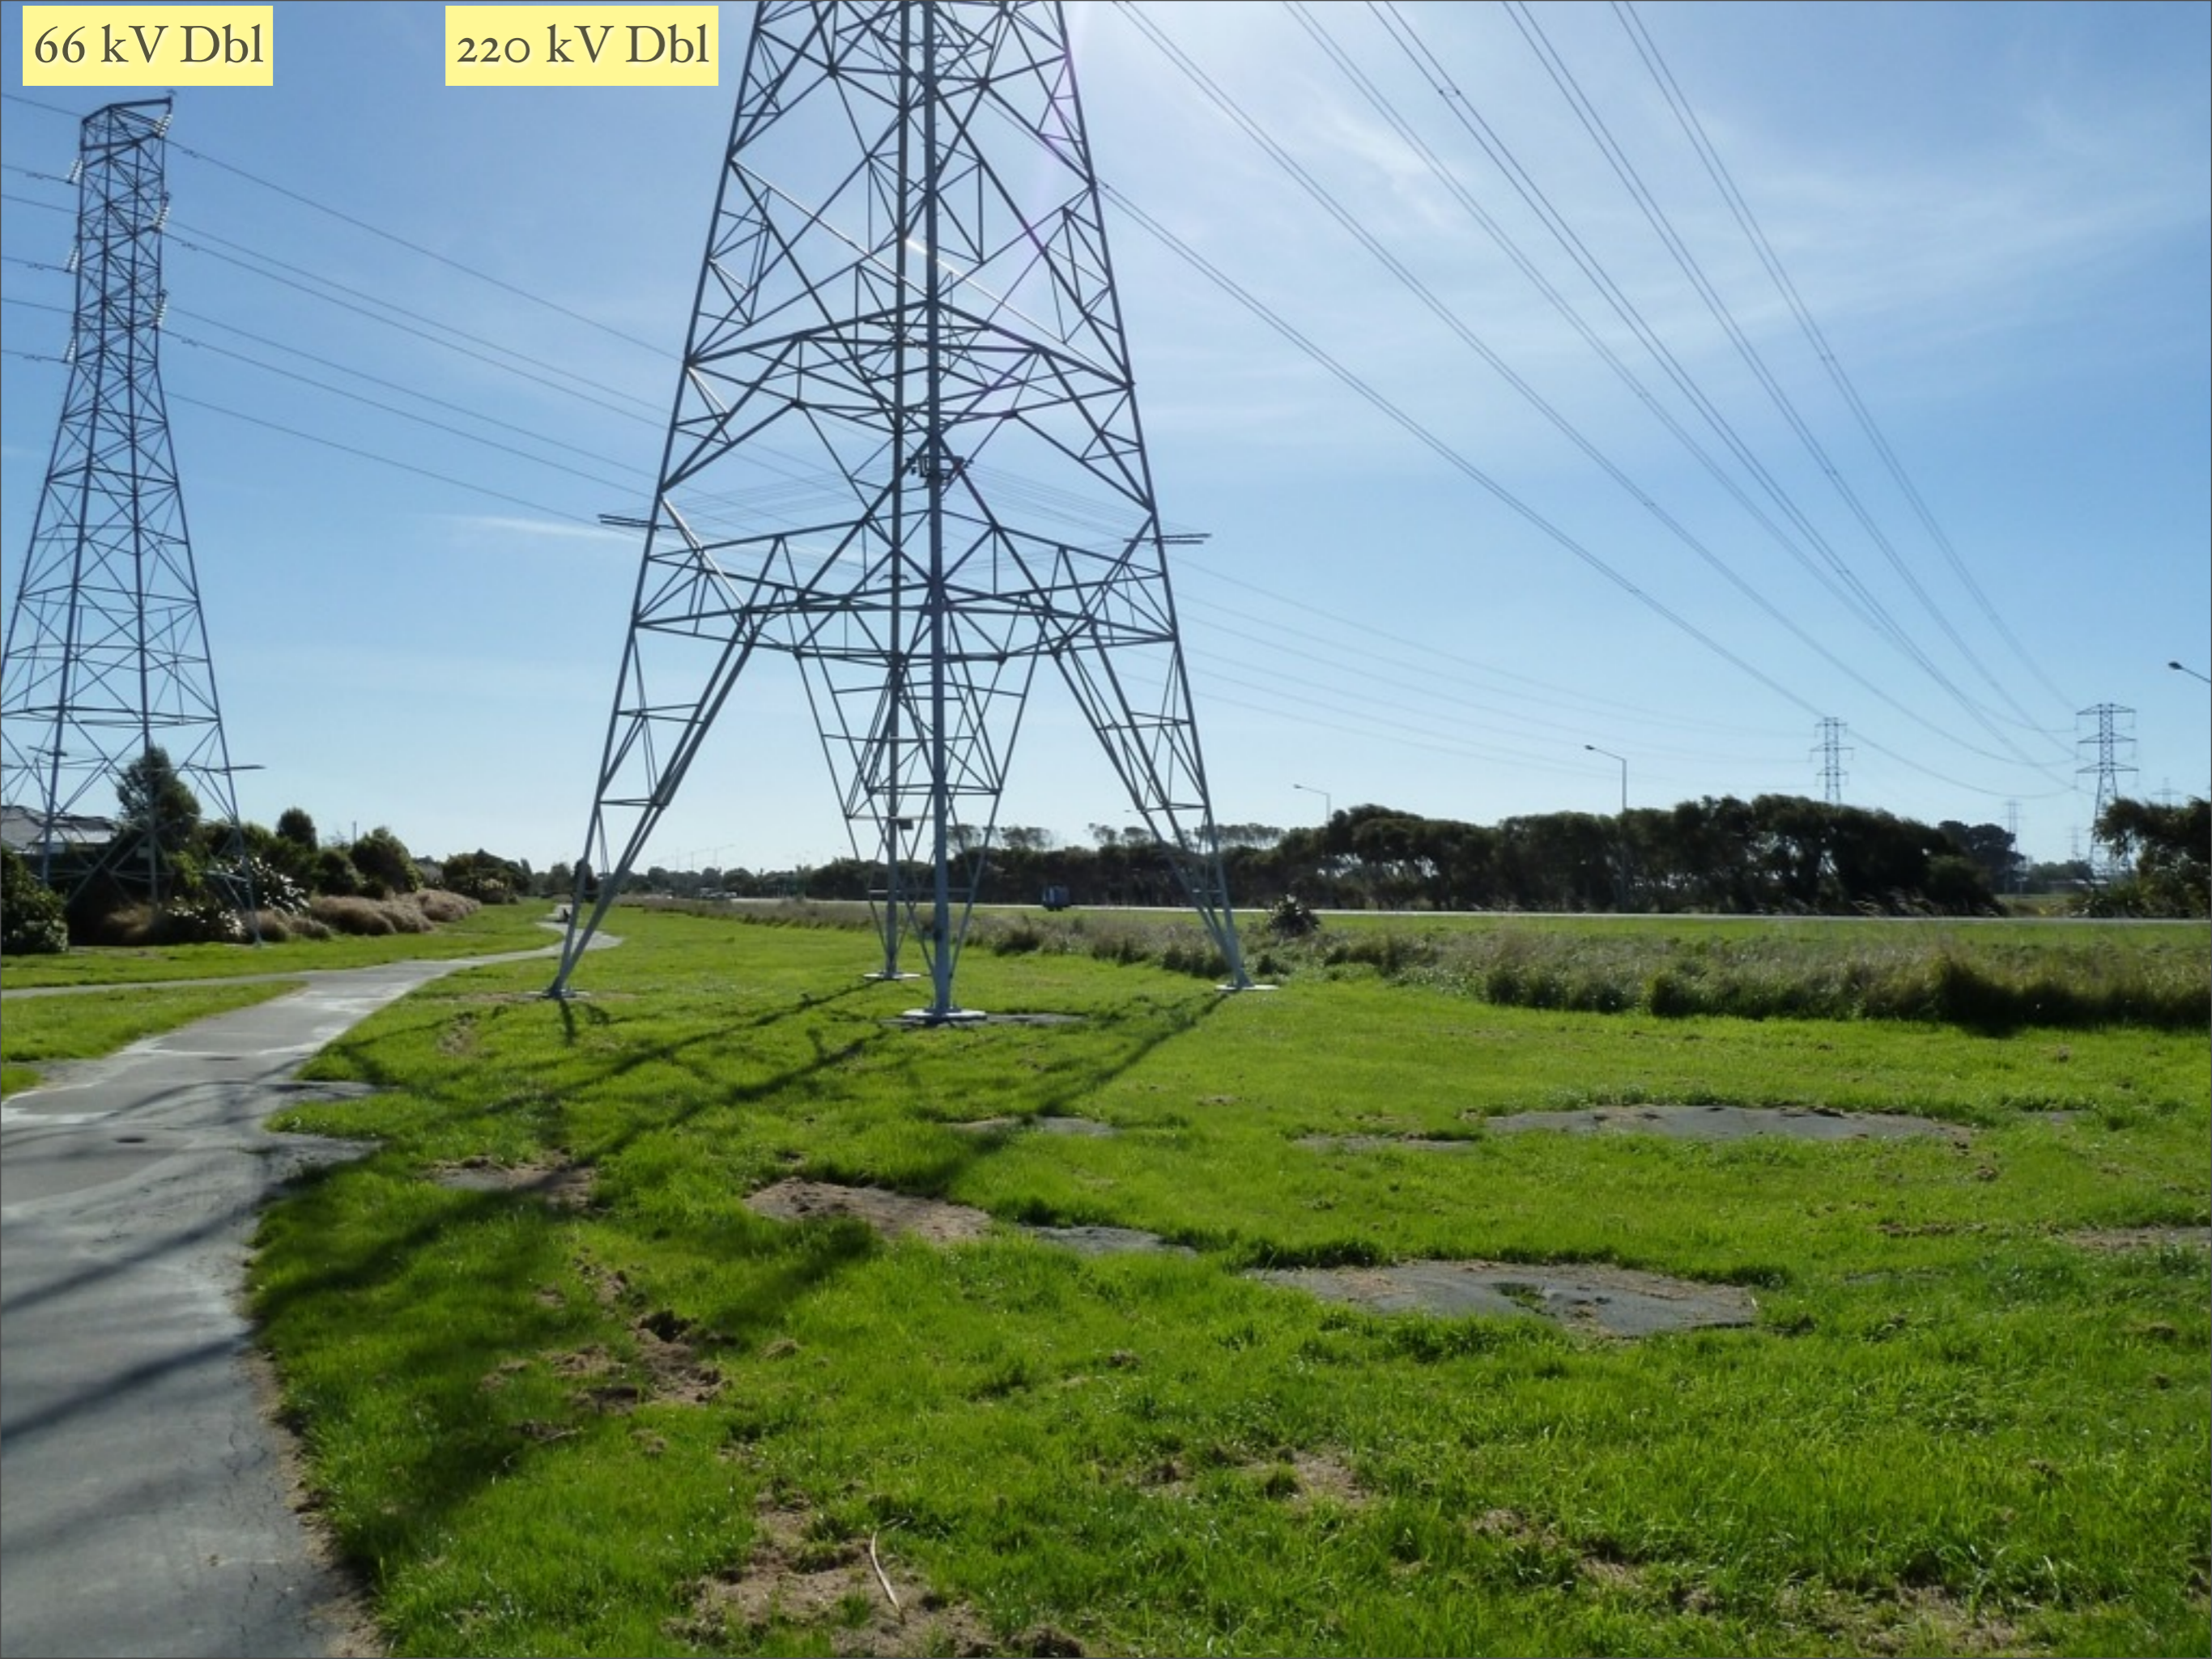
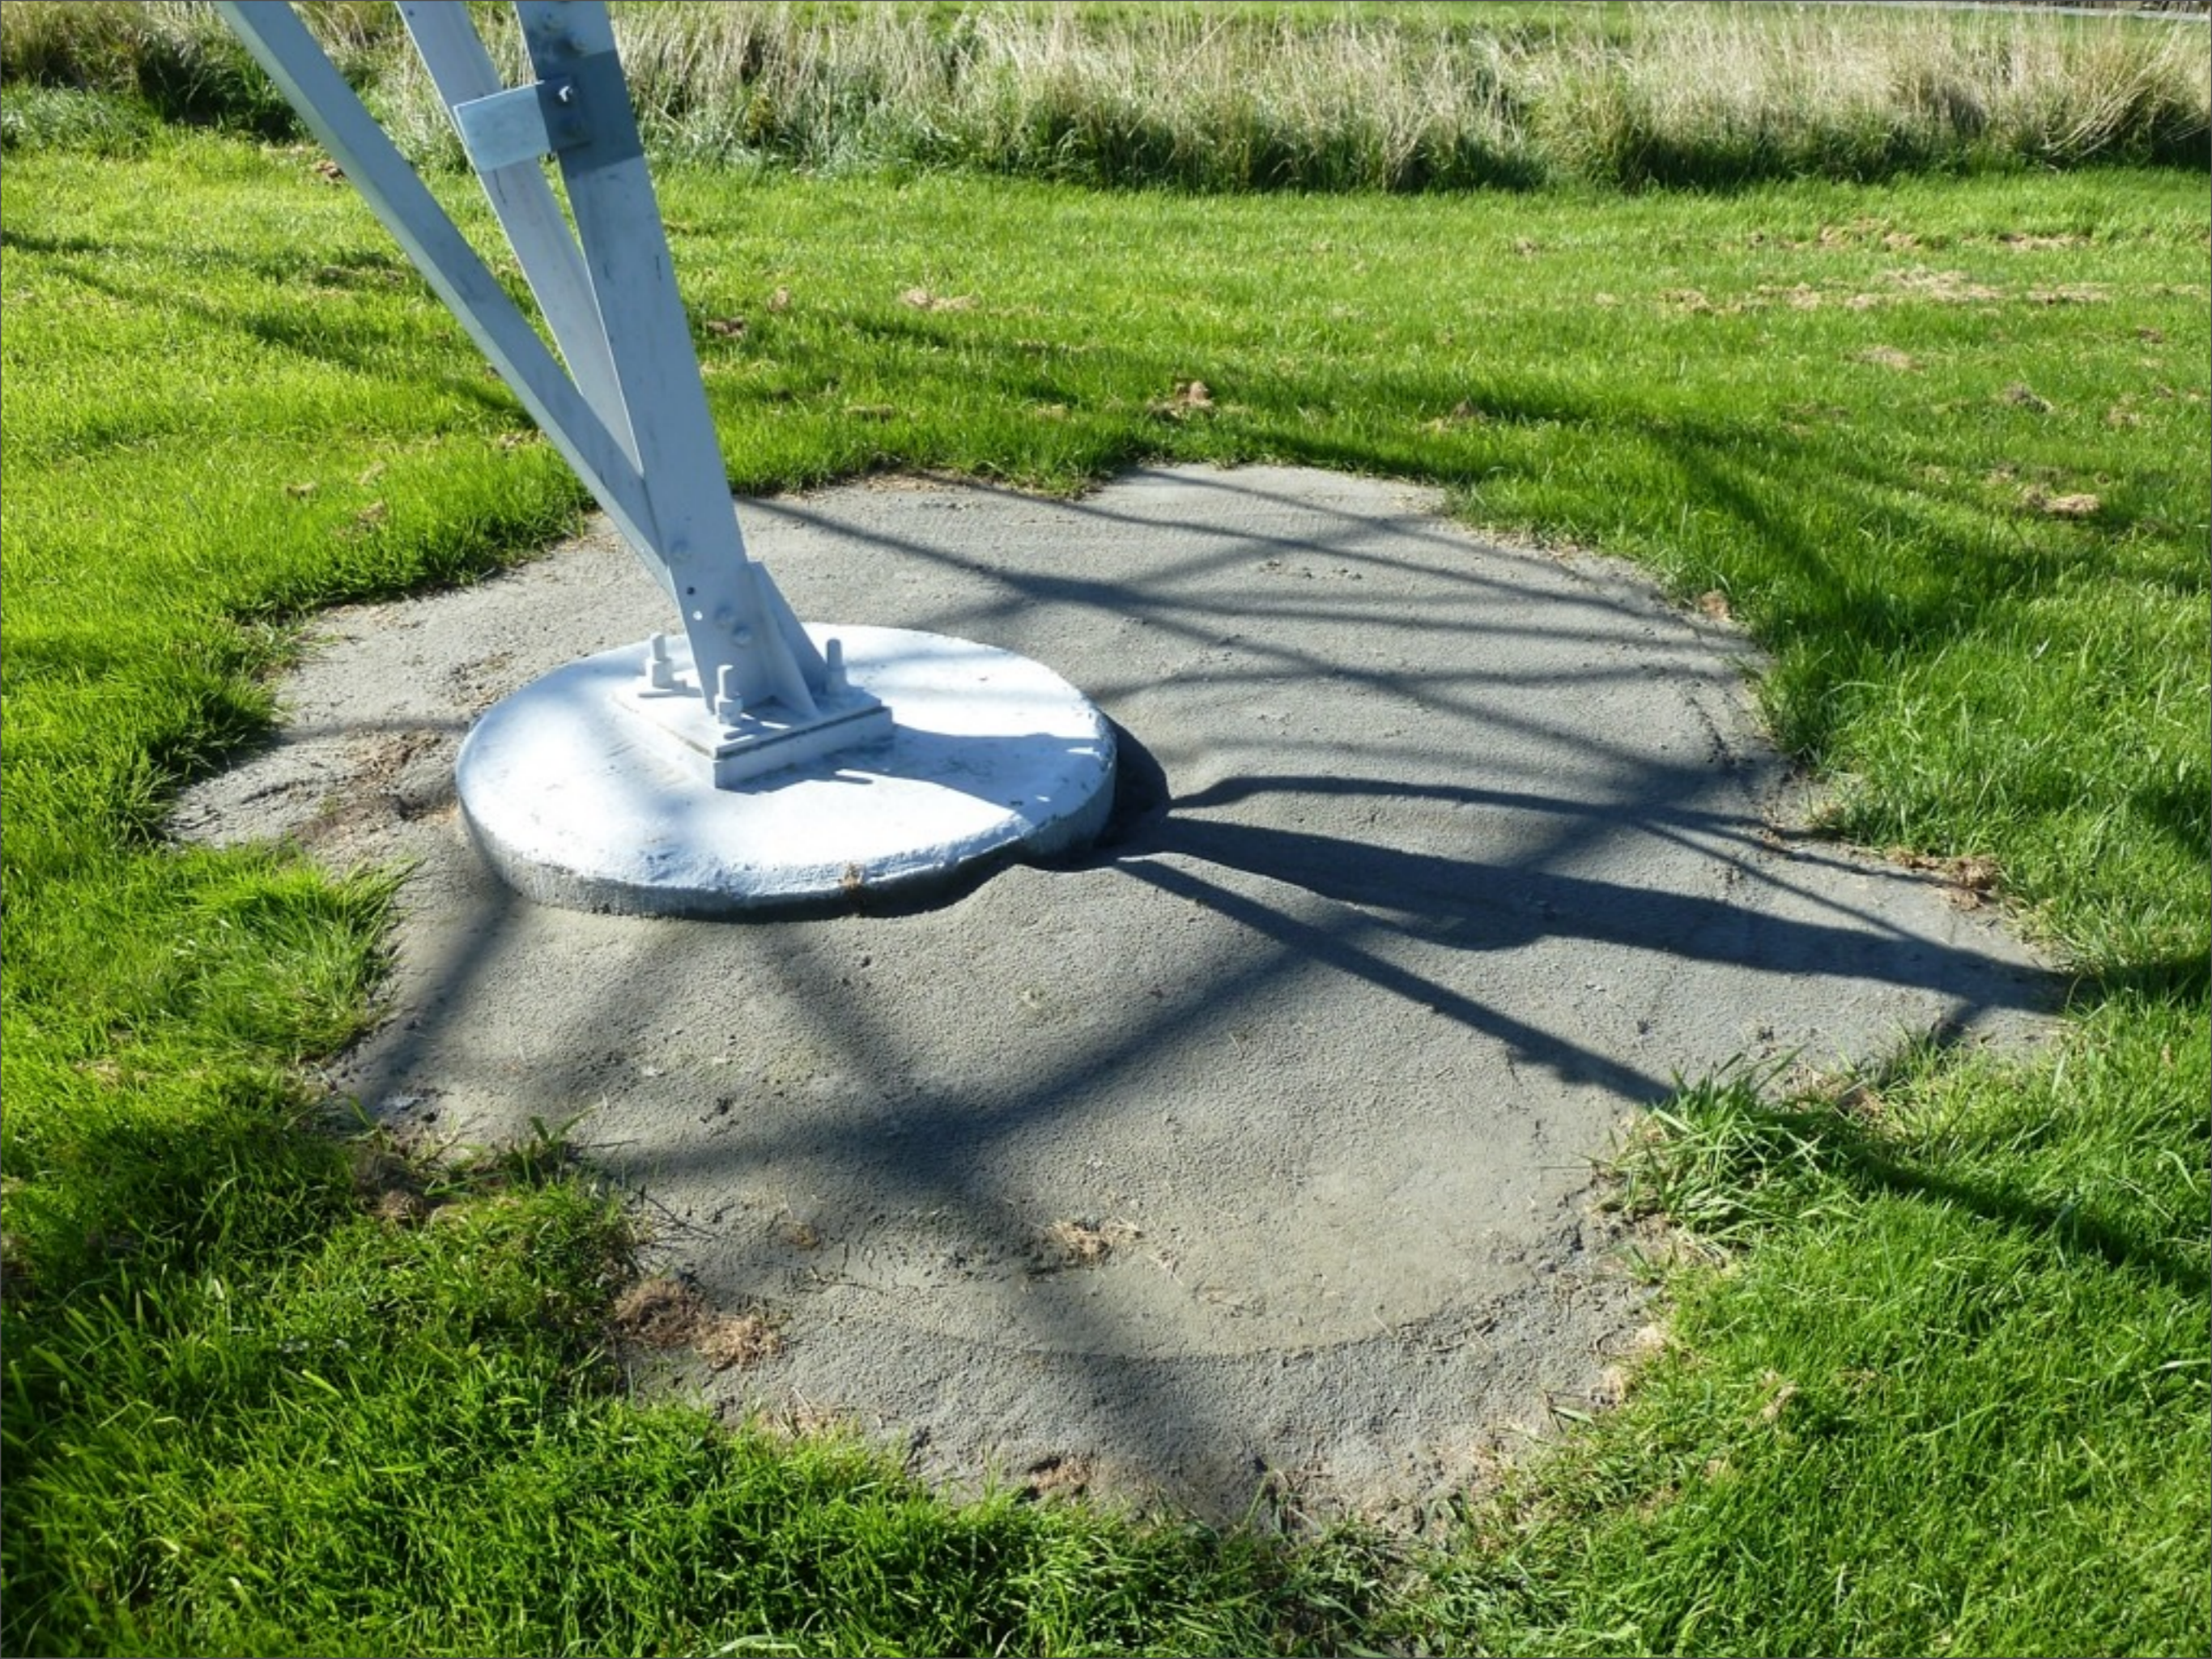
Martindales Rd

Rockfall impact

220 kV - Displaced sideways or slightly tilted  
No observed panel distortion

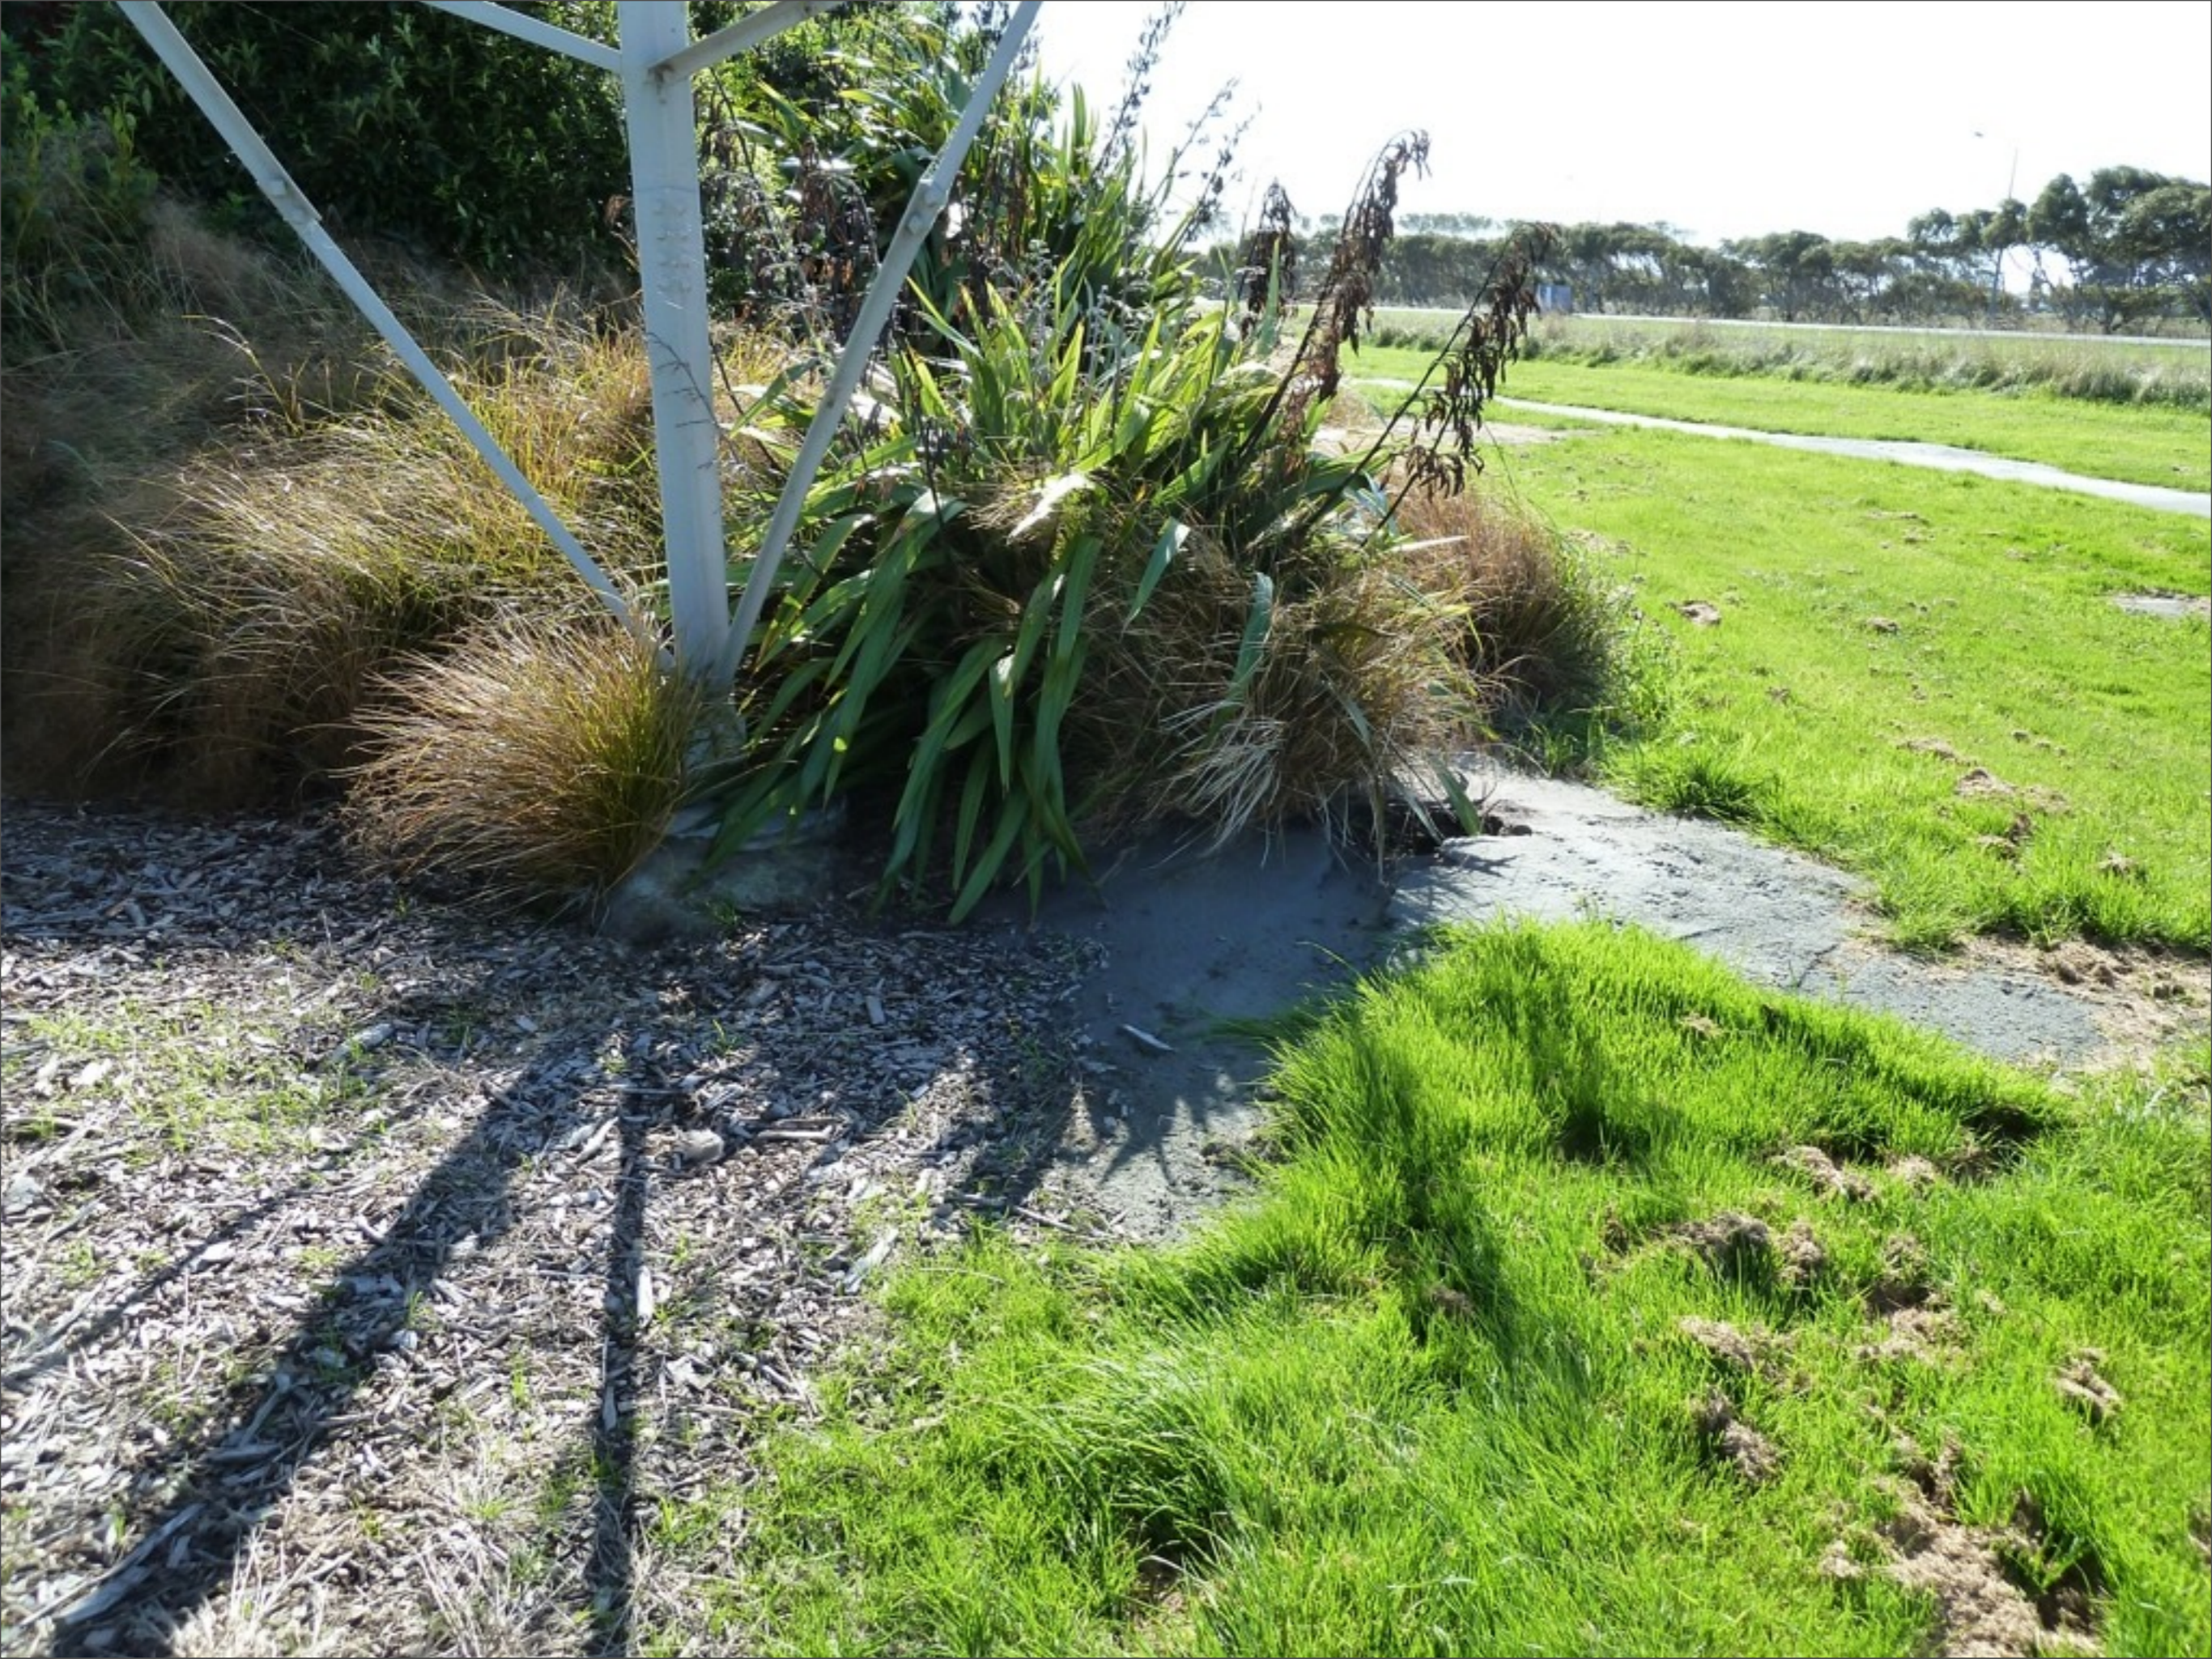
Buckled inwards

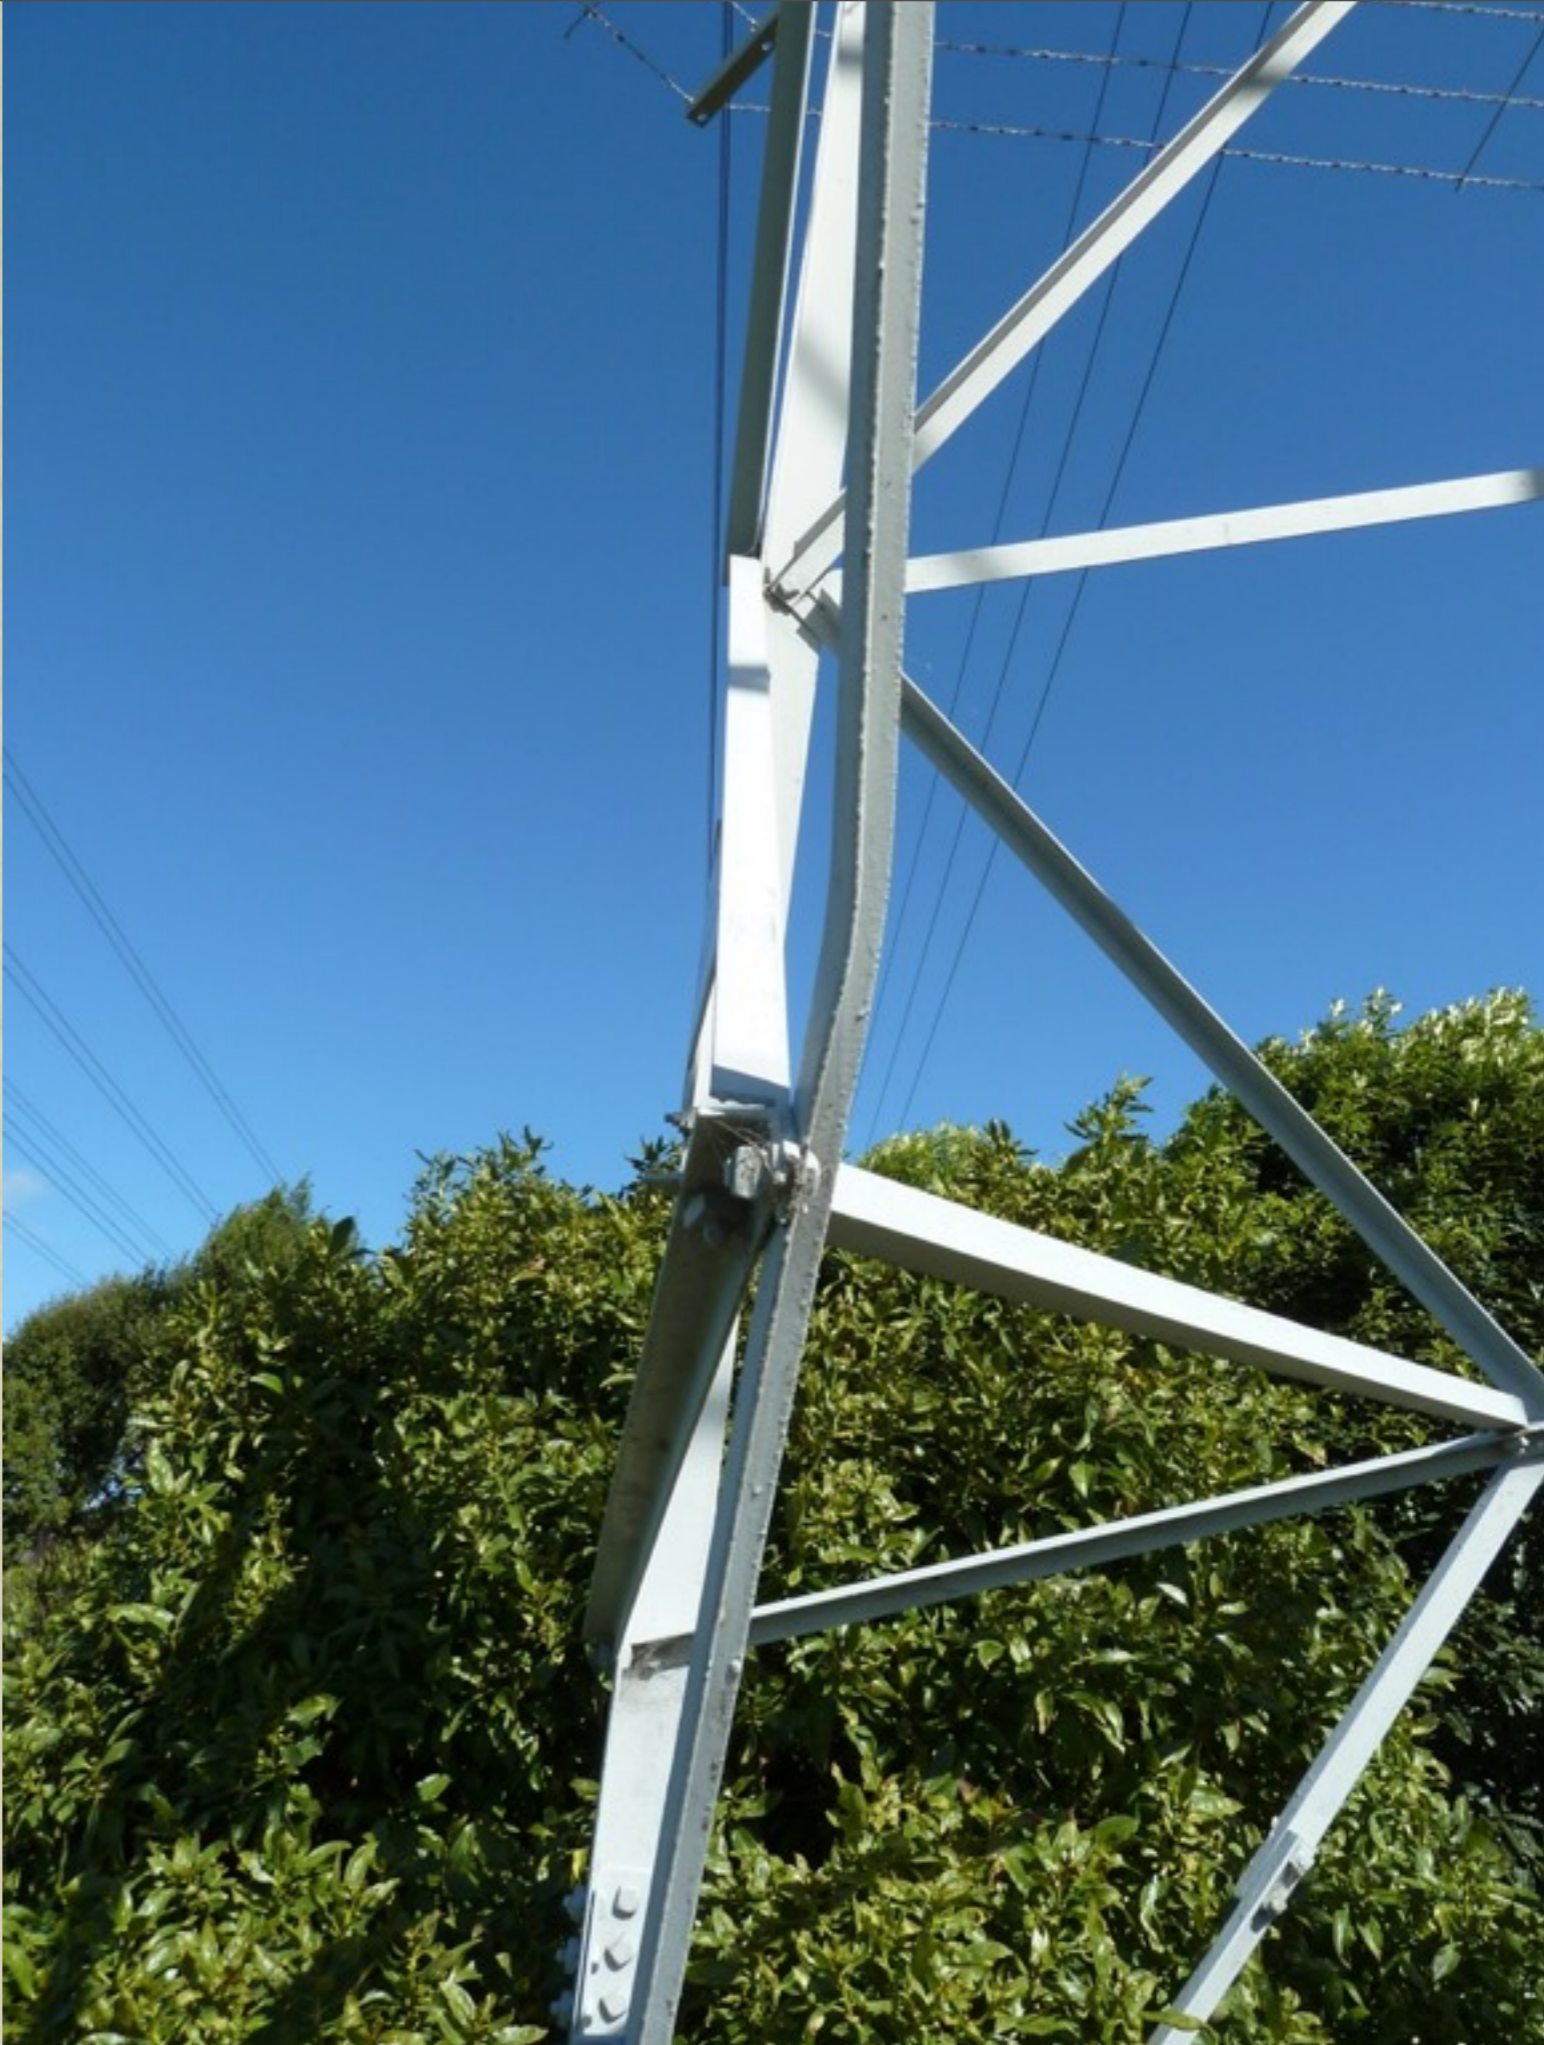
Buckled outwards
