Christchurch, Feb 22 2011 and Sept 4 2010

John Eiding  
G&E Engineering Systems Inc.  
[eidinger@geEngineeringSystems.com](mailto:eidinger@geEngineeringSystems.com)

## Impact to Electric Power Systems

ASCE - Structural Congress

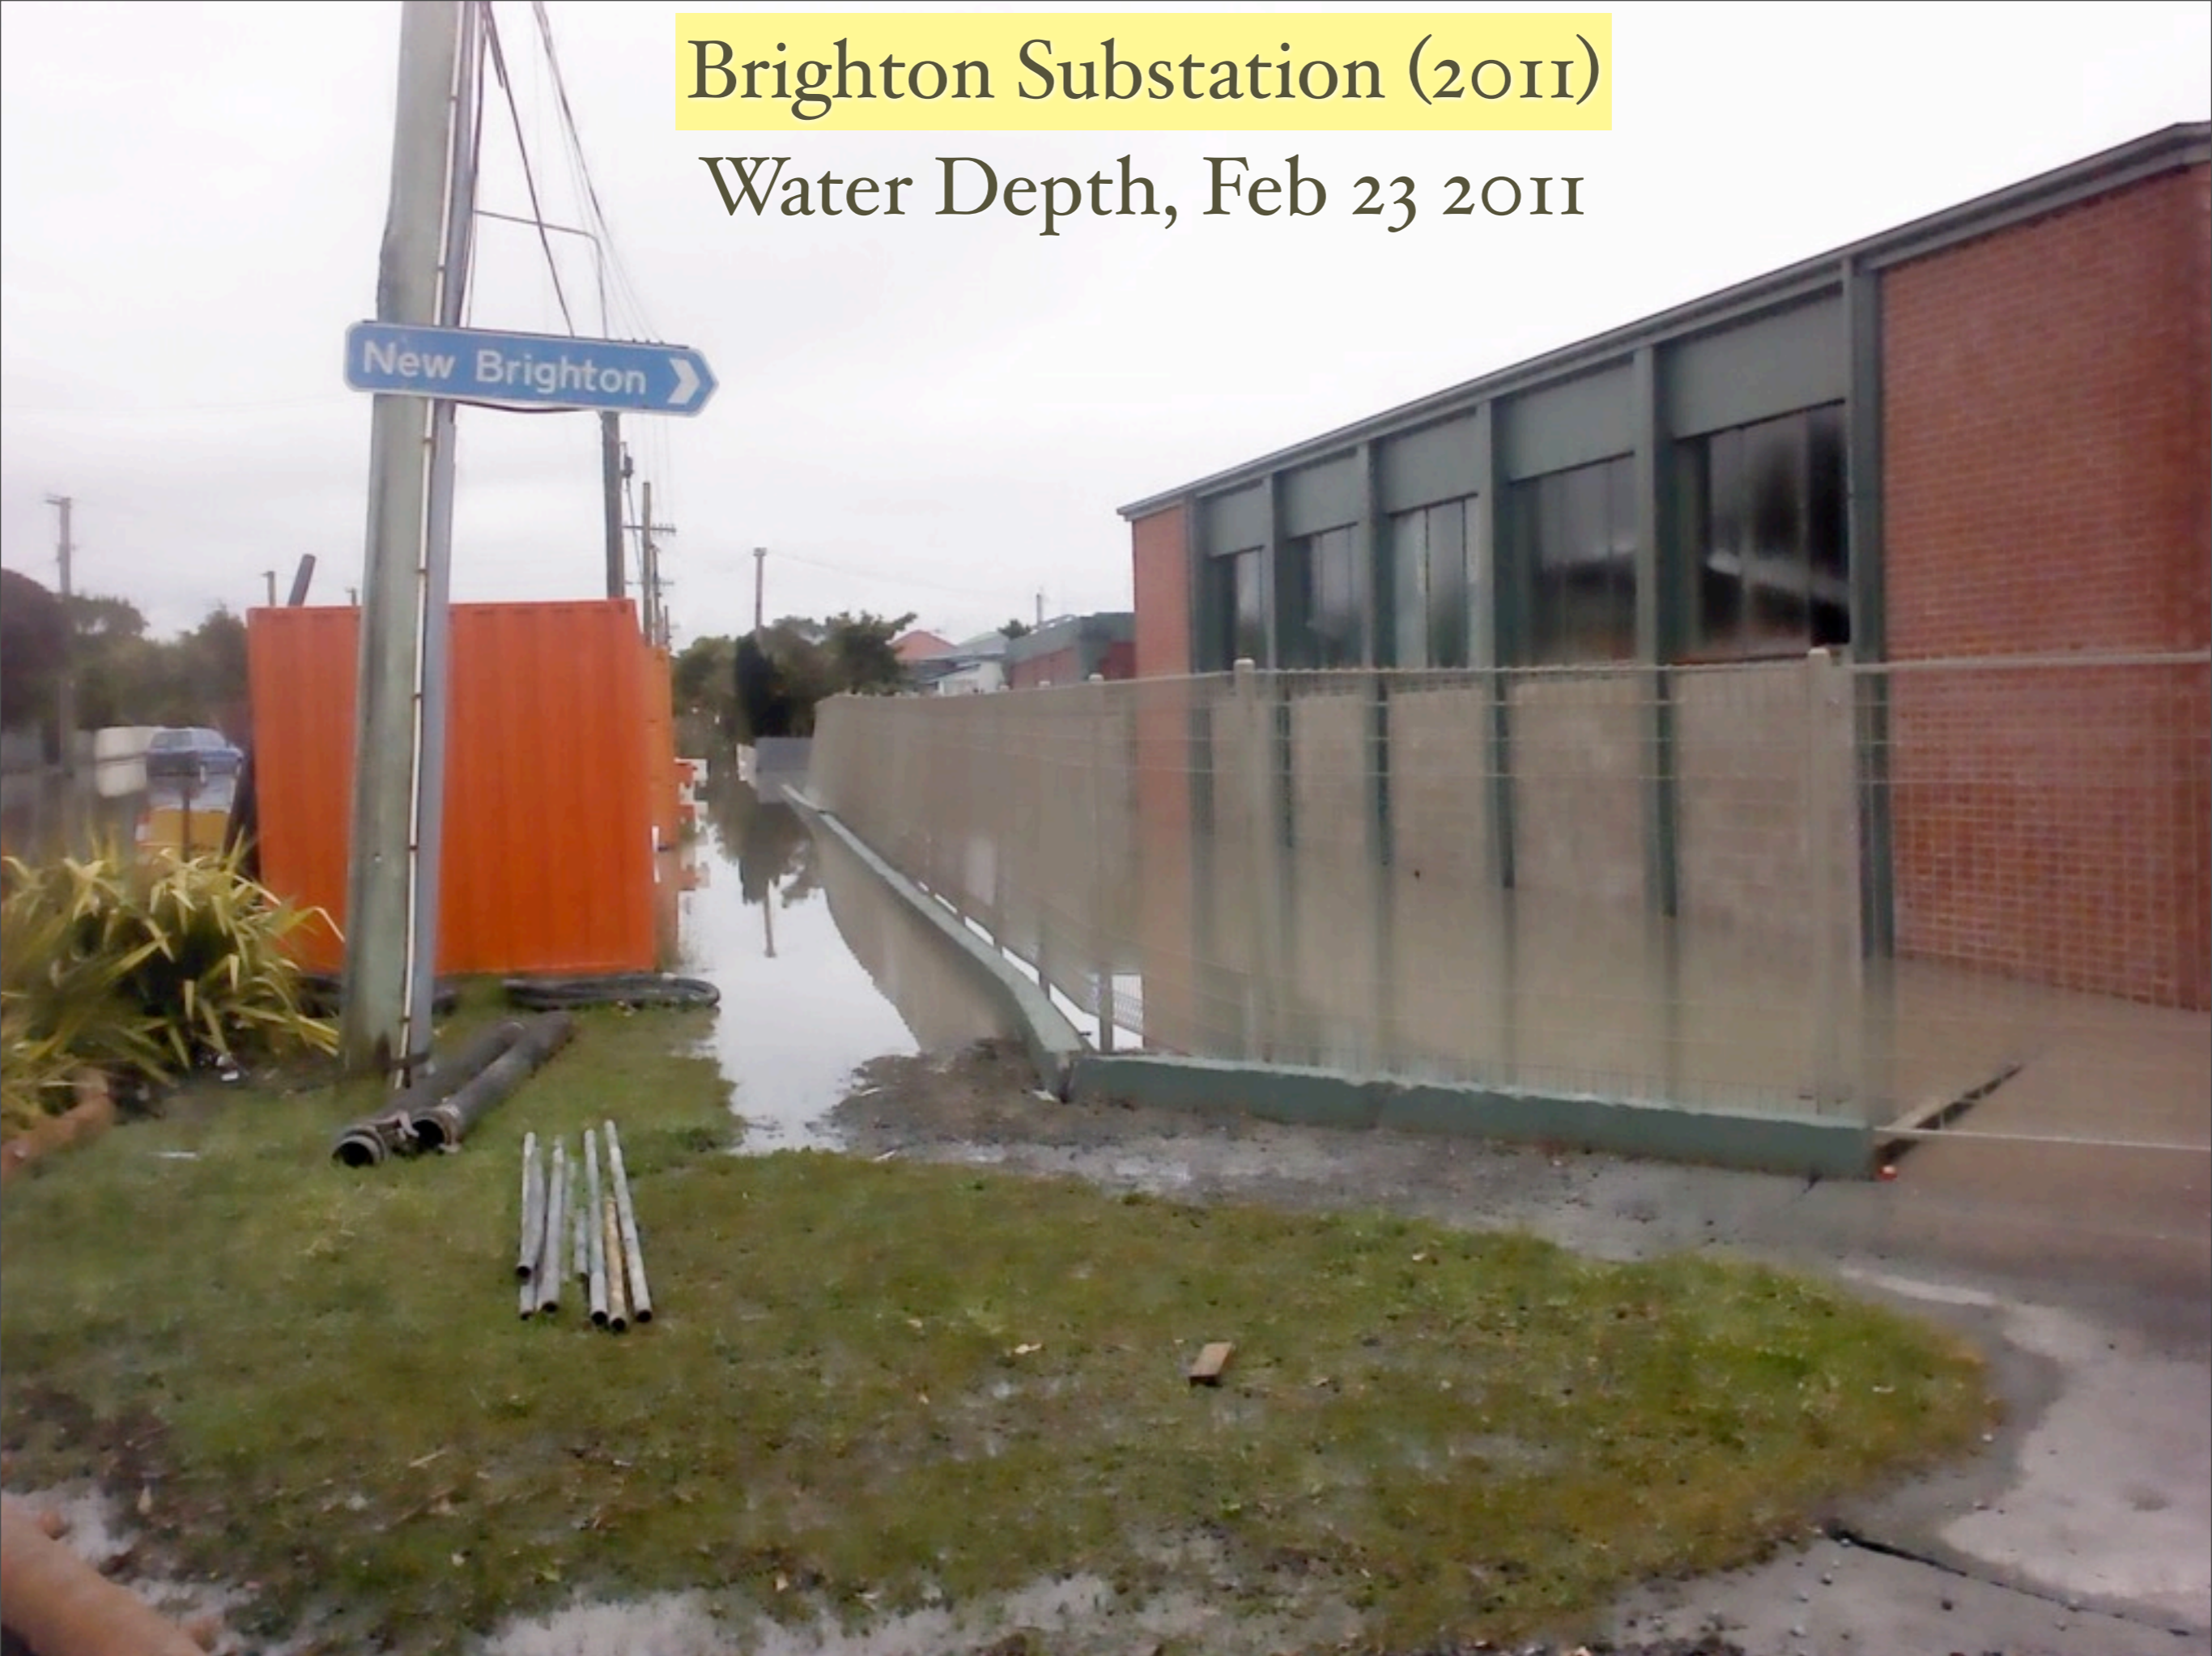
Water Depth, Feb 23 2011

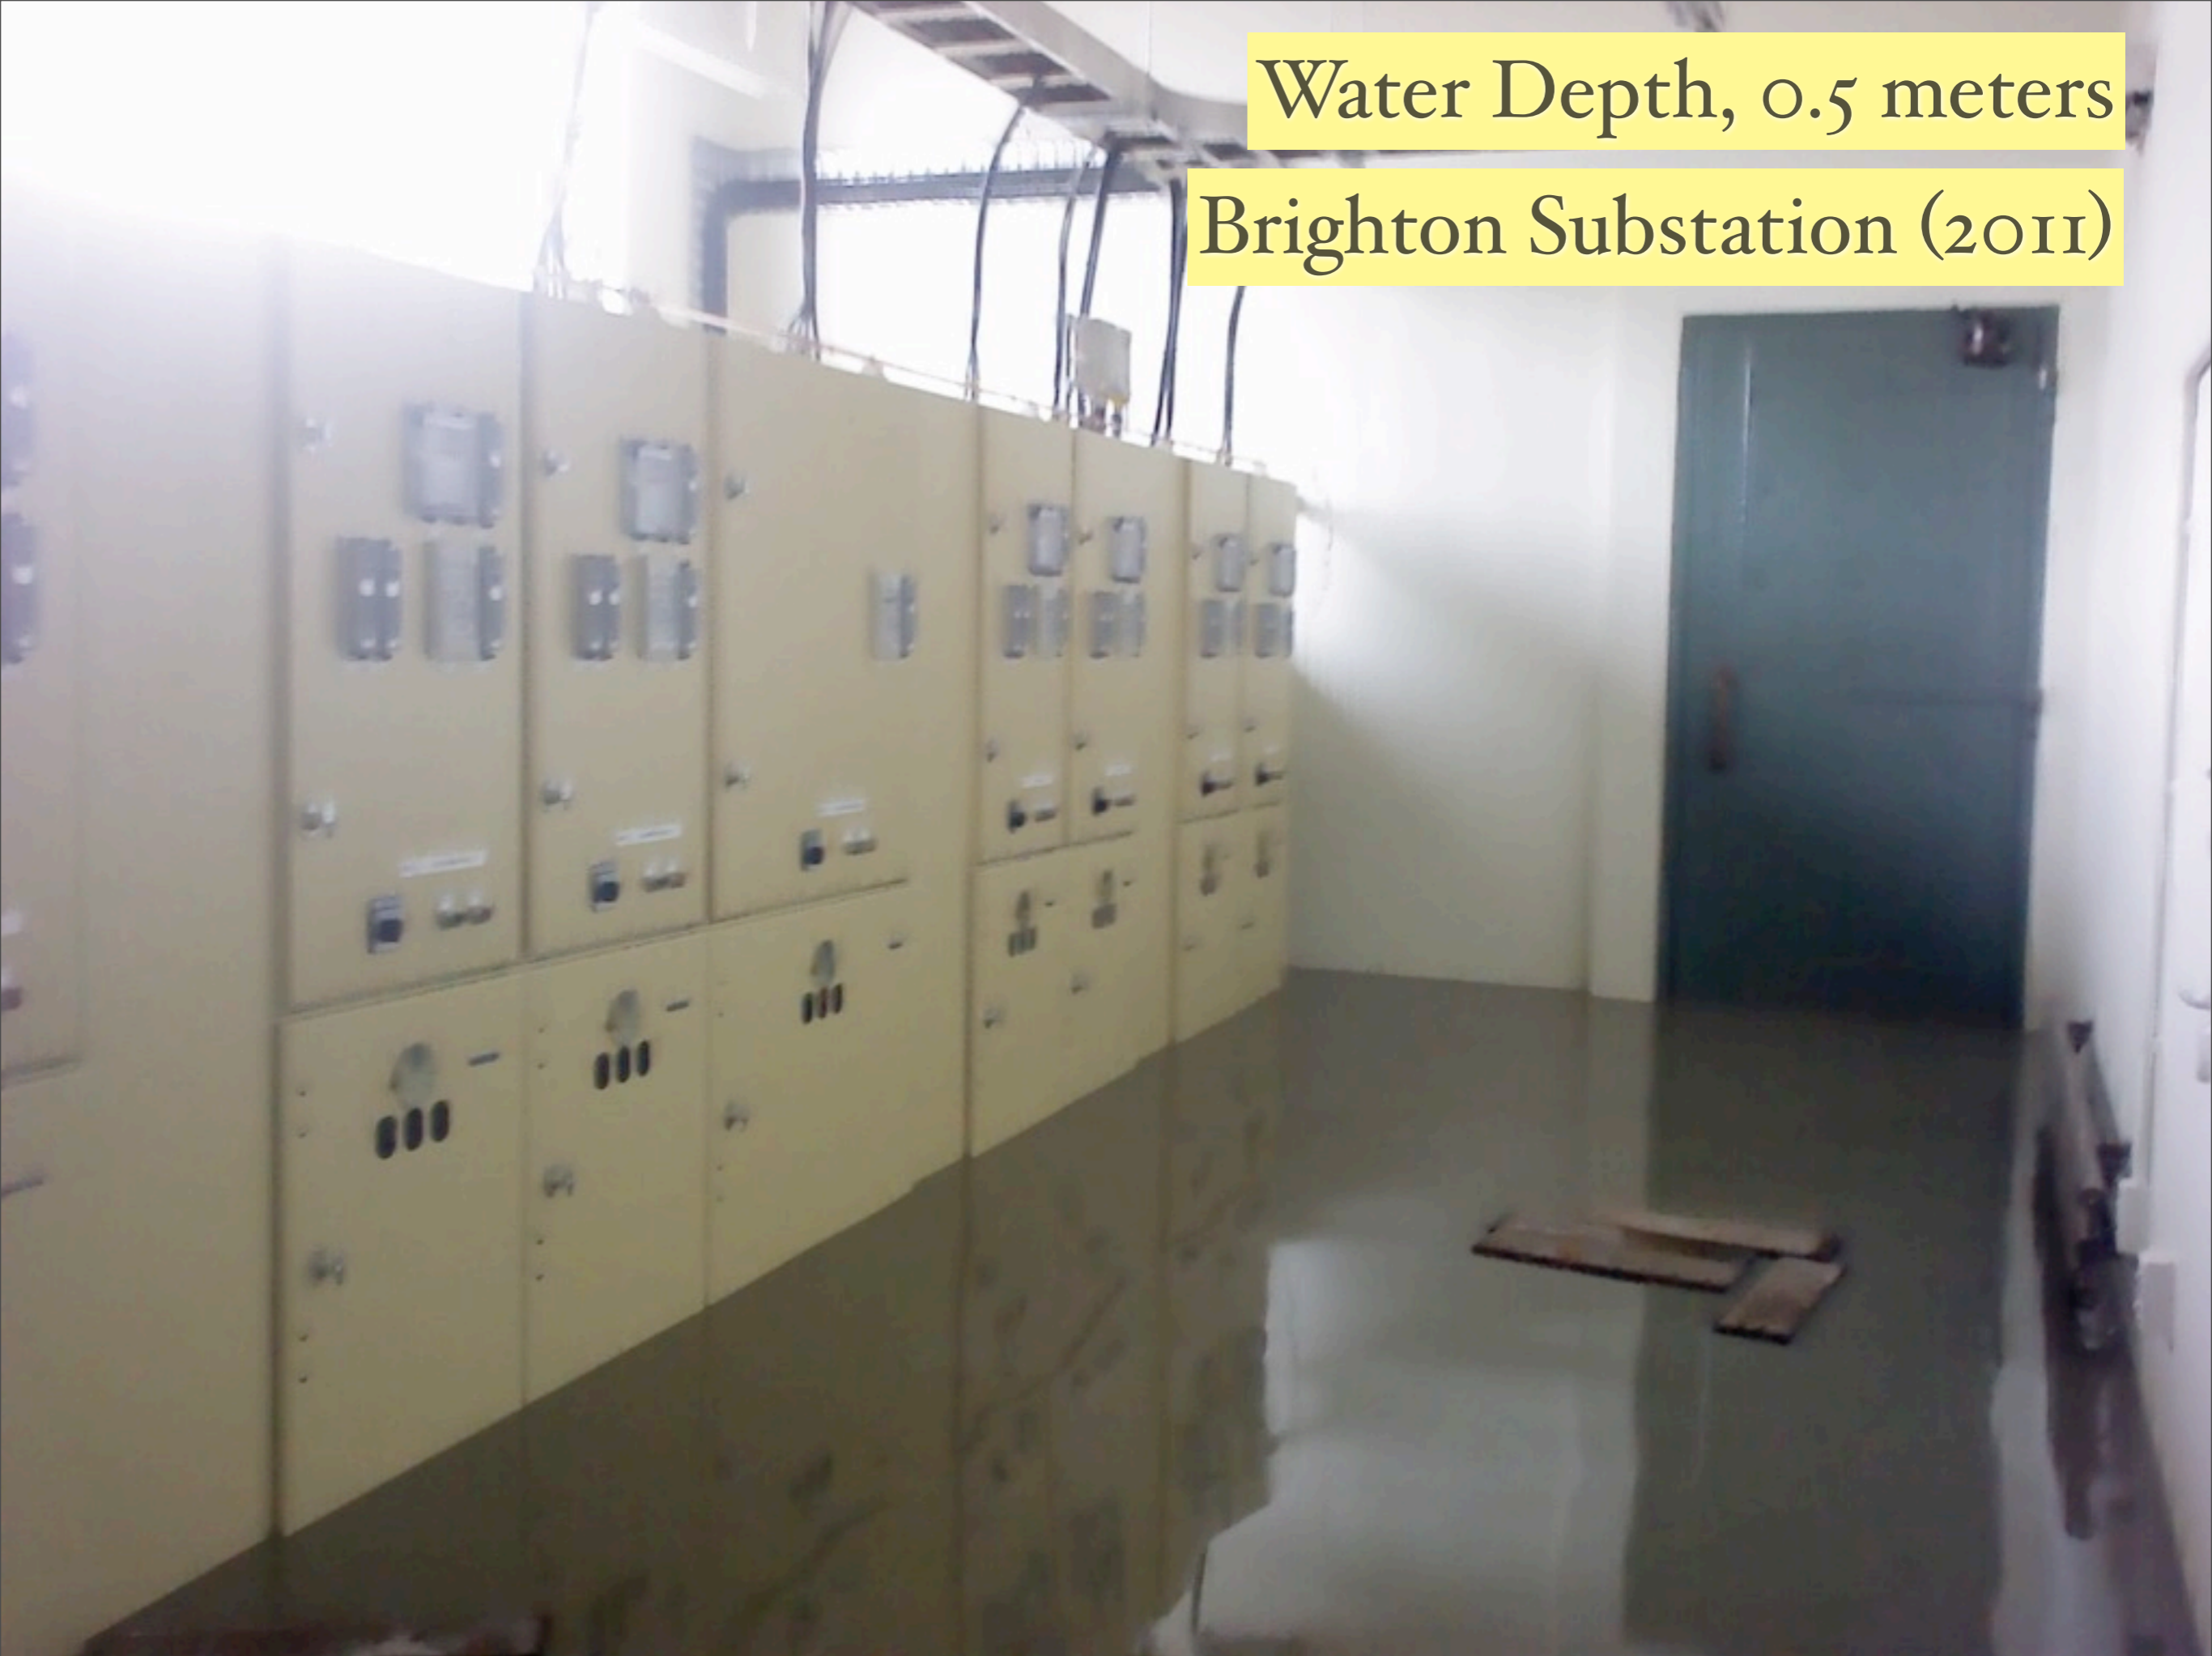
Water Depth, 0.5 meters  
Brighton Substation (2011)

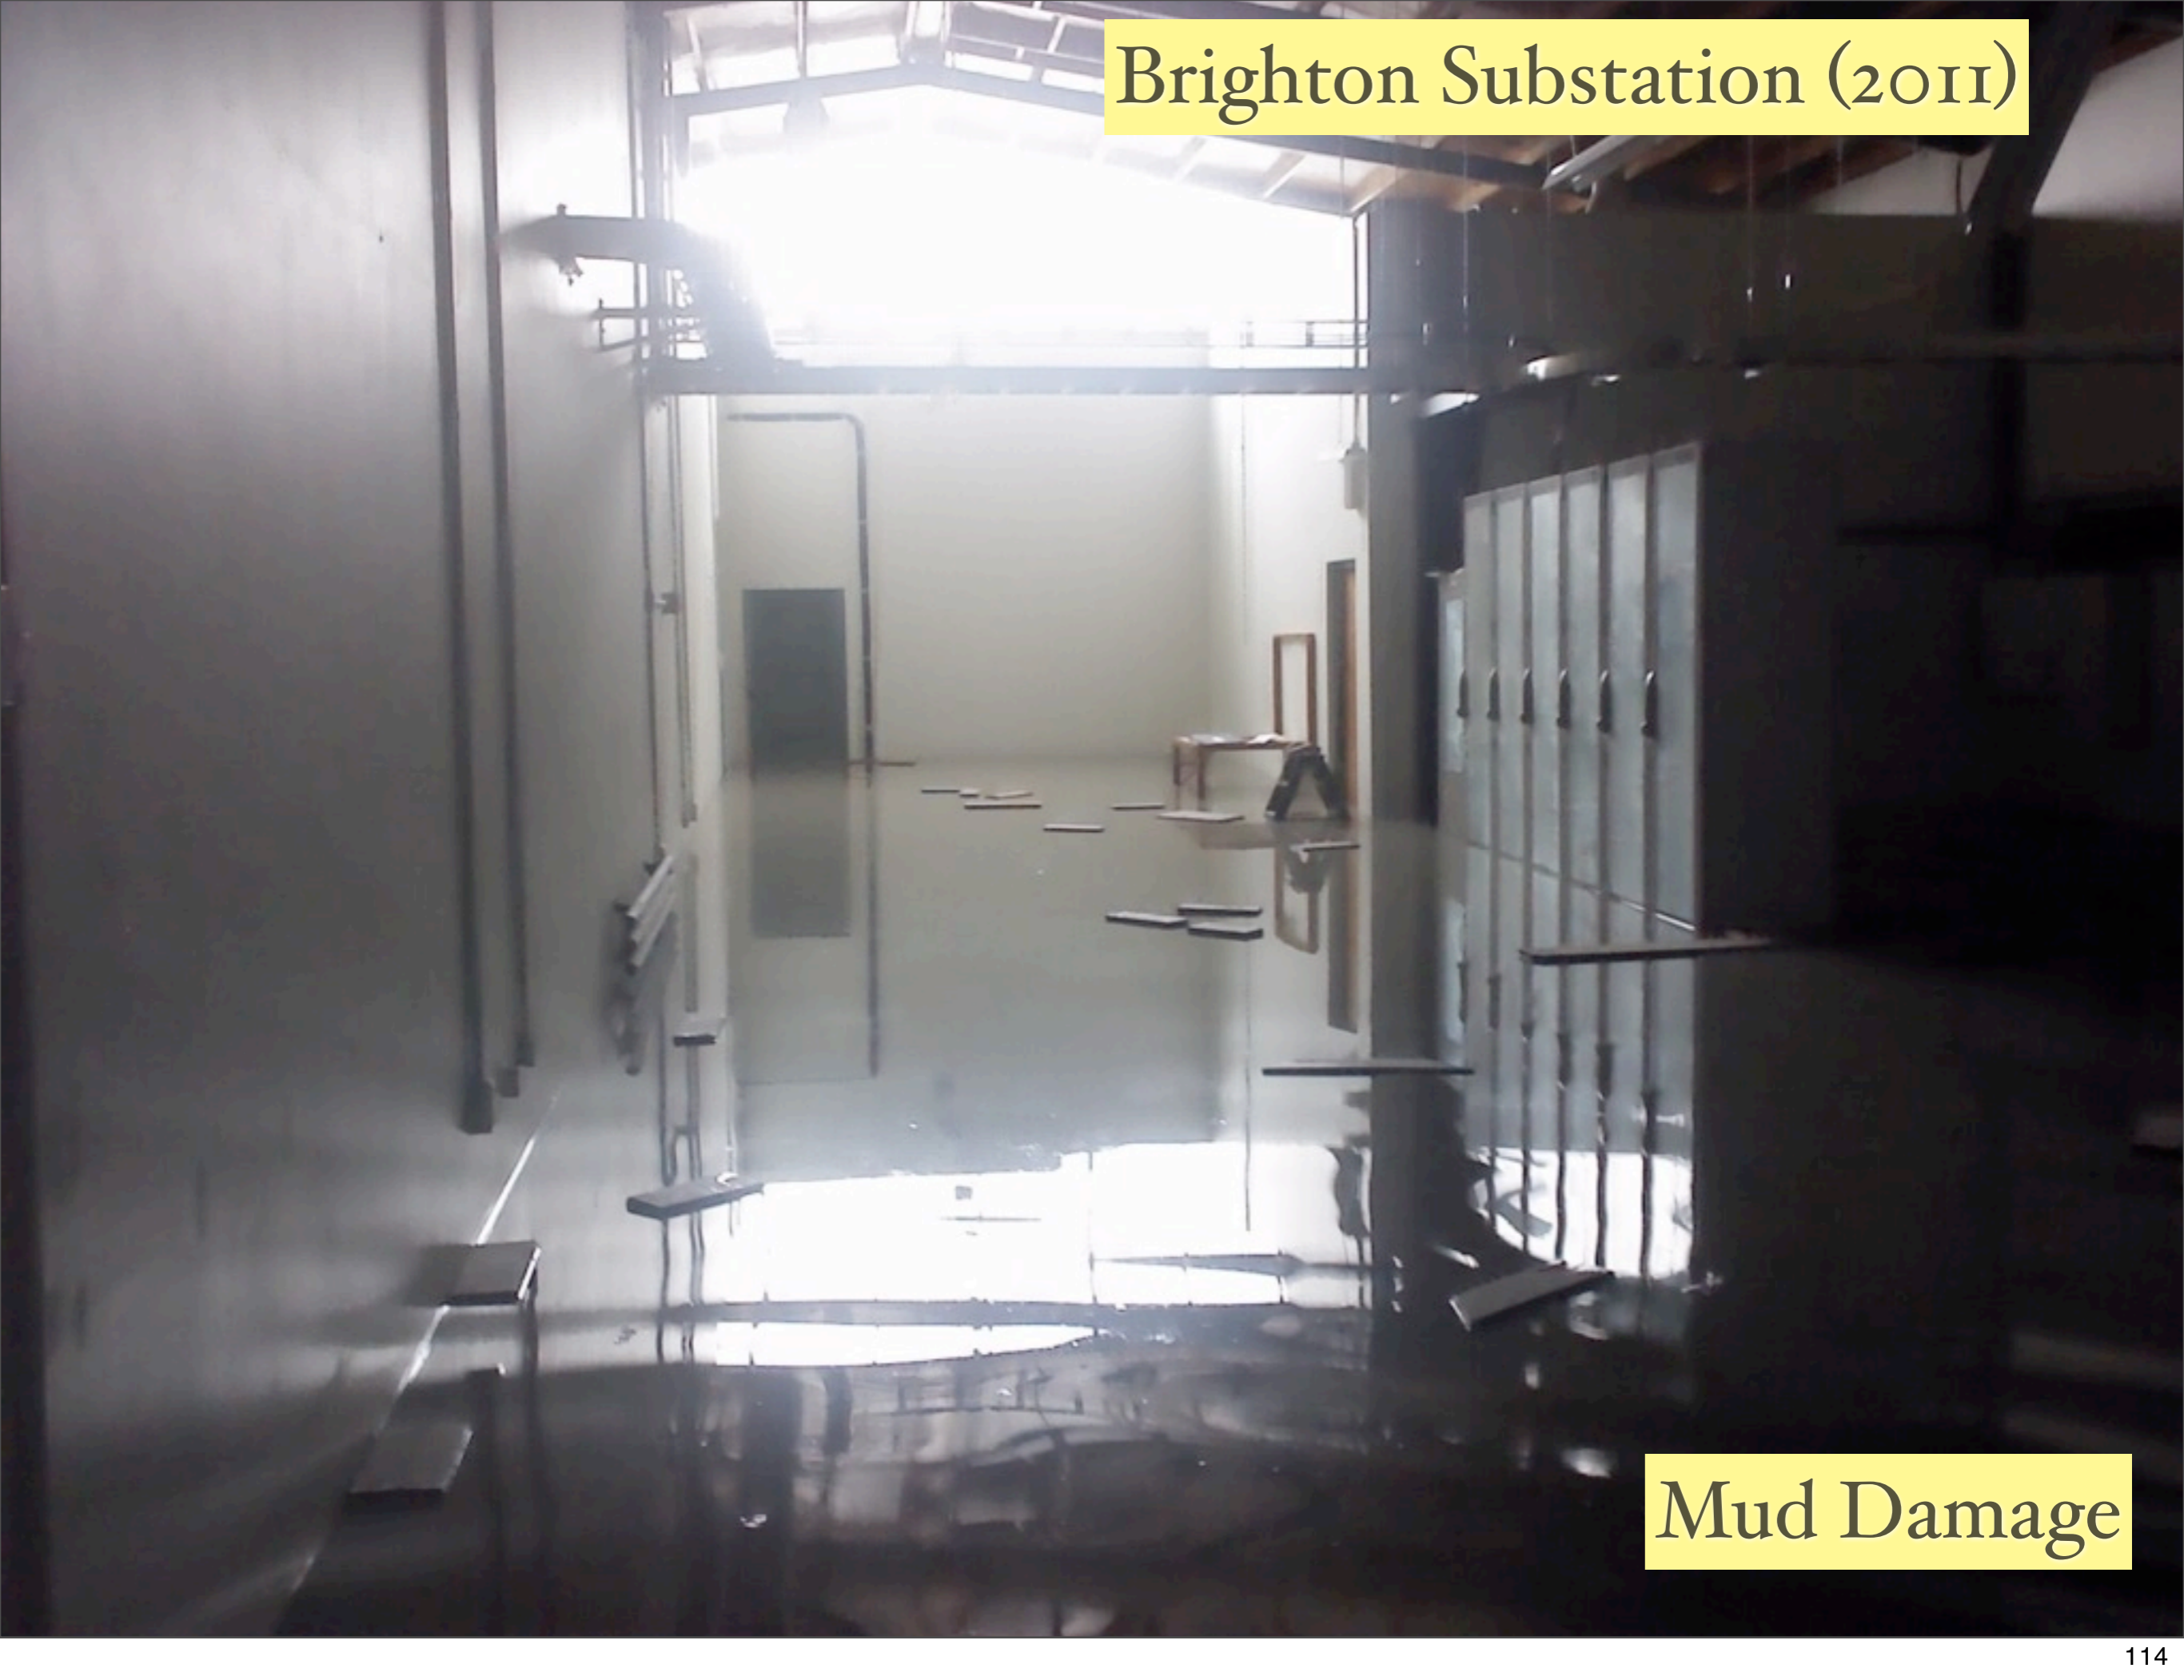
# Brighton Substation (2011)

Mud Damage
