Kumamoto M 6.0 and 7.0 Earthquakes of April 14, 16 2016

Electric Power
John Eiding
G&E Engineering Systems Inc.
September 15 2016

Electric Power

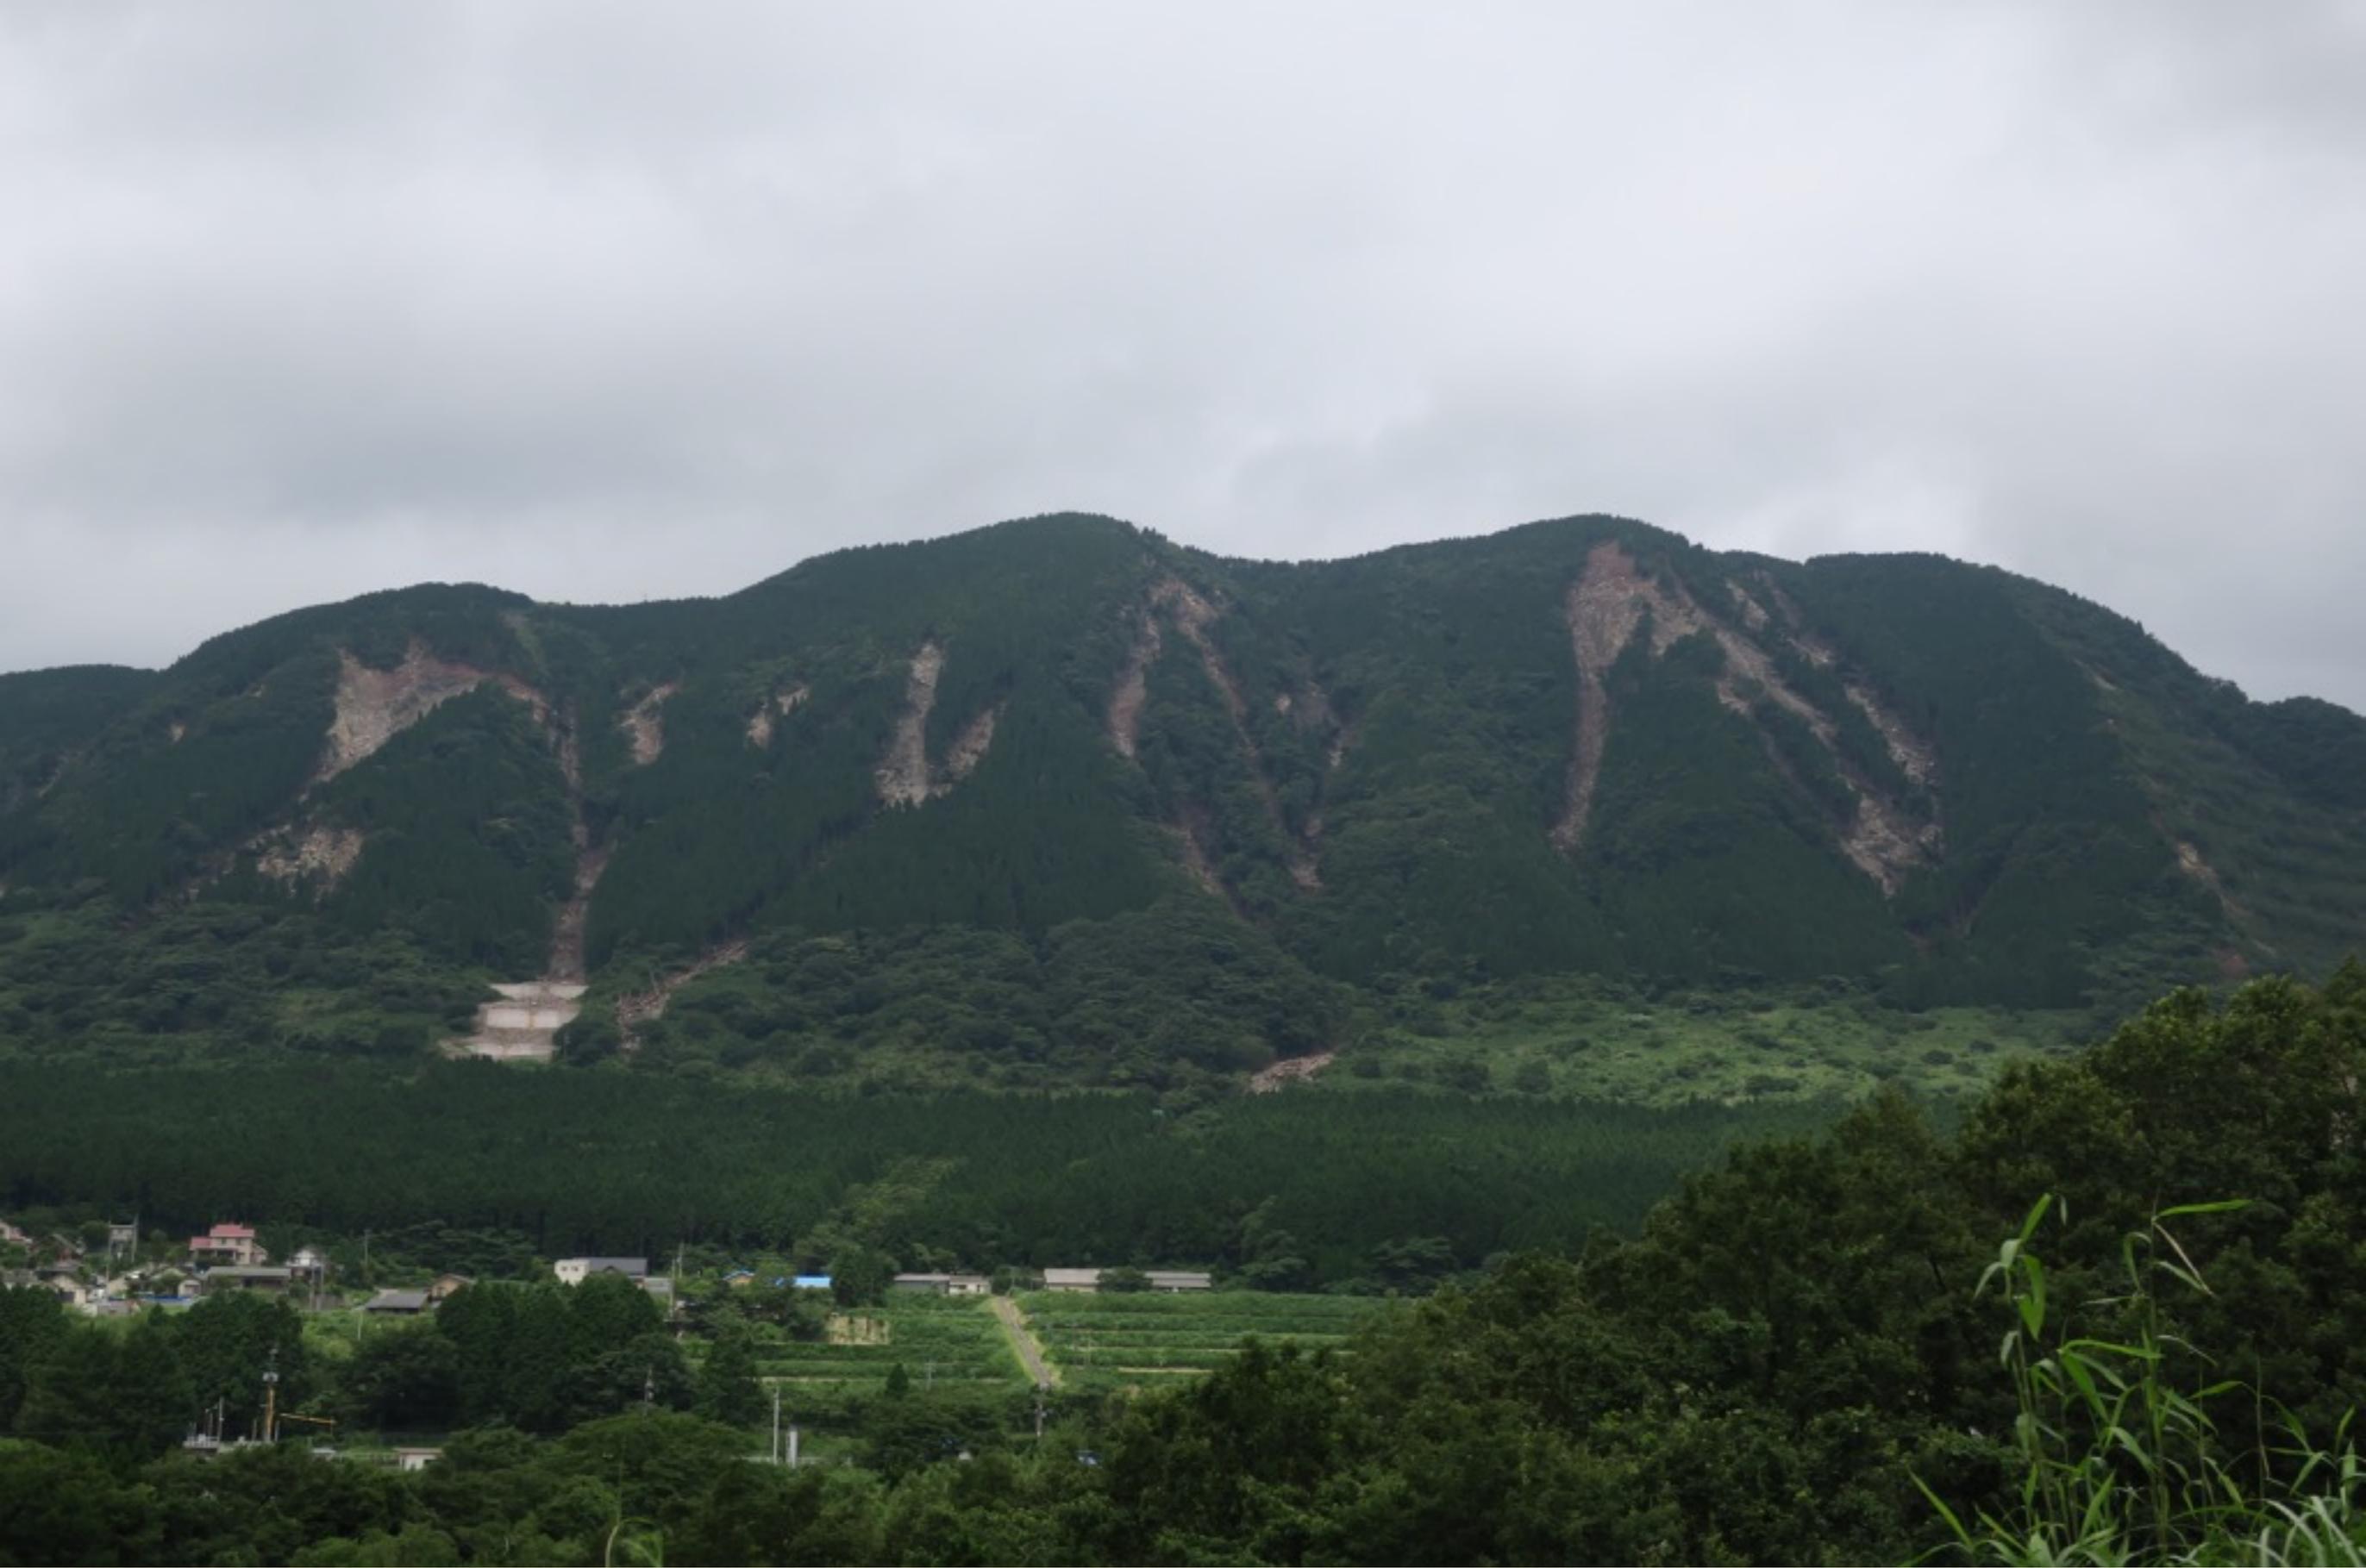
PGA ~0.4g+. Slope > 35°. Percent Massive Slide = 10%

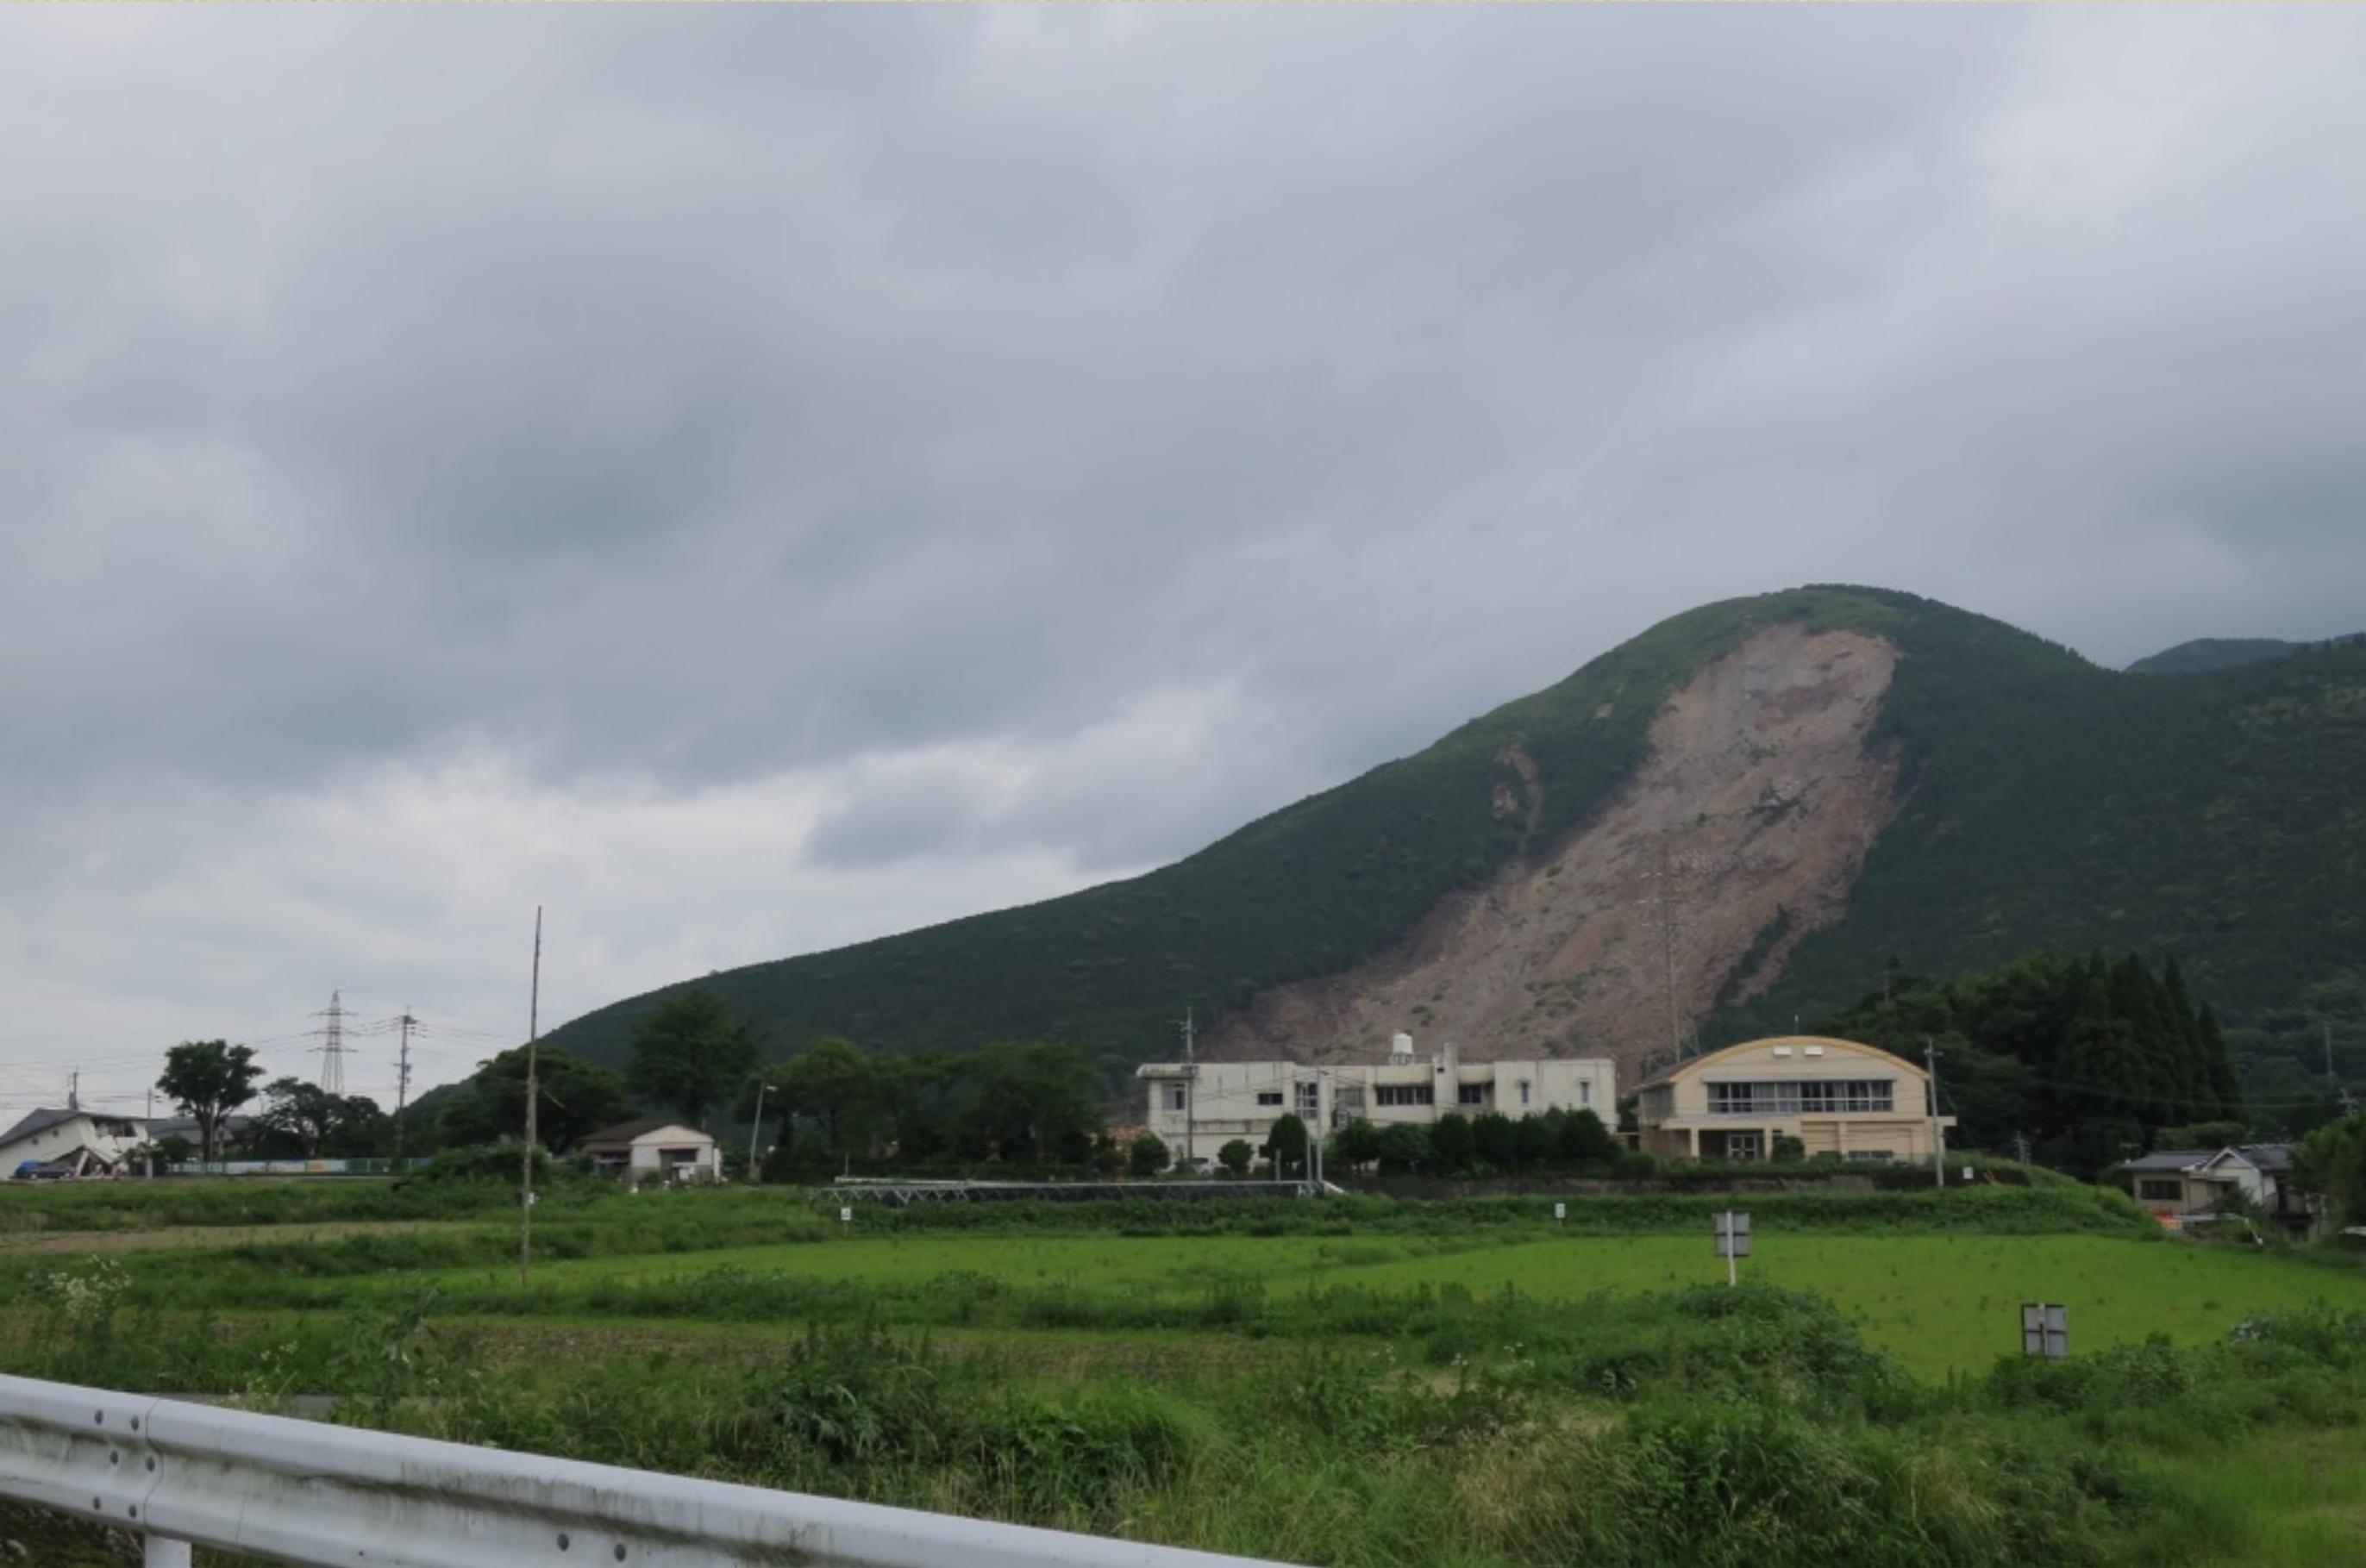
PGA ~0.4g+. Slope > 35°. Percent Massive Slide = 20%

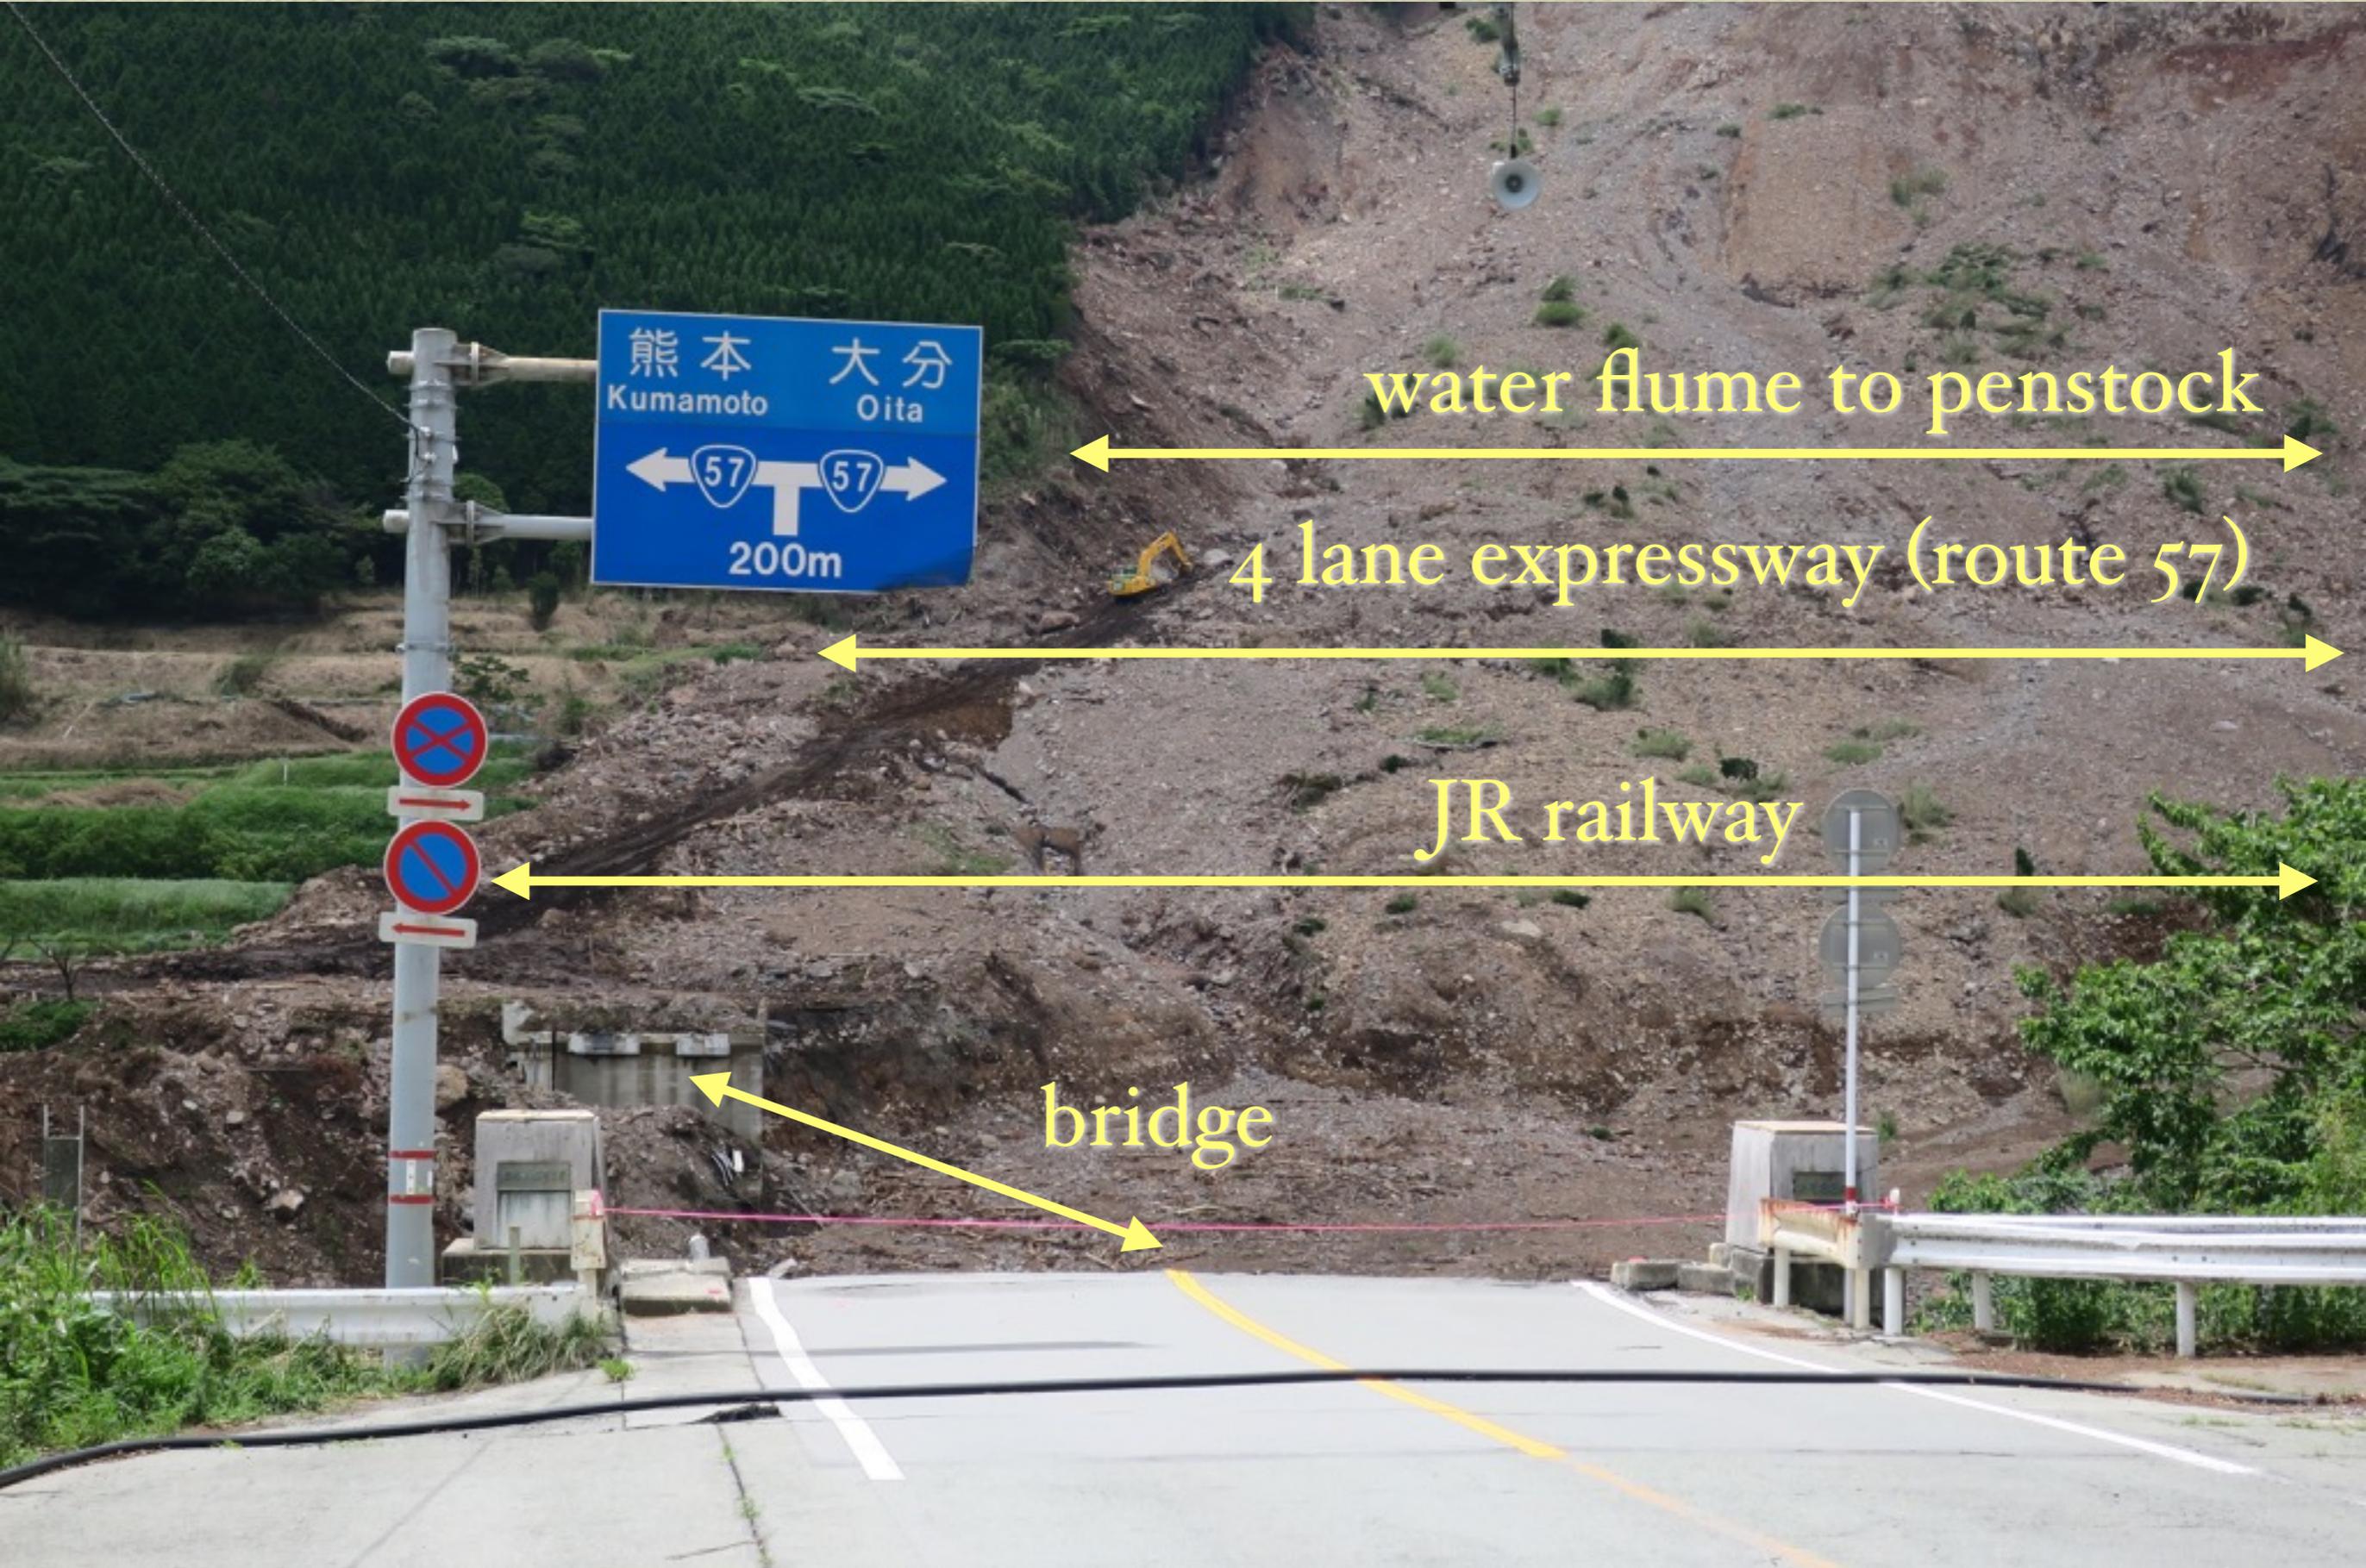
Foreground: Bridge Collapsed due to landslides at abutments
Background. Massive landslide fails 4 lane expressway and railroad tracks

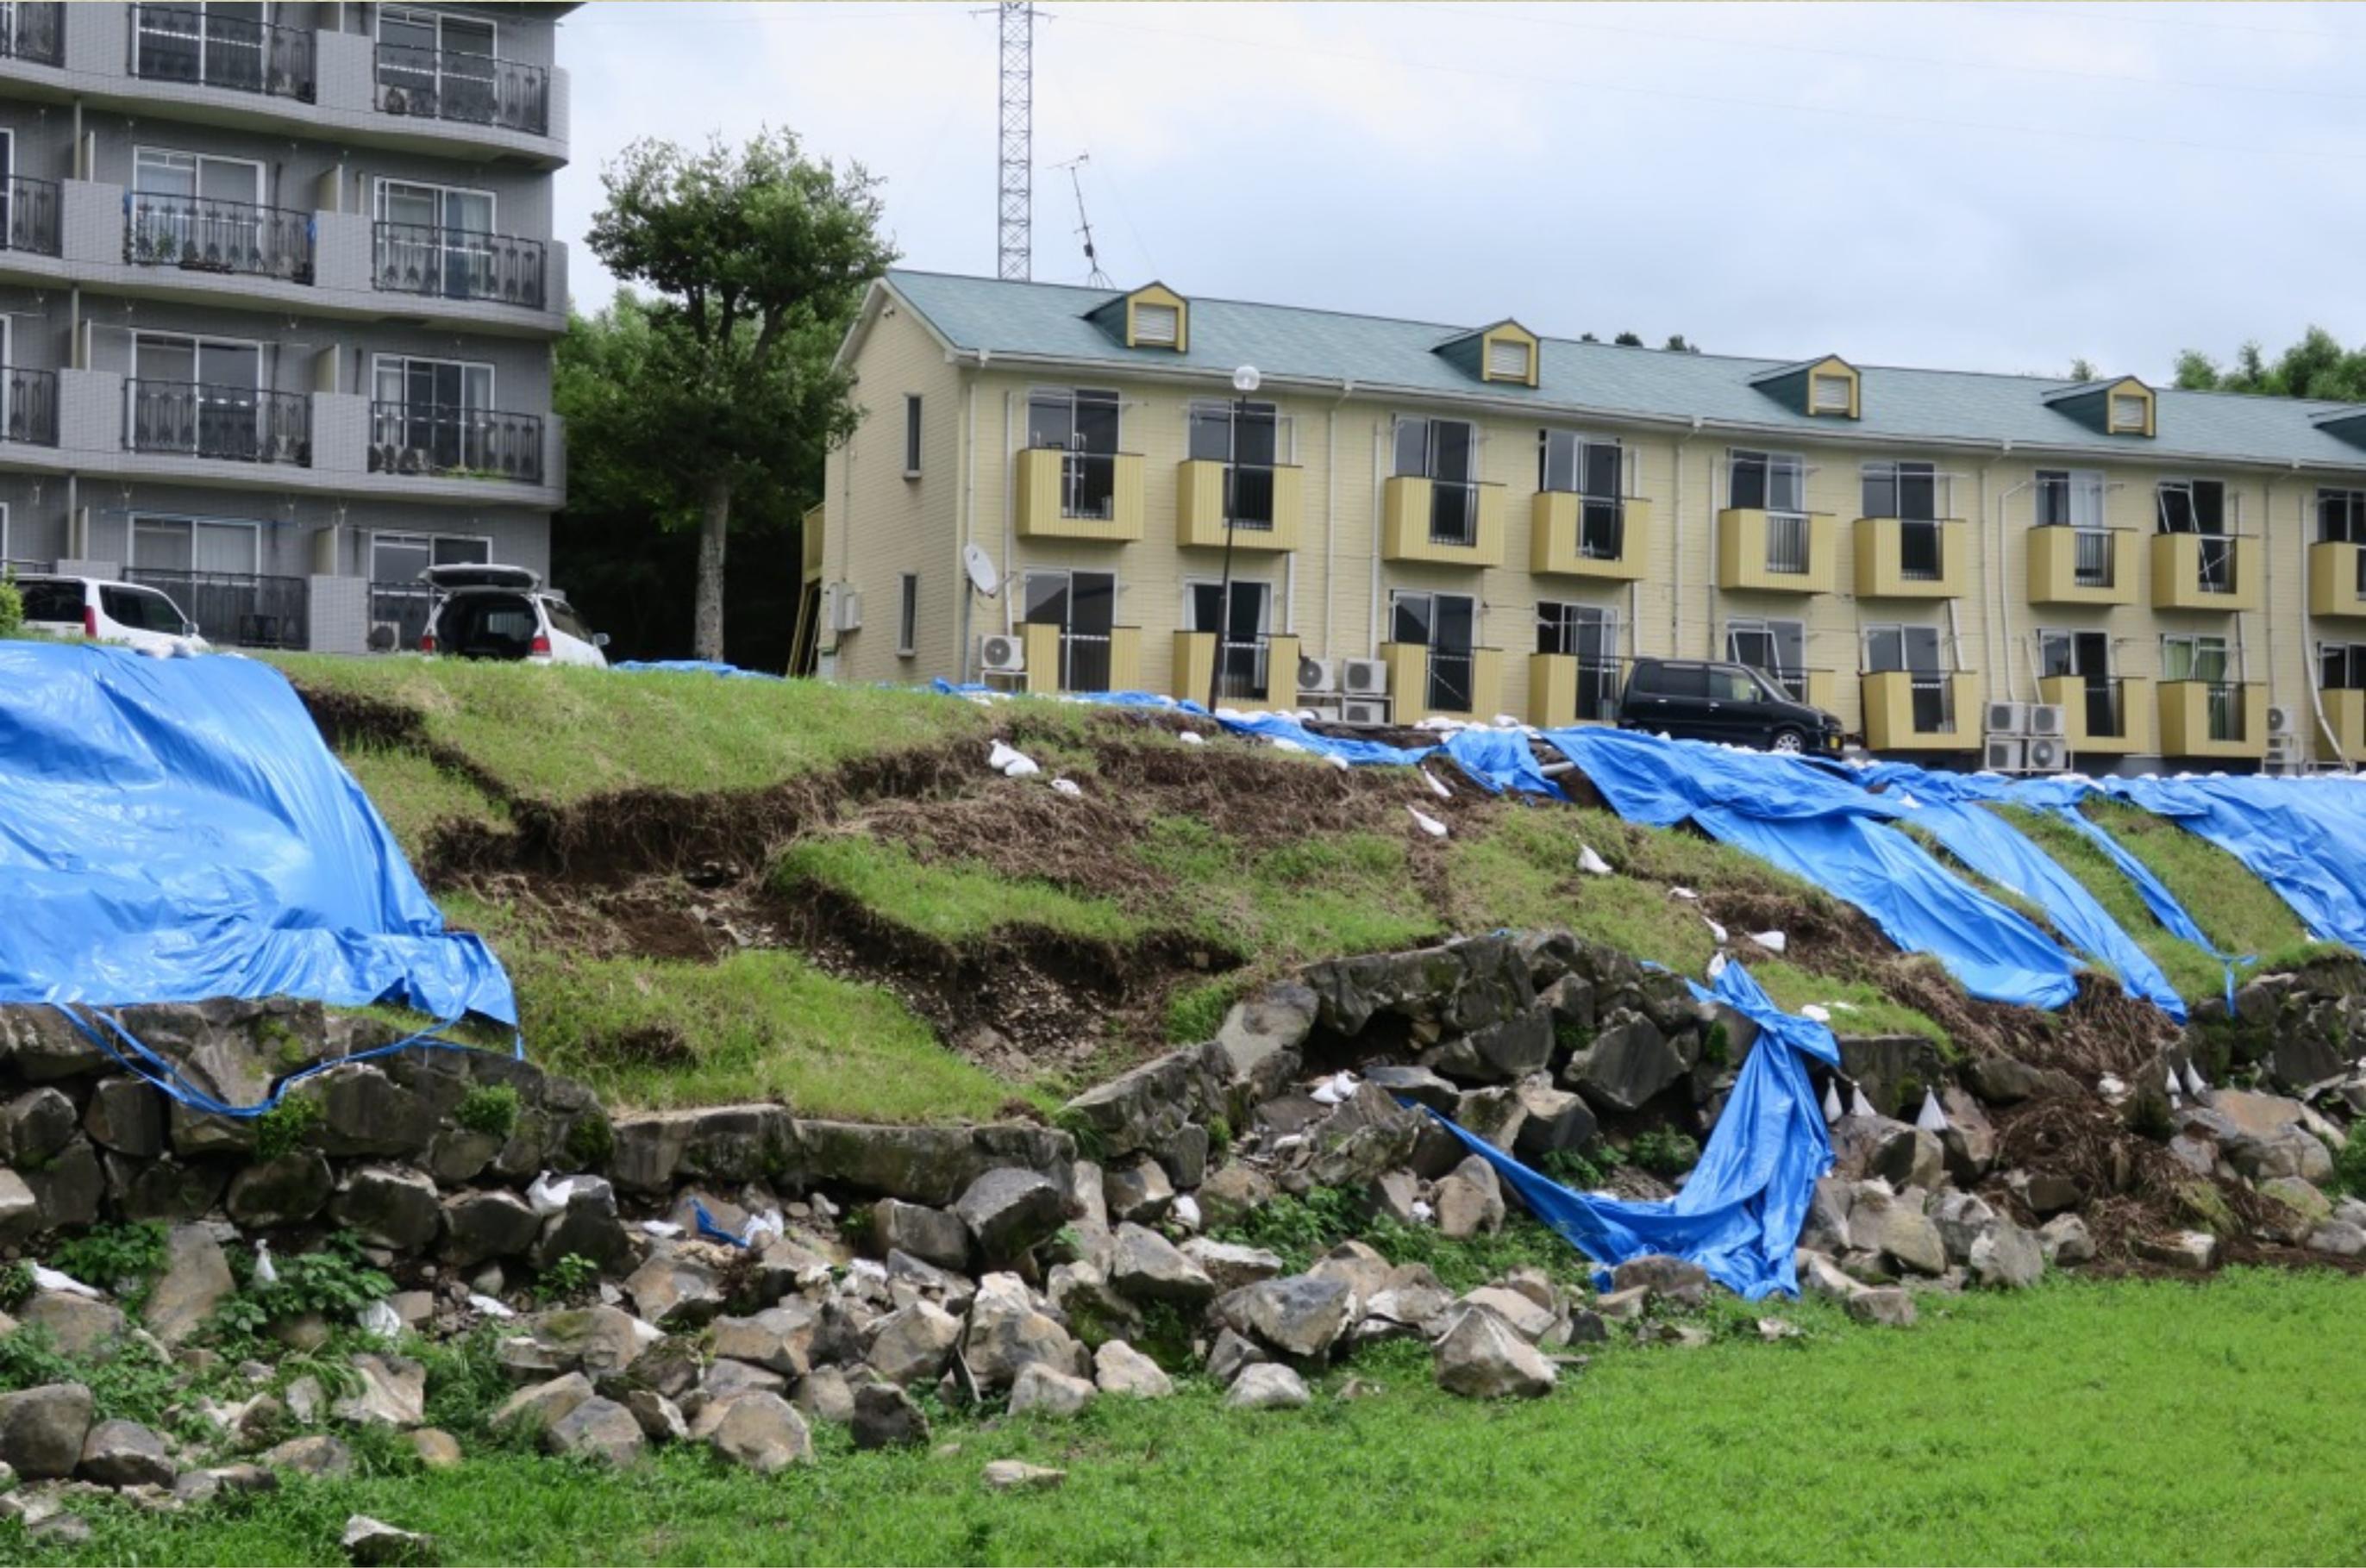
PGA $\sim 0.7g+$. Embankment failure

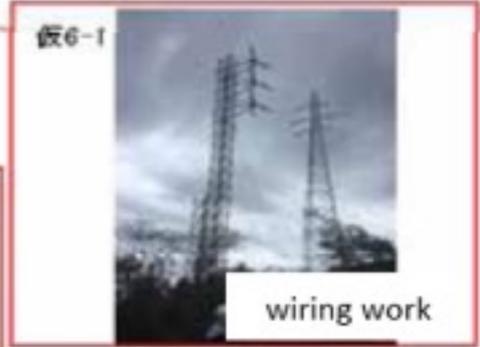
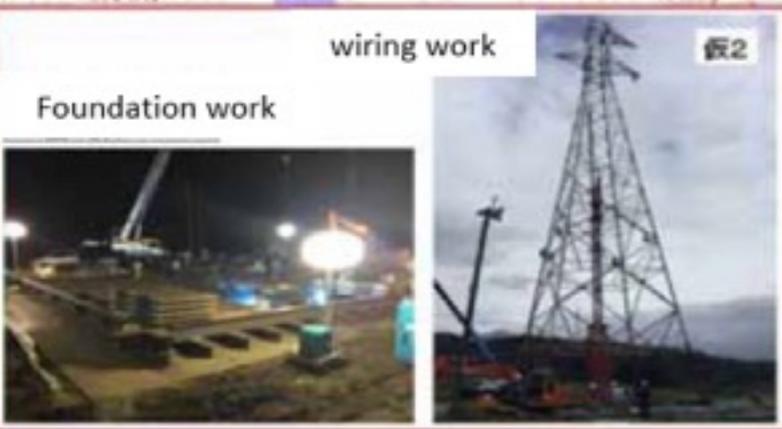
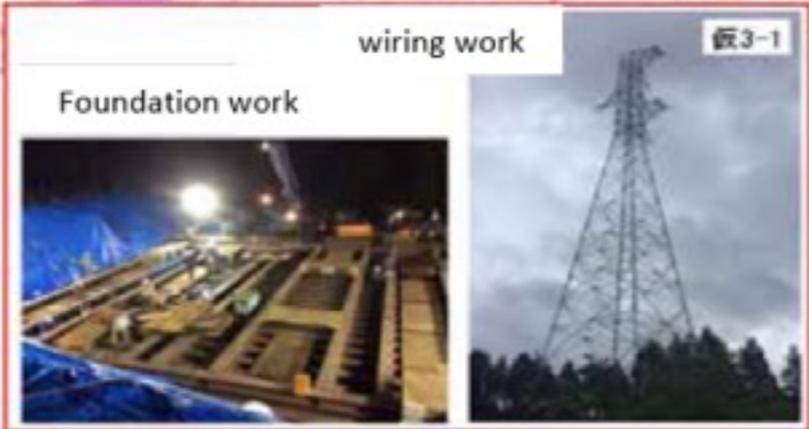
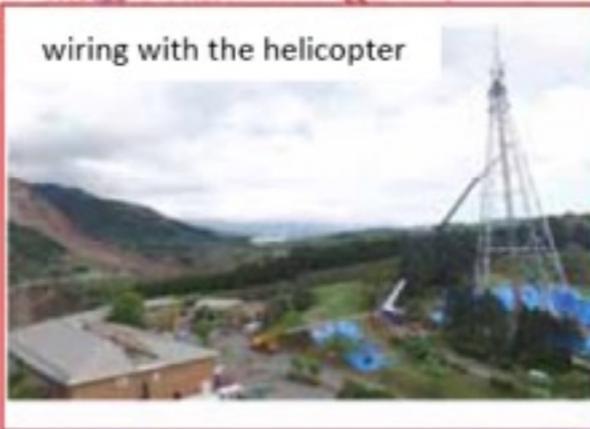
② 66kV Kurokawa-Ichinomiya Line in Tateno Area with the Temporary Route

Steel Tower
Minor Damage
(buckled brace)

Steel Pole
No Damage

Steel Tower
Major Damage
(2 foot PGD)

Steel Tower
Major Damage
(3 foot PGD)

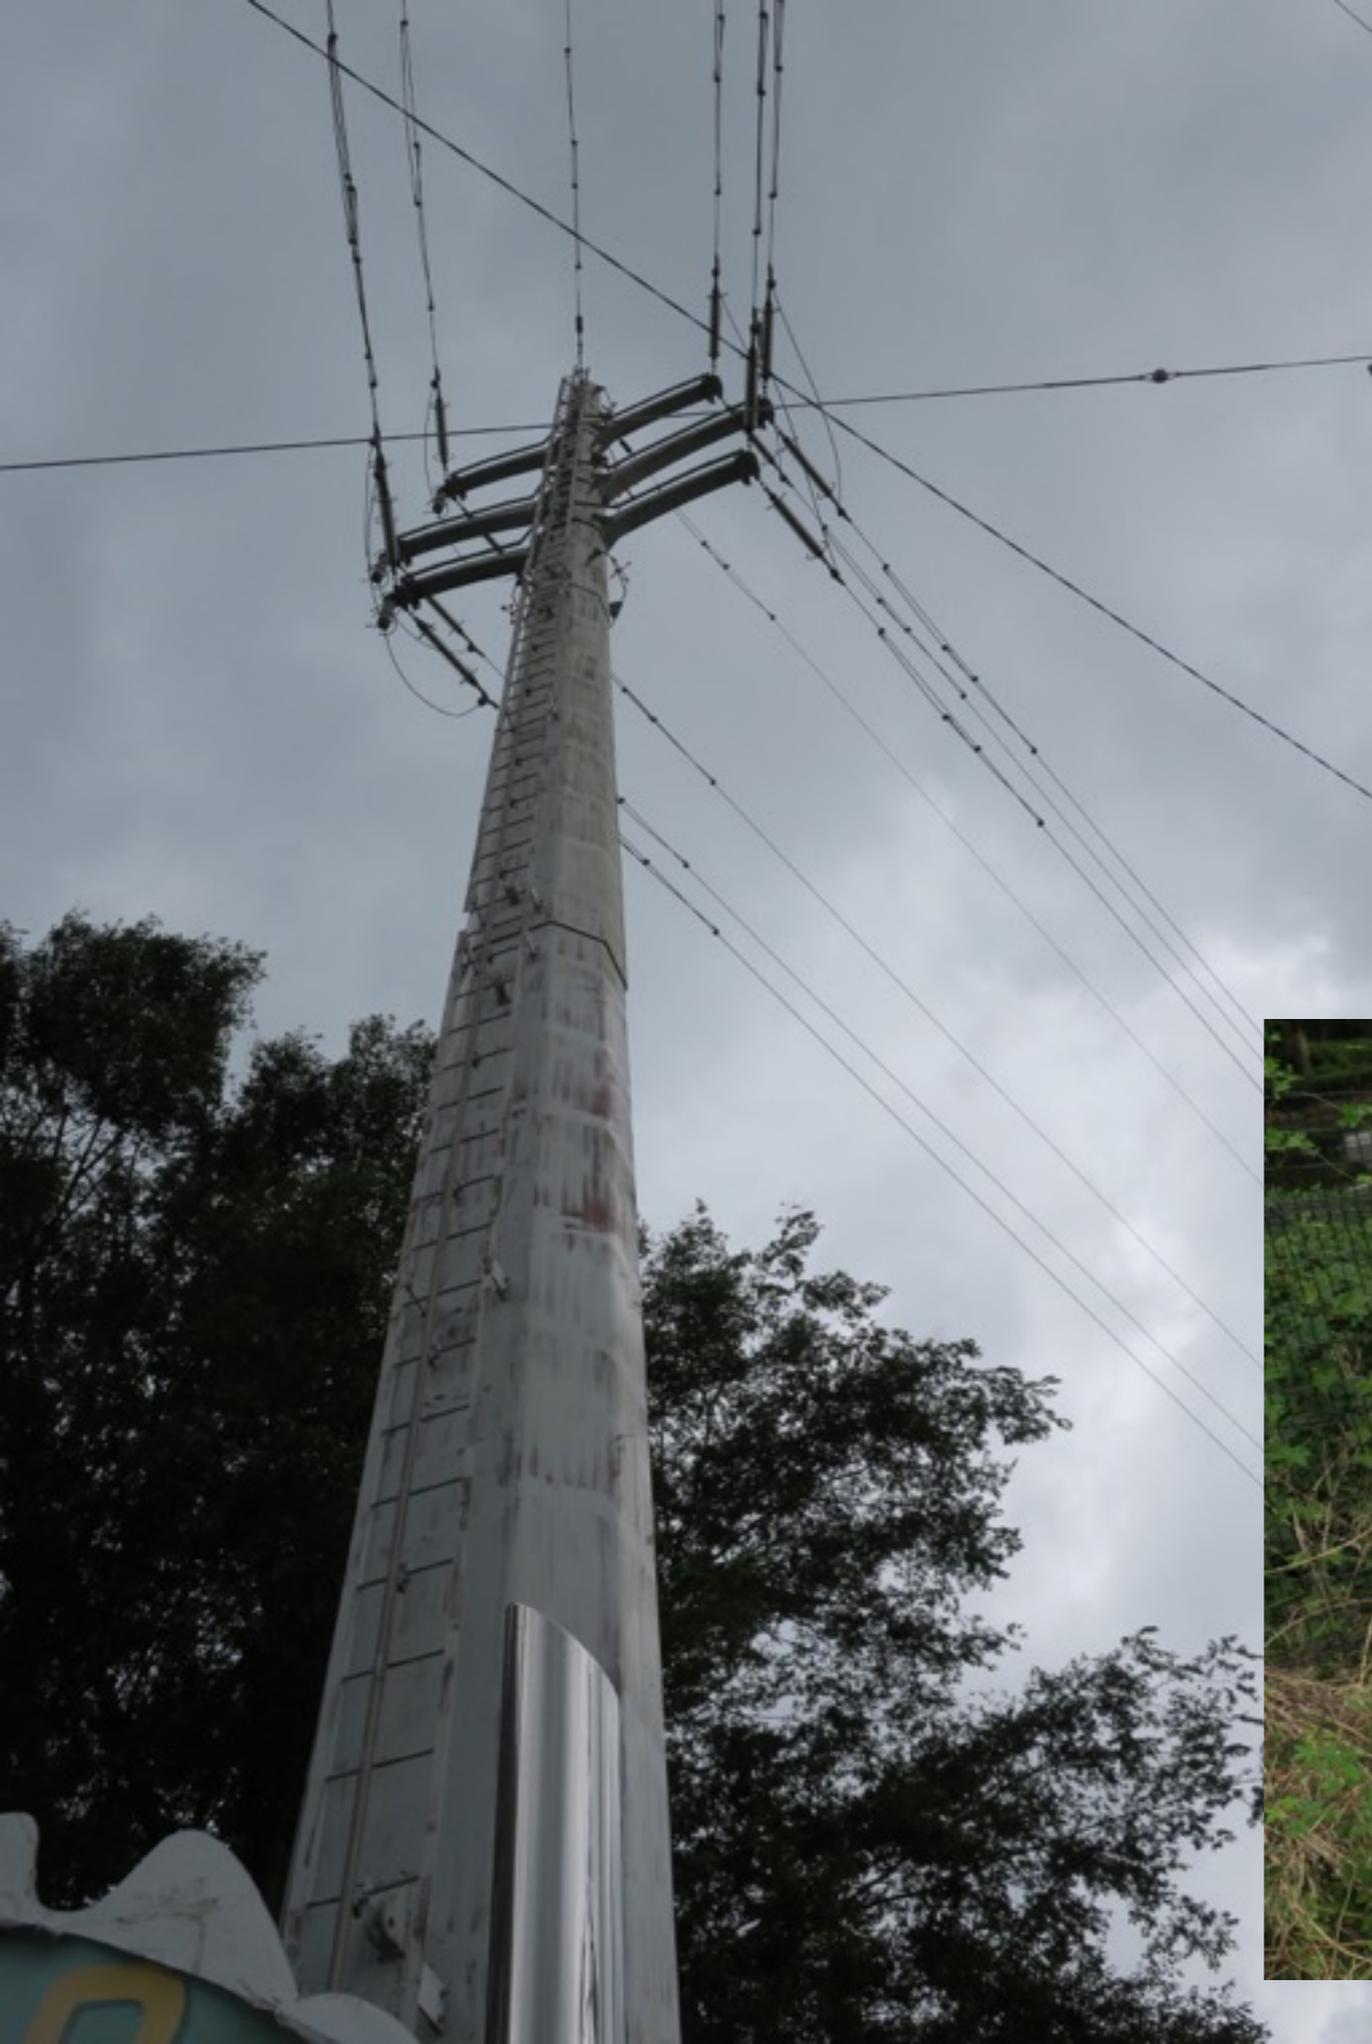
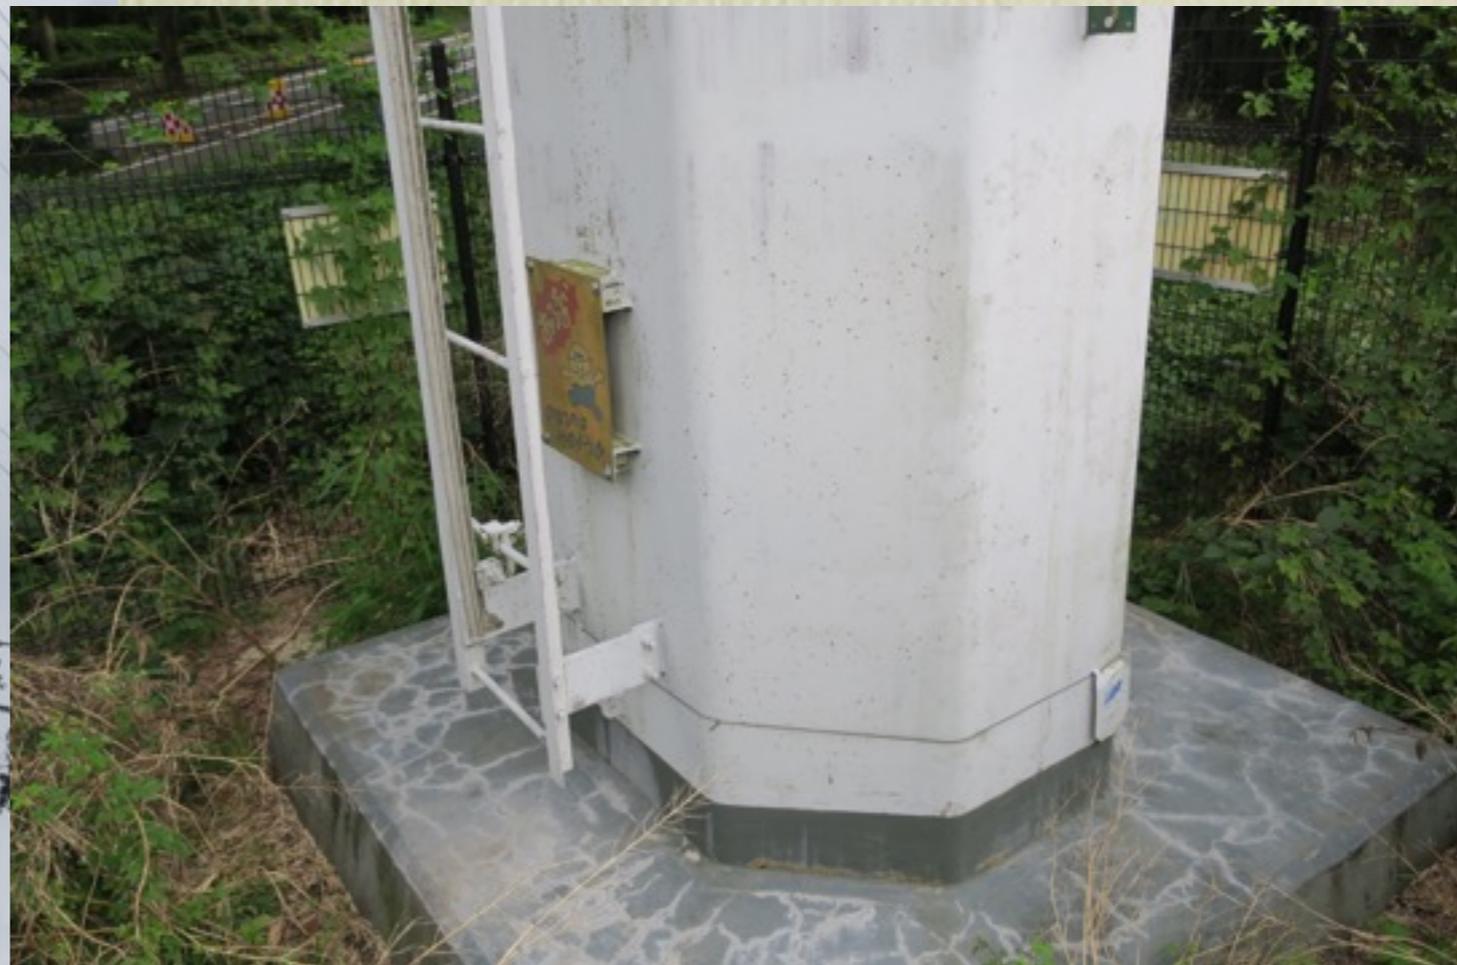
Steel Pole 9
No apparent yielding
