Kumamoto M 6.0 and 7.0 Earthquakes of April 14, 16 2016

Electric Power
John Eiding
G&E Engineering Systems Inc.
September 15 2016

Electric Power

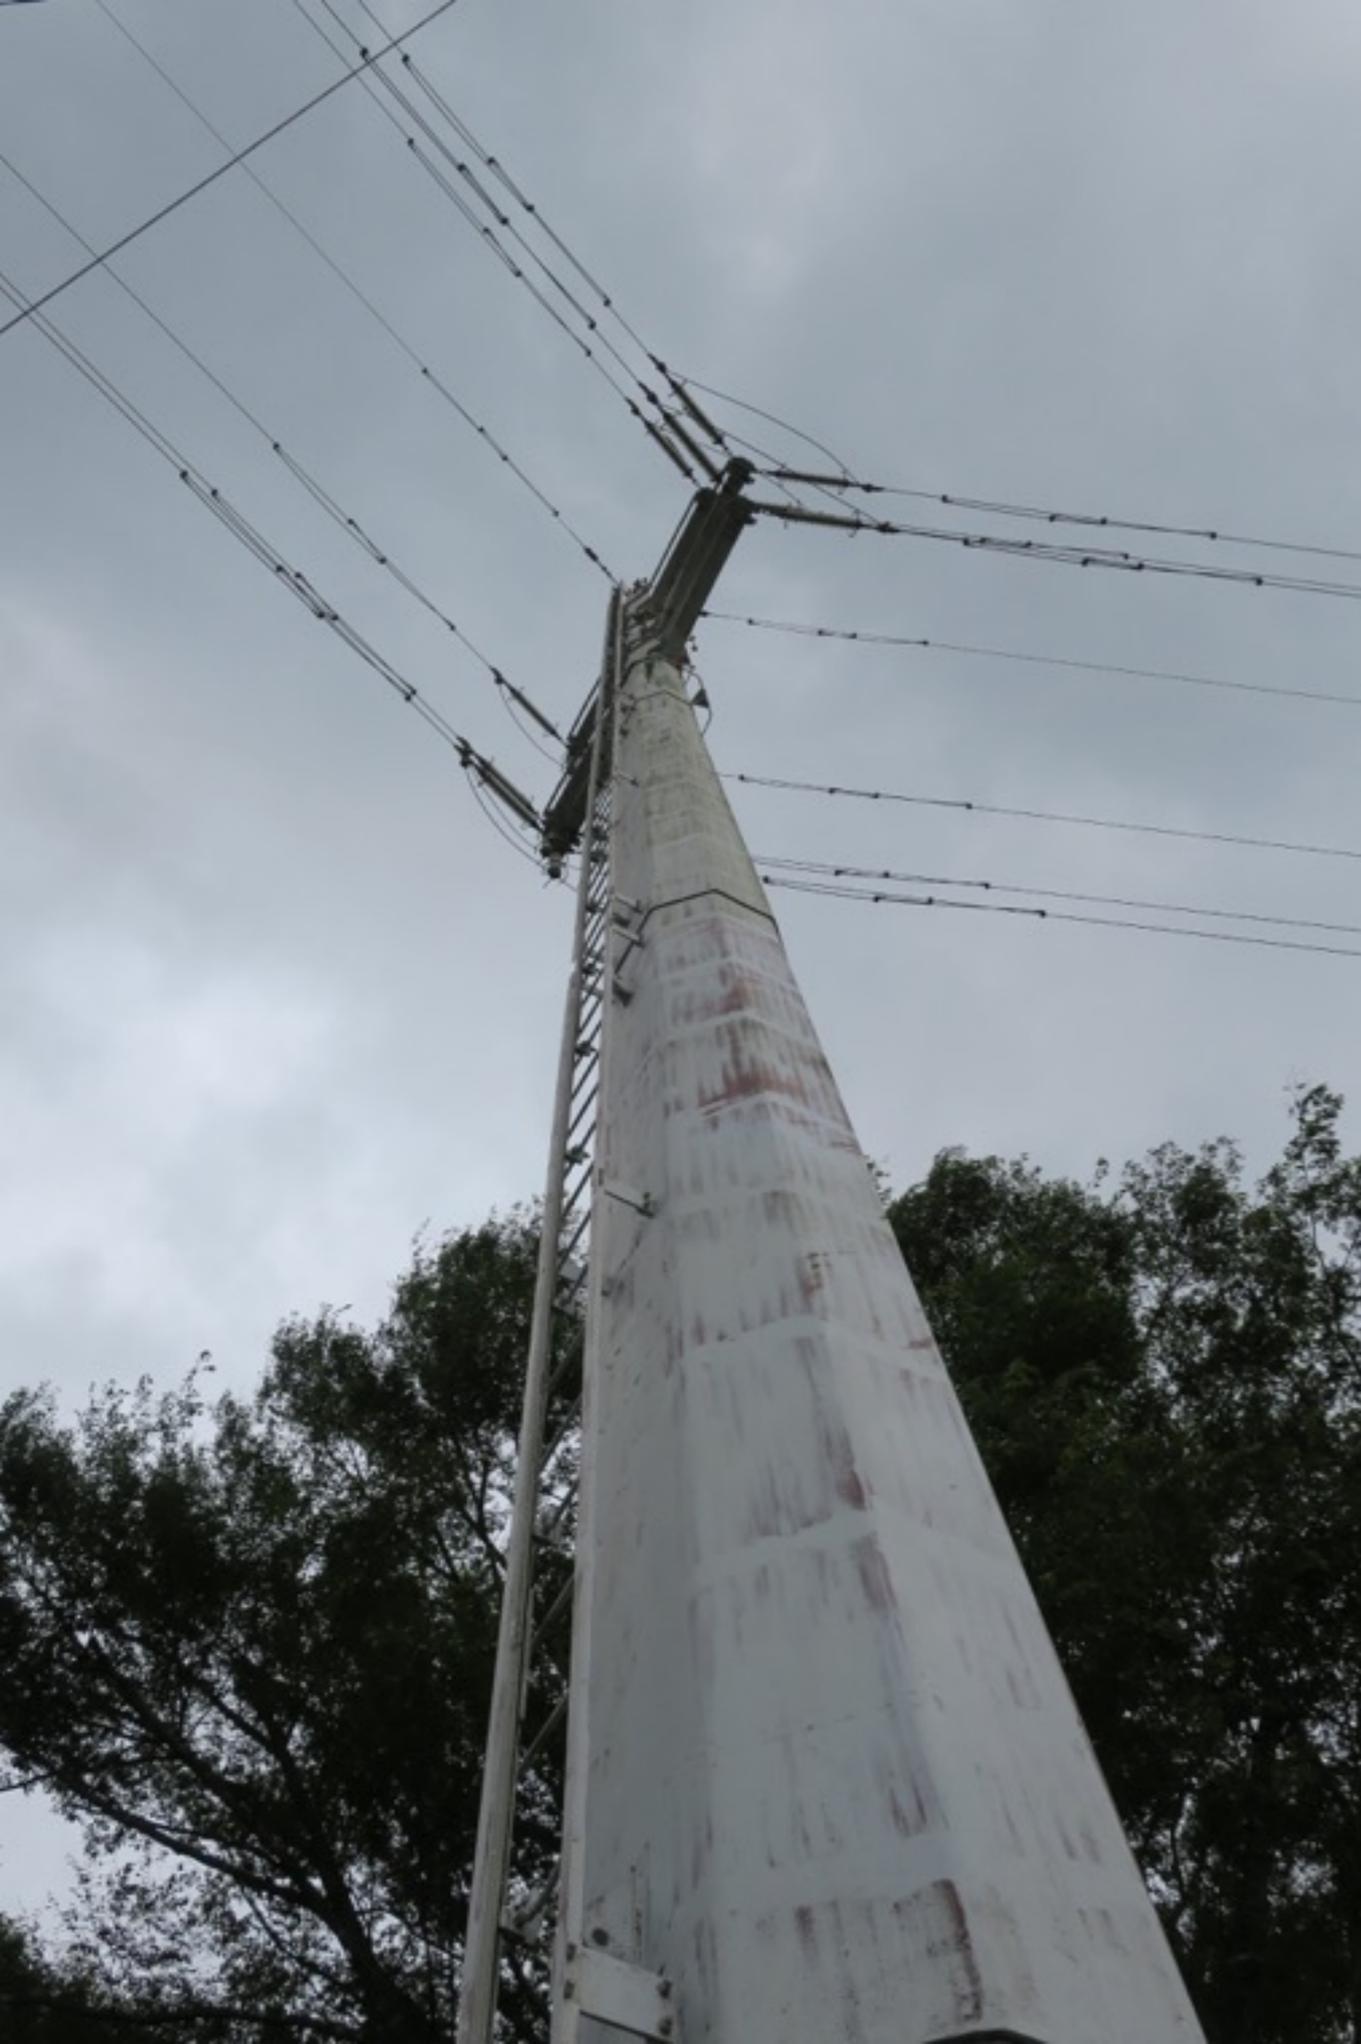
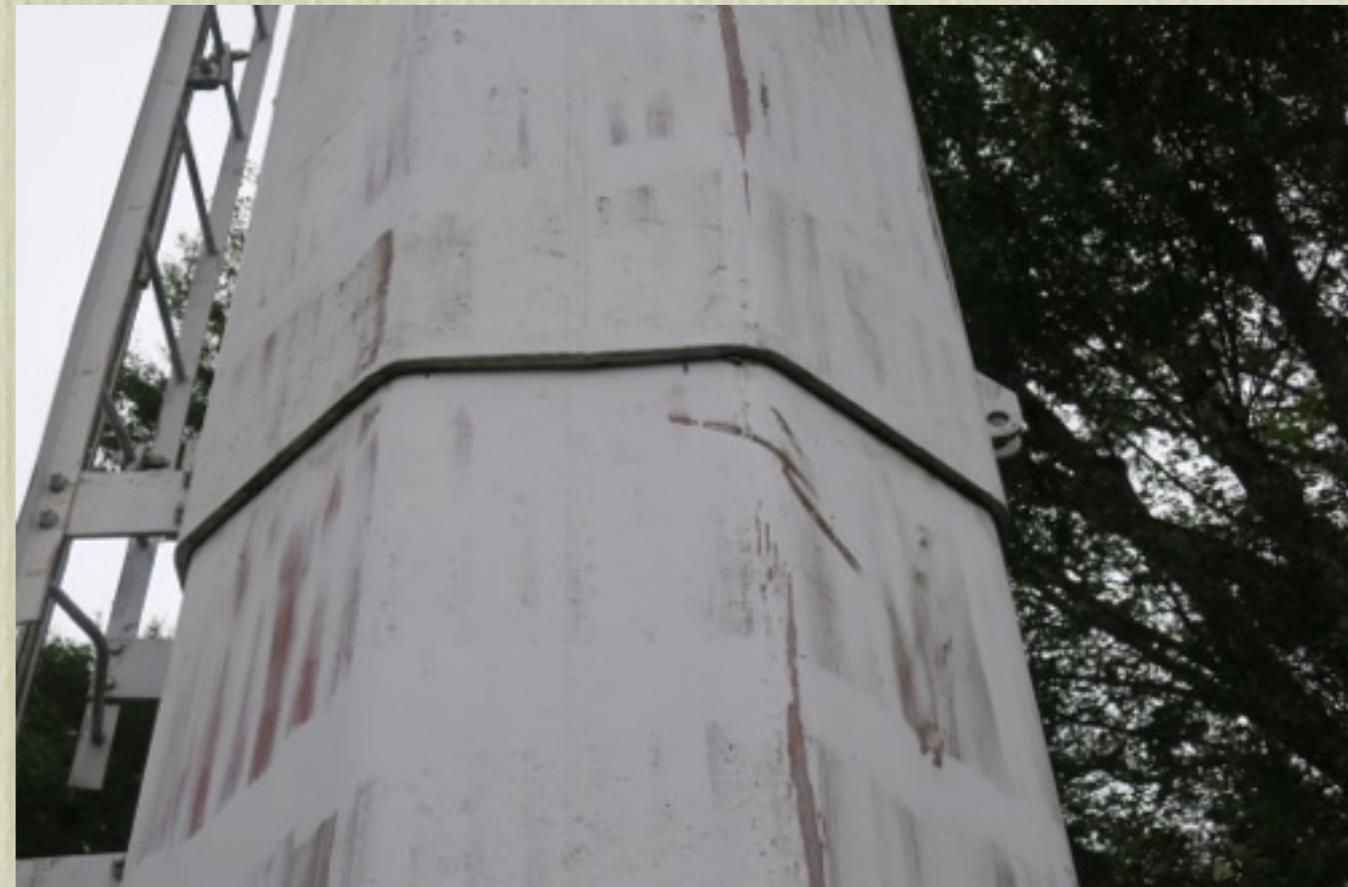
Steel Pole 9
No apparent yielding

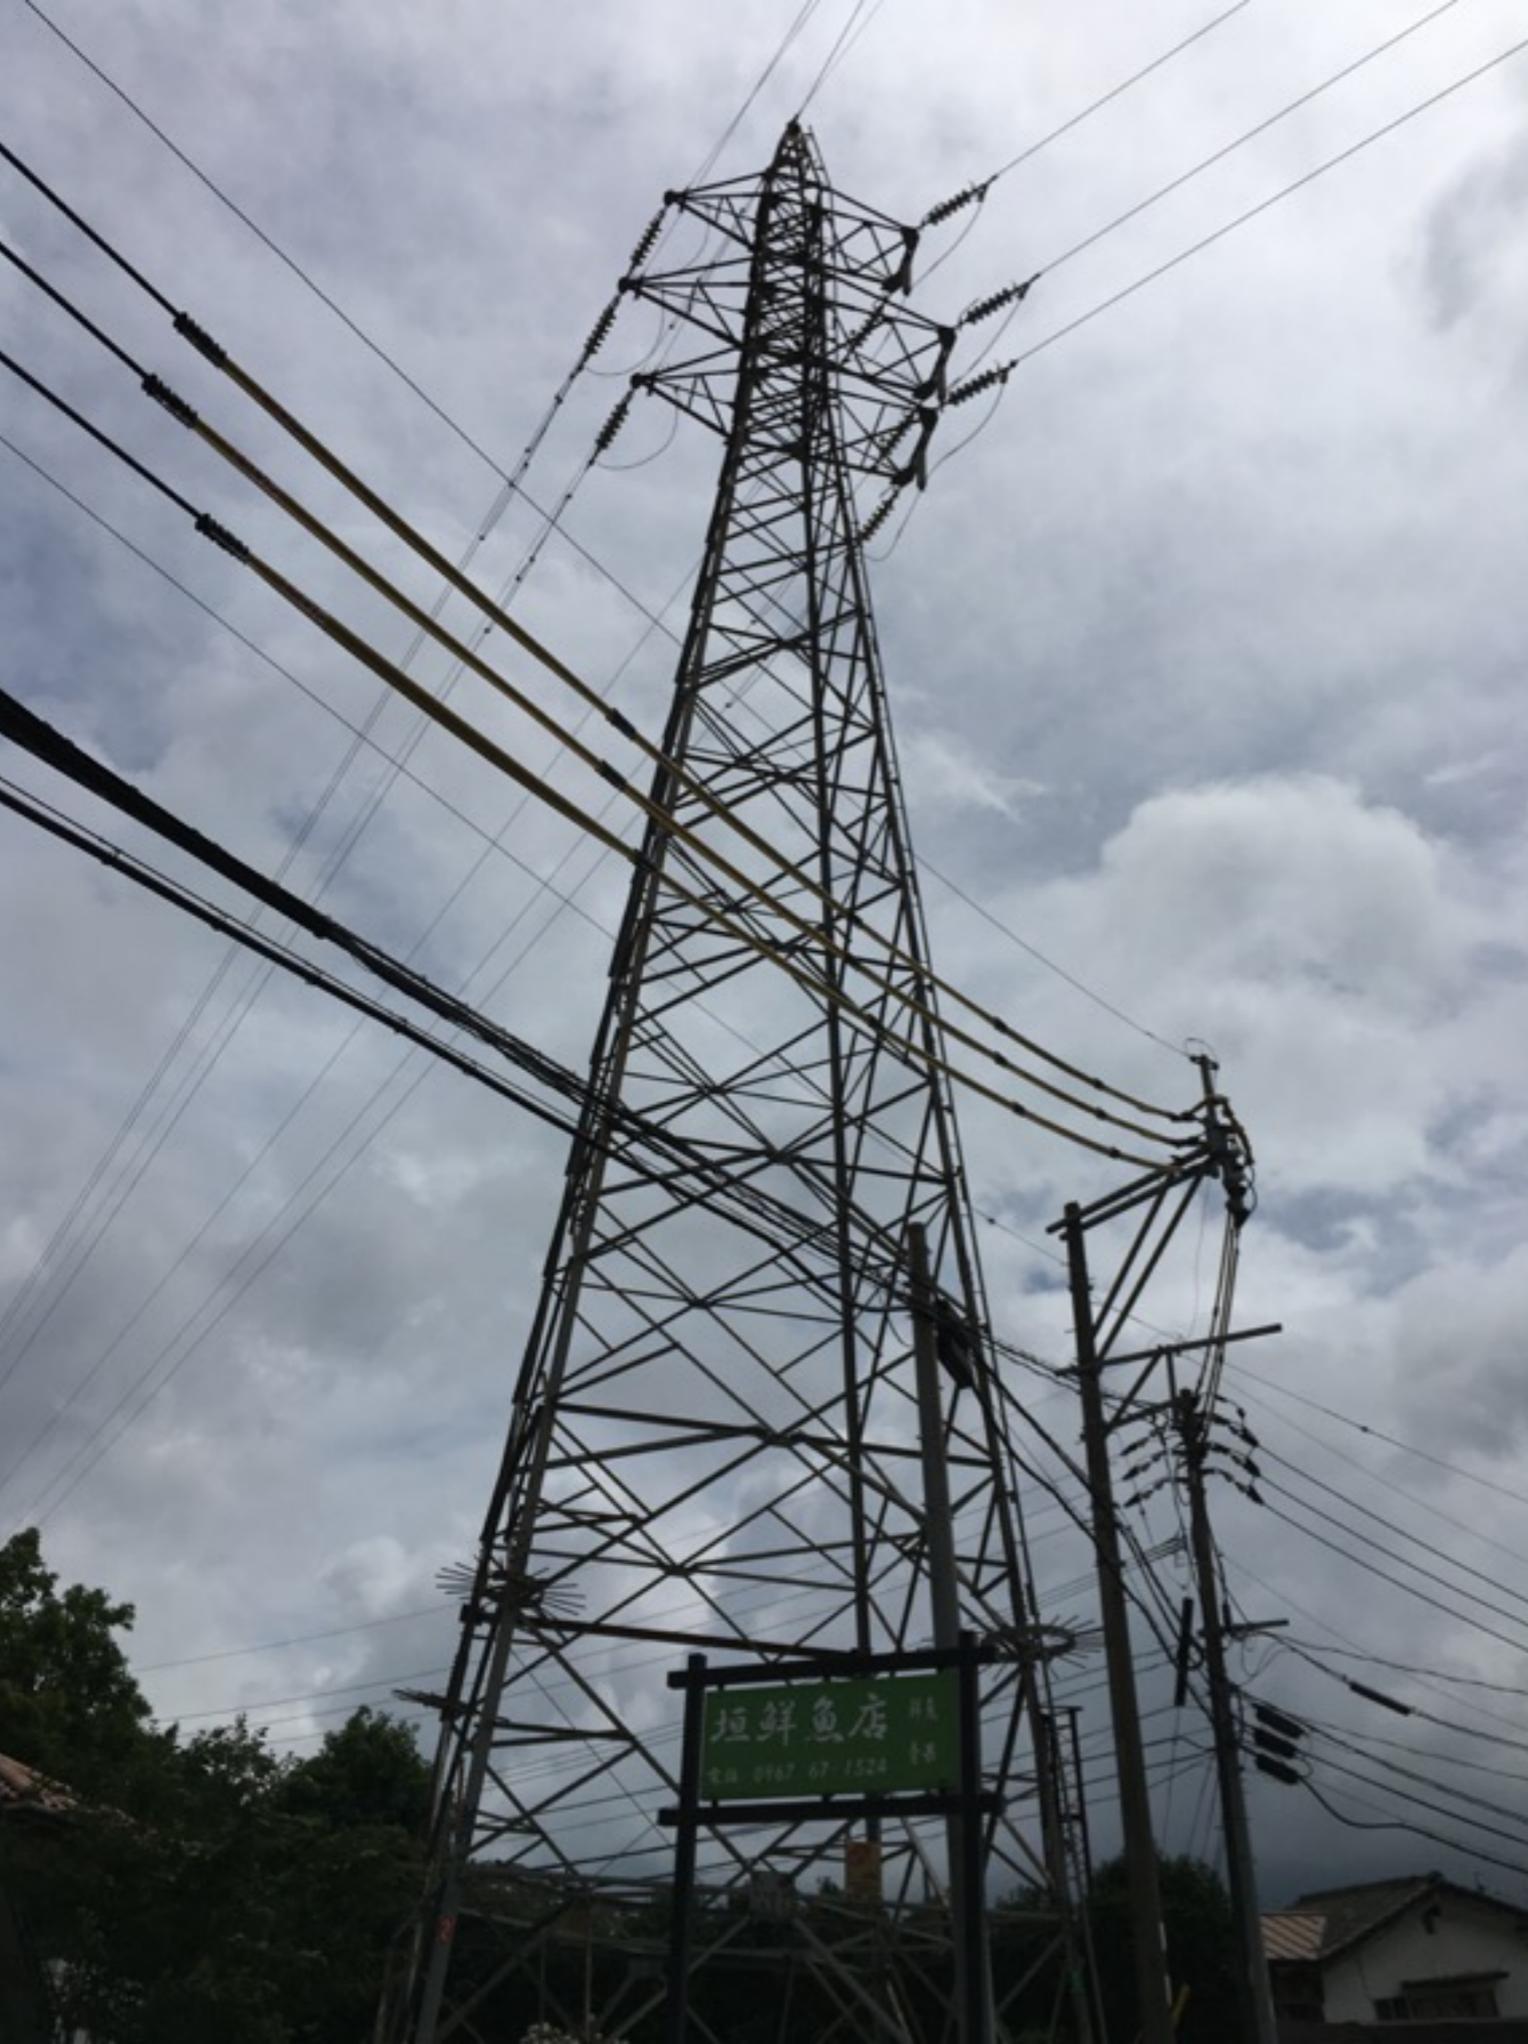
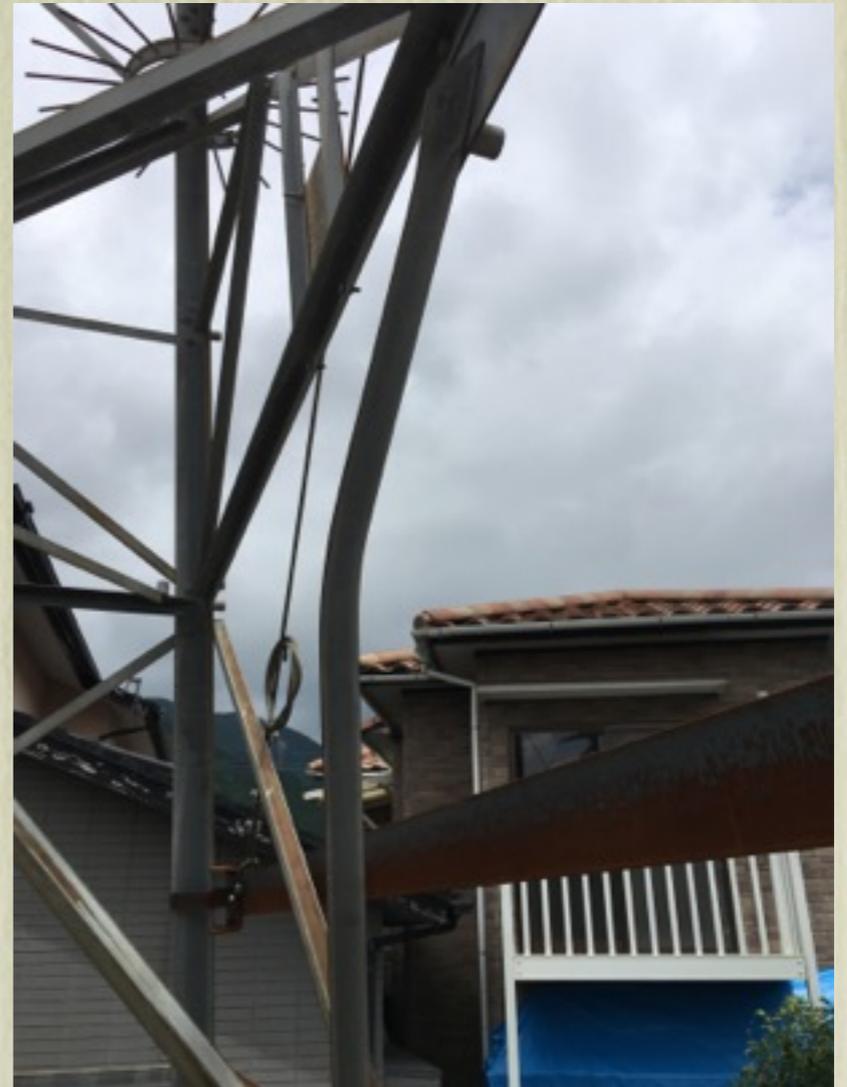
Steel Tower 10 Buckled Brace

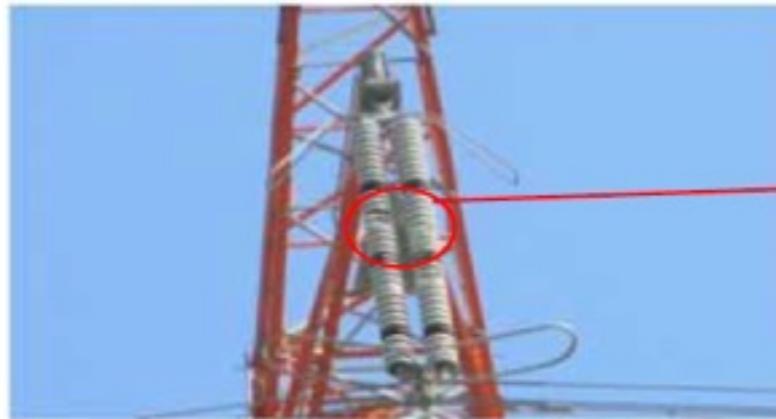
500kV Reihoku
thermal power line
№191

500kV Insulators Damaged

Solution: add spacers. Cause: vertical motions?
This damage did not cause faults

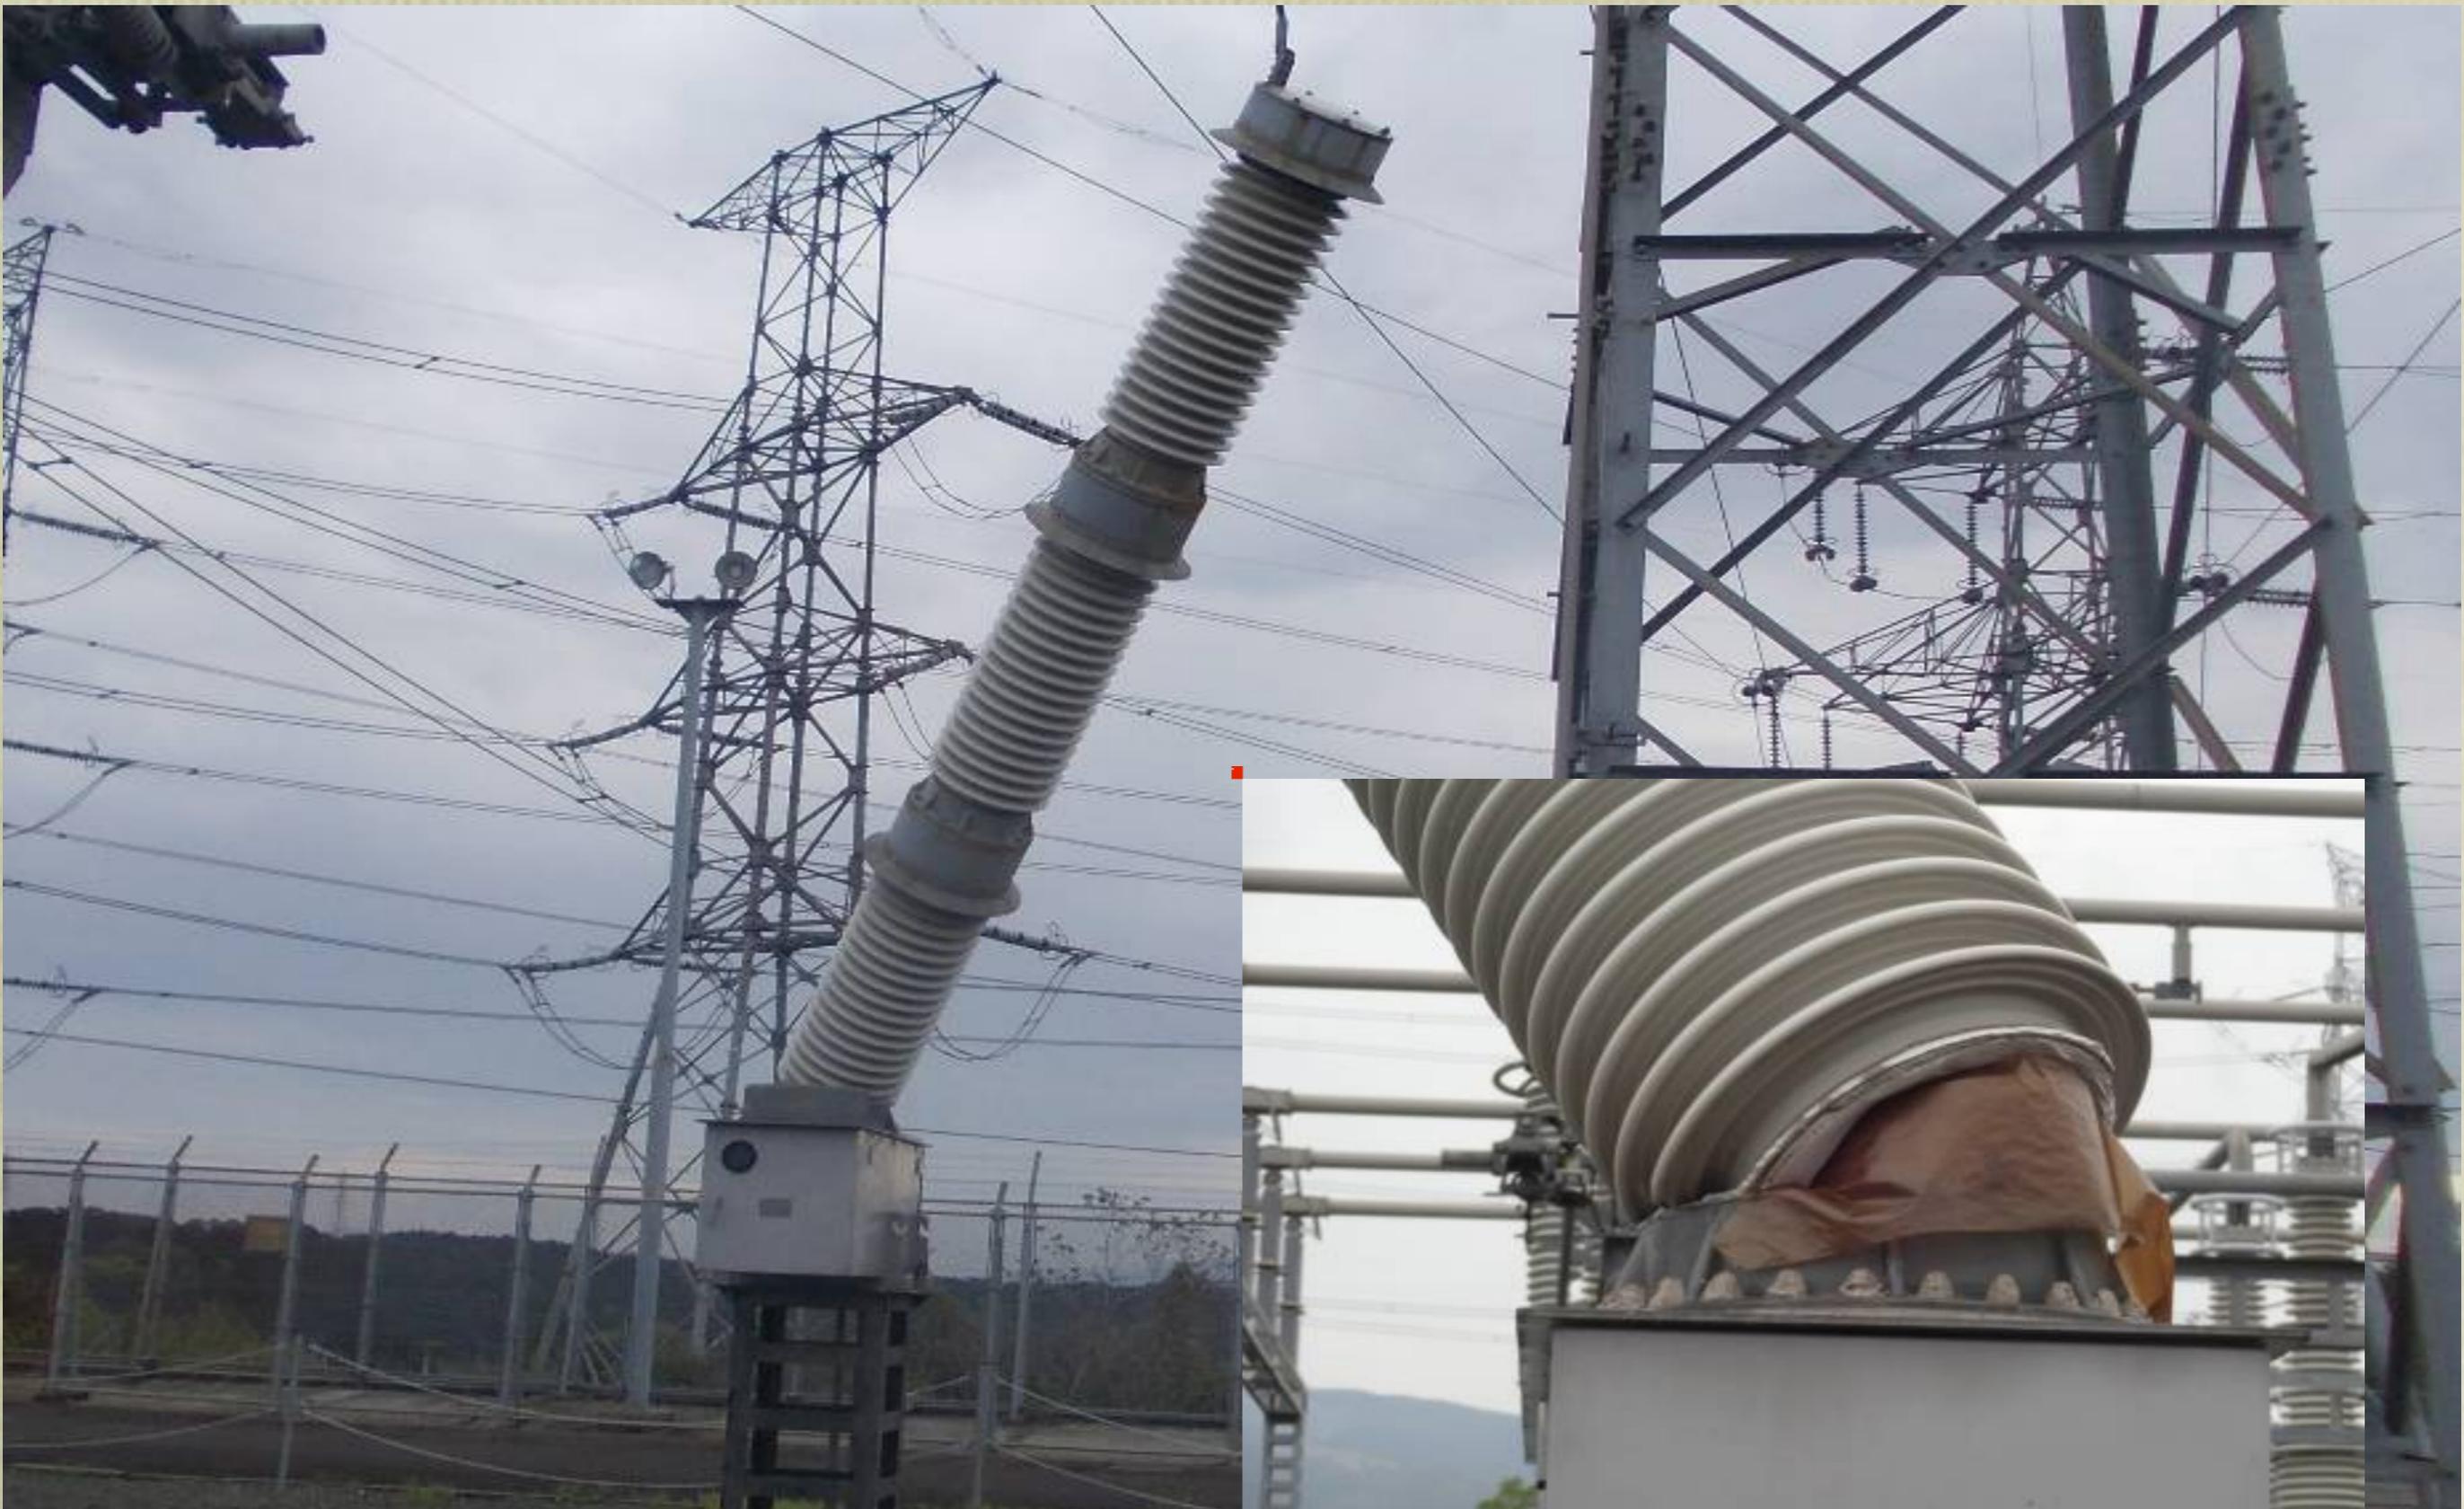
VT. Older design. No seismic qualification
Similar device broke at Sendai 2011 Tohoku EQ

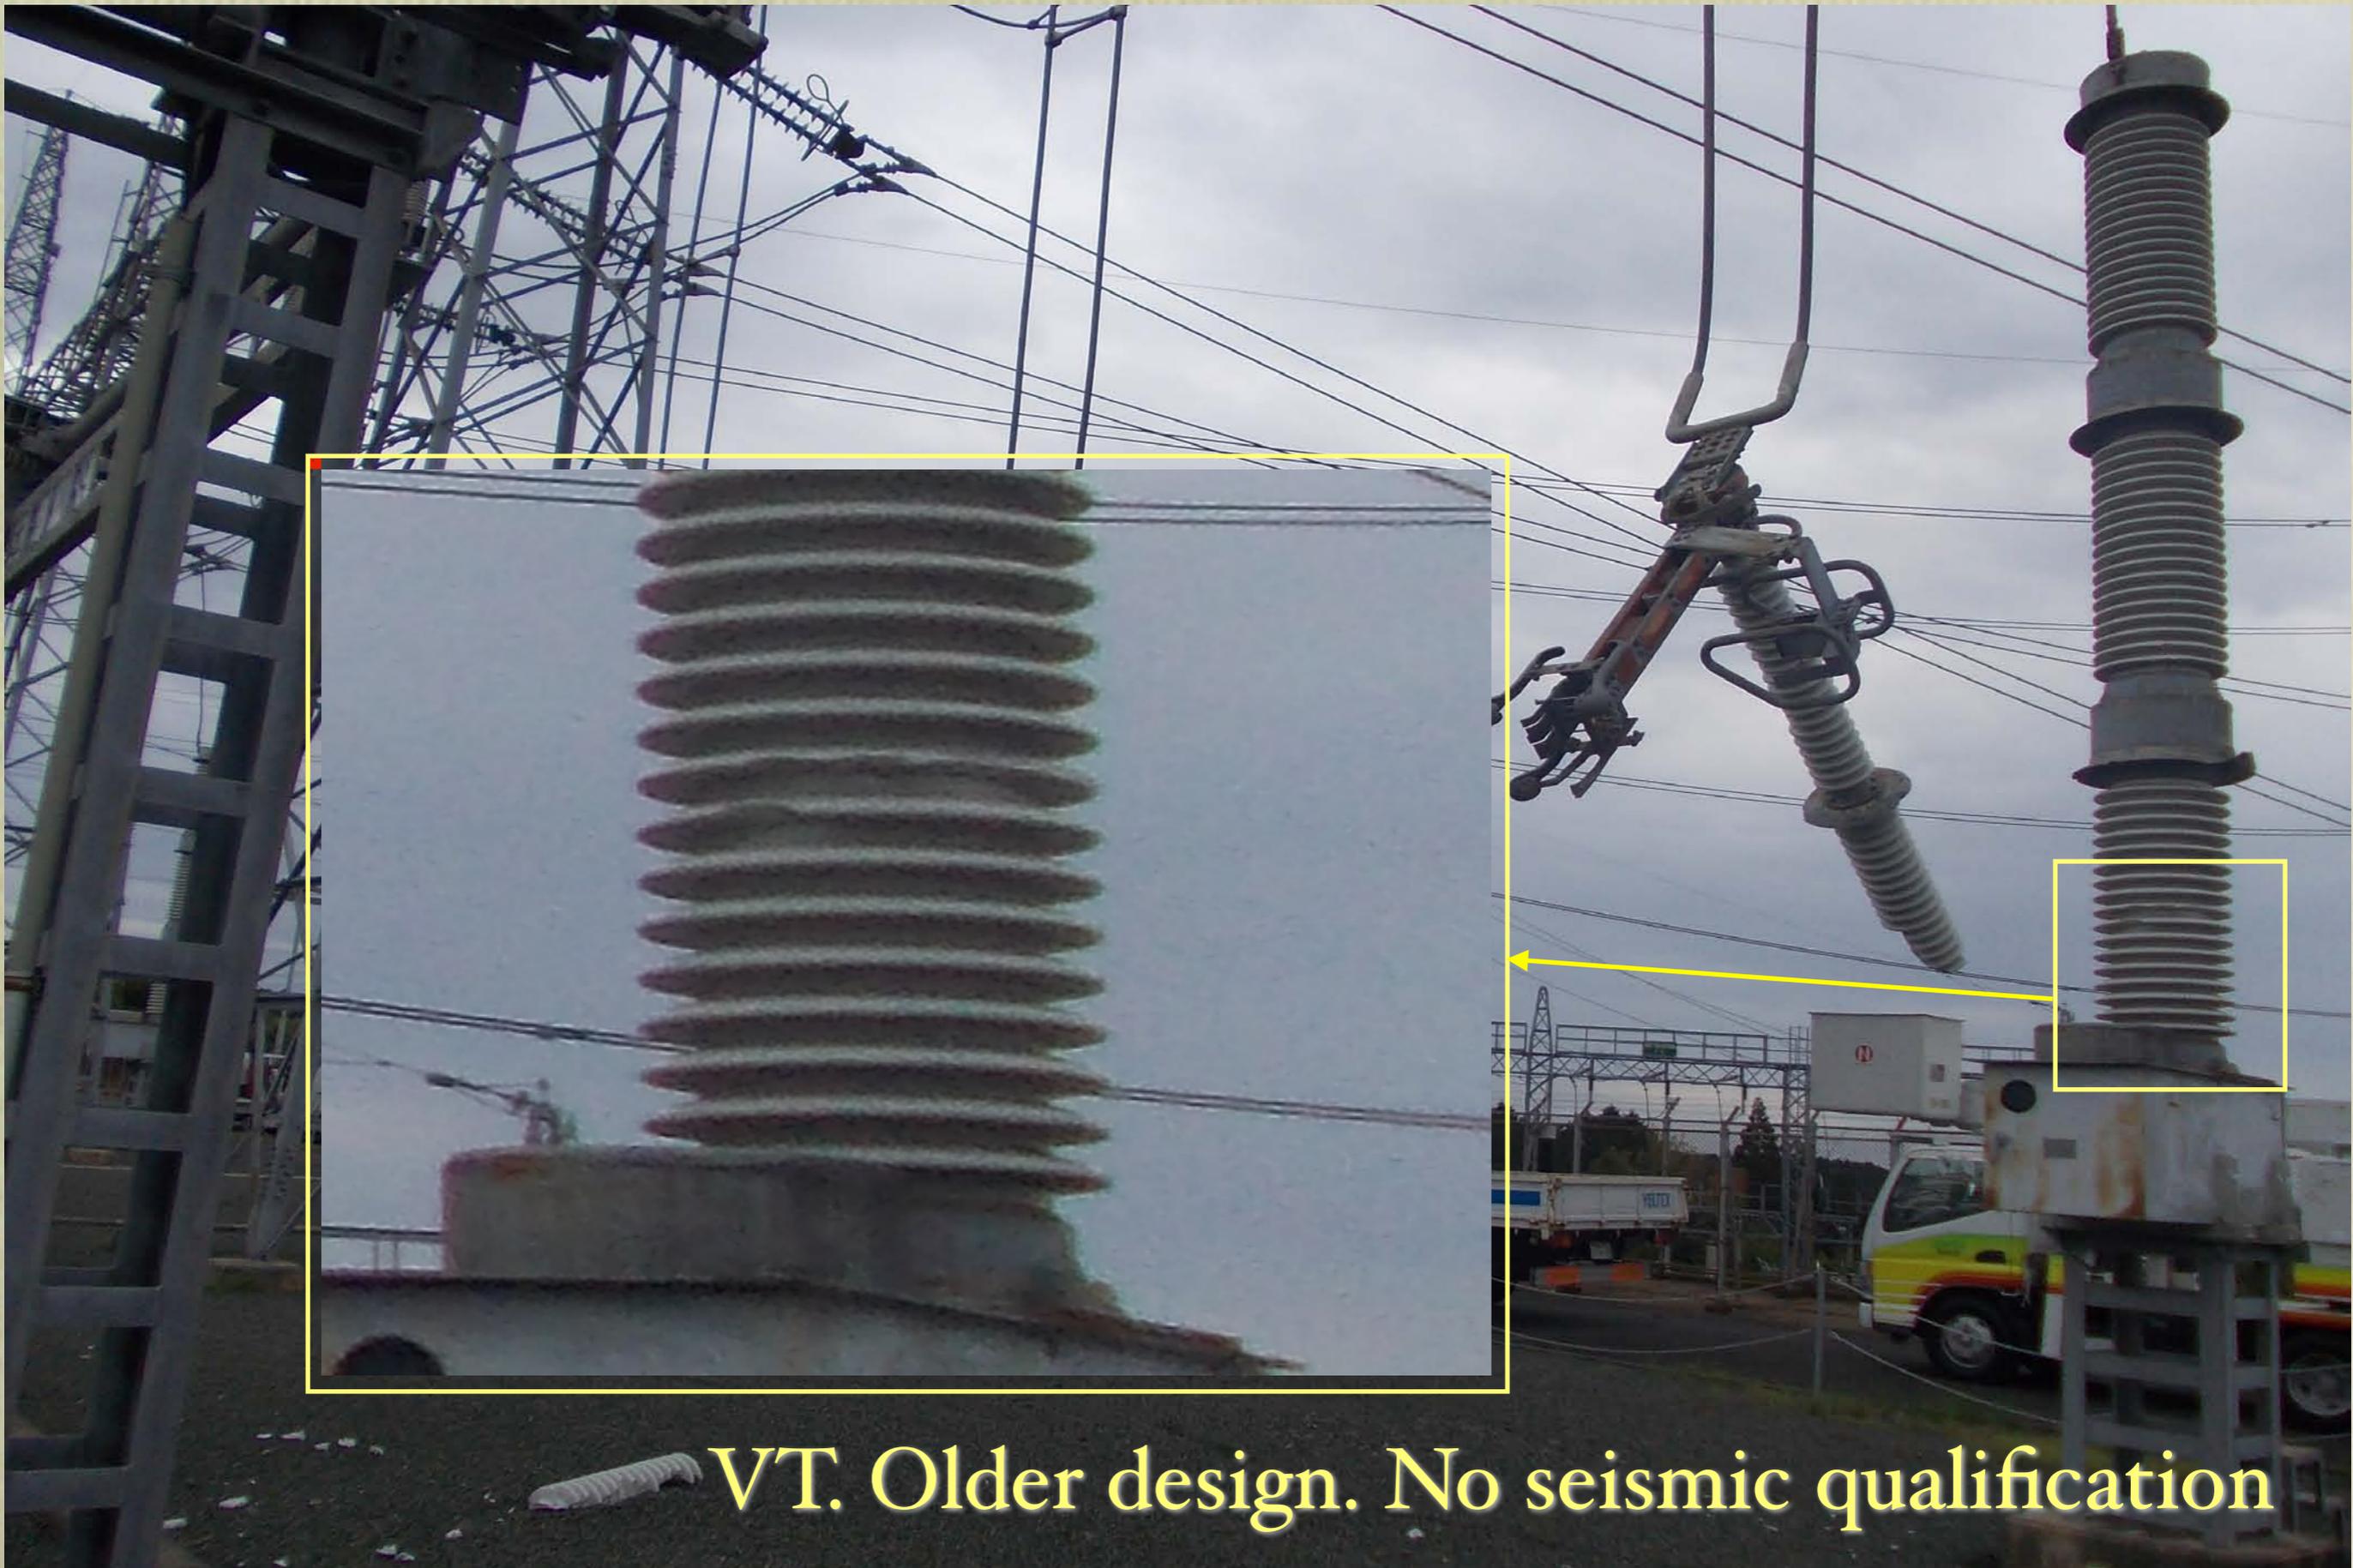
VT. Older design. No seismic qualification

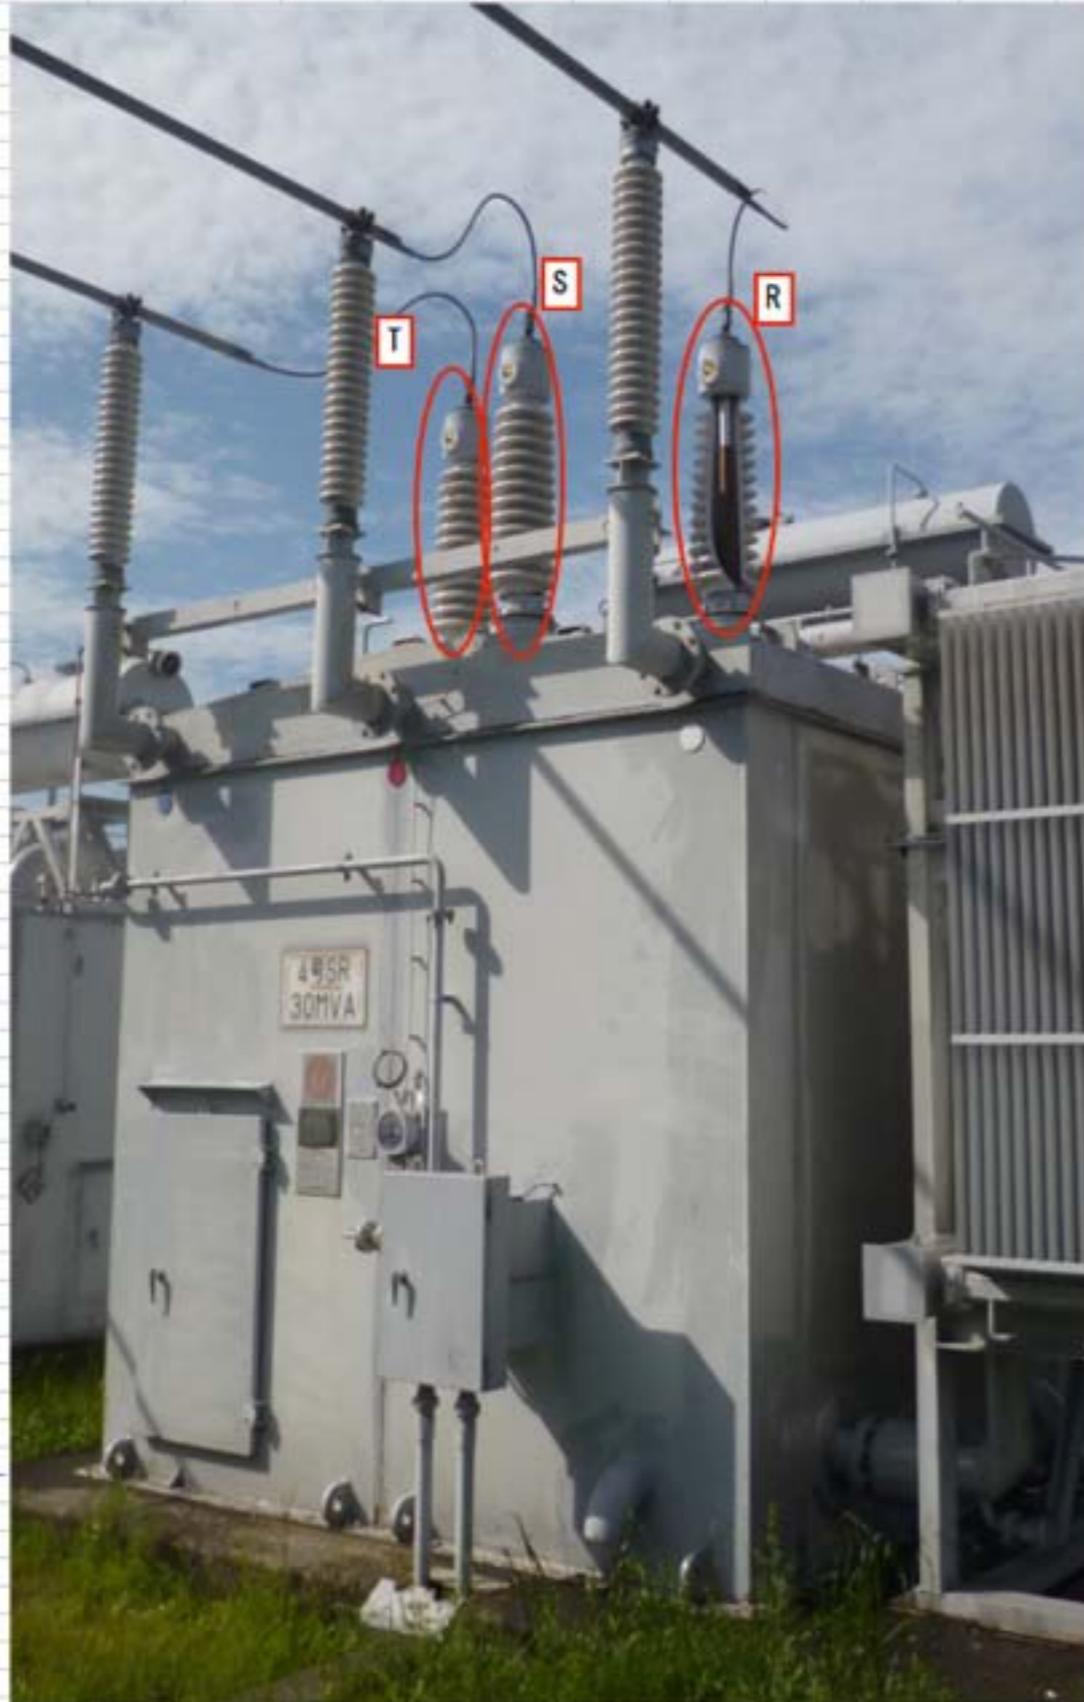
66kV bushing (S)

66 kV Slipped Bushing and oil leakage

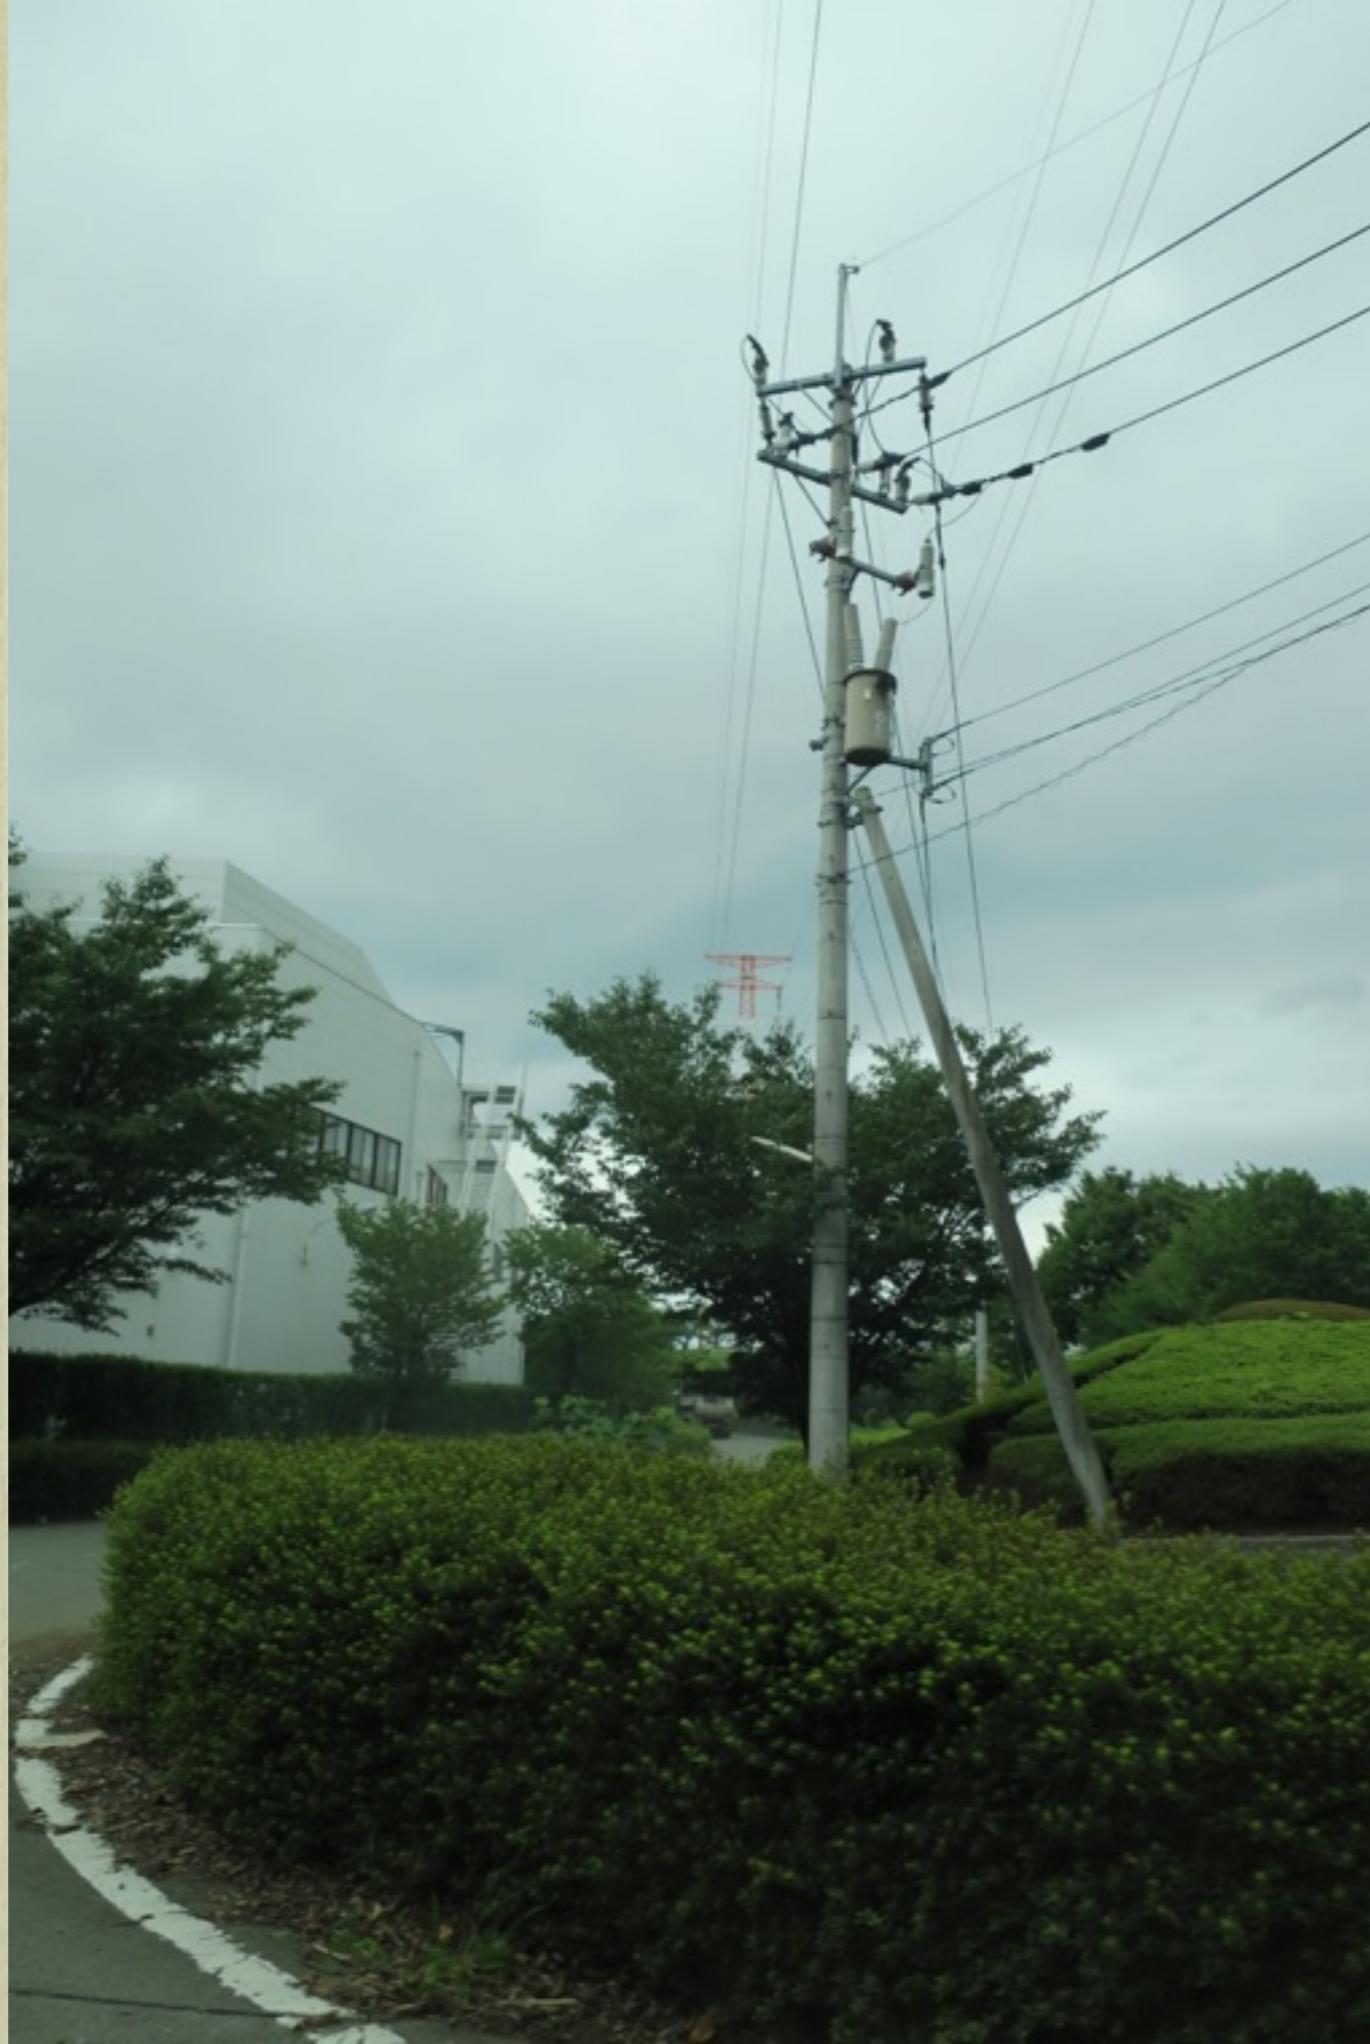
Common
Distribution
Pole

Reinforced
Concrete
Tube

Primary is
Commonly
6.5 kV

Wood Poles
are Rare

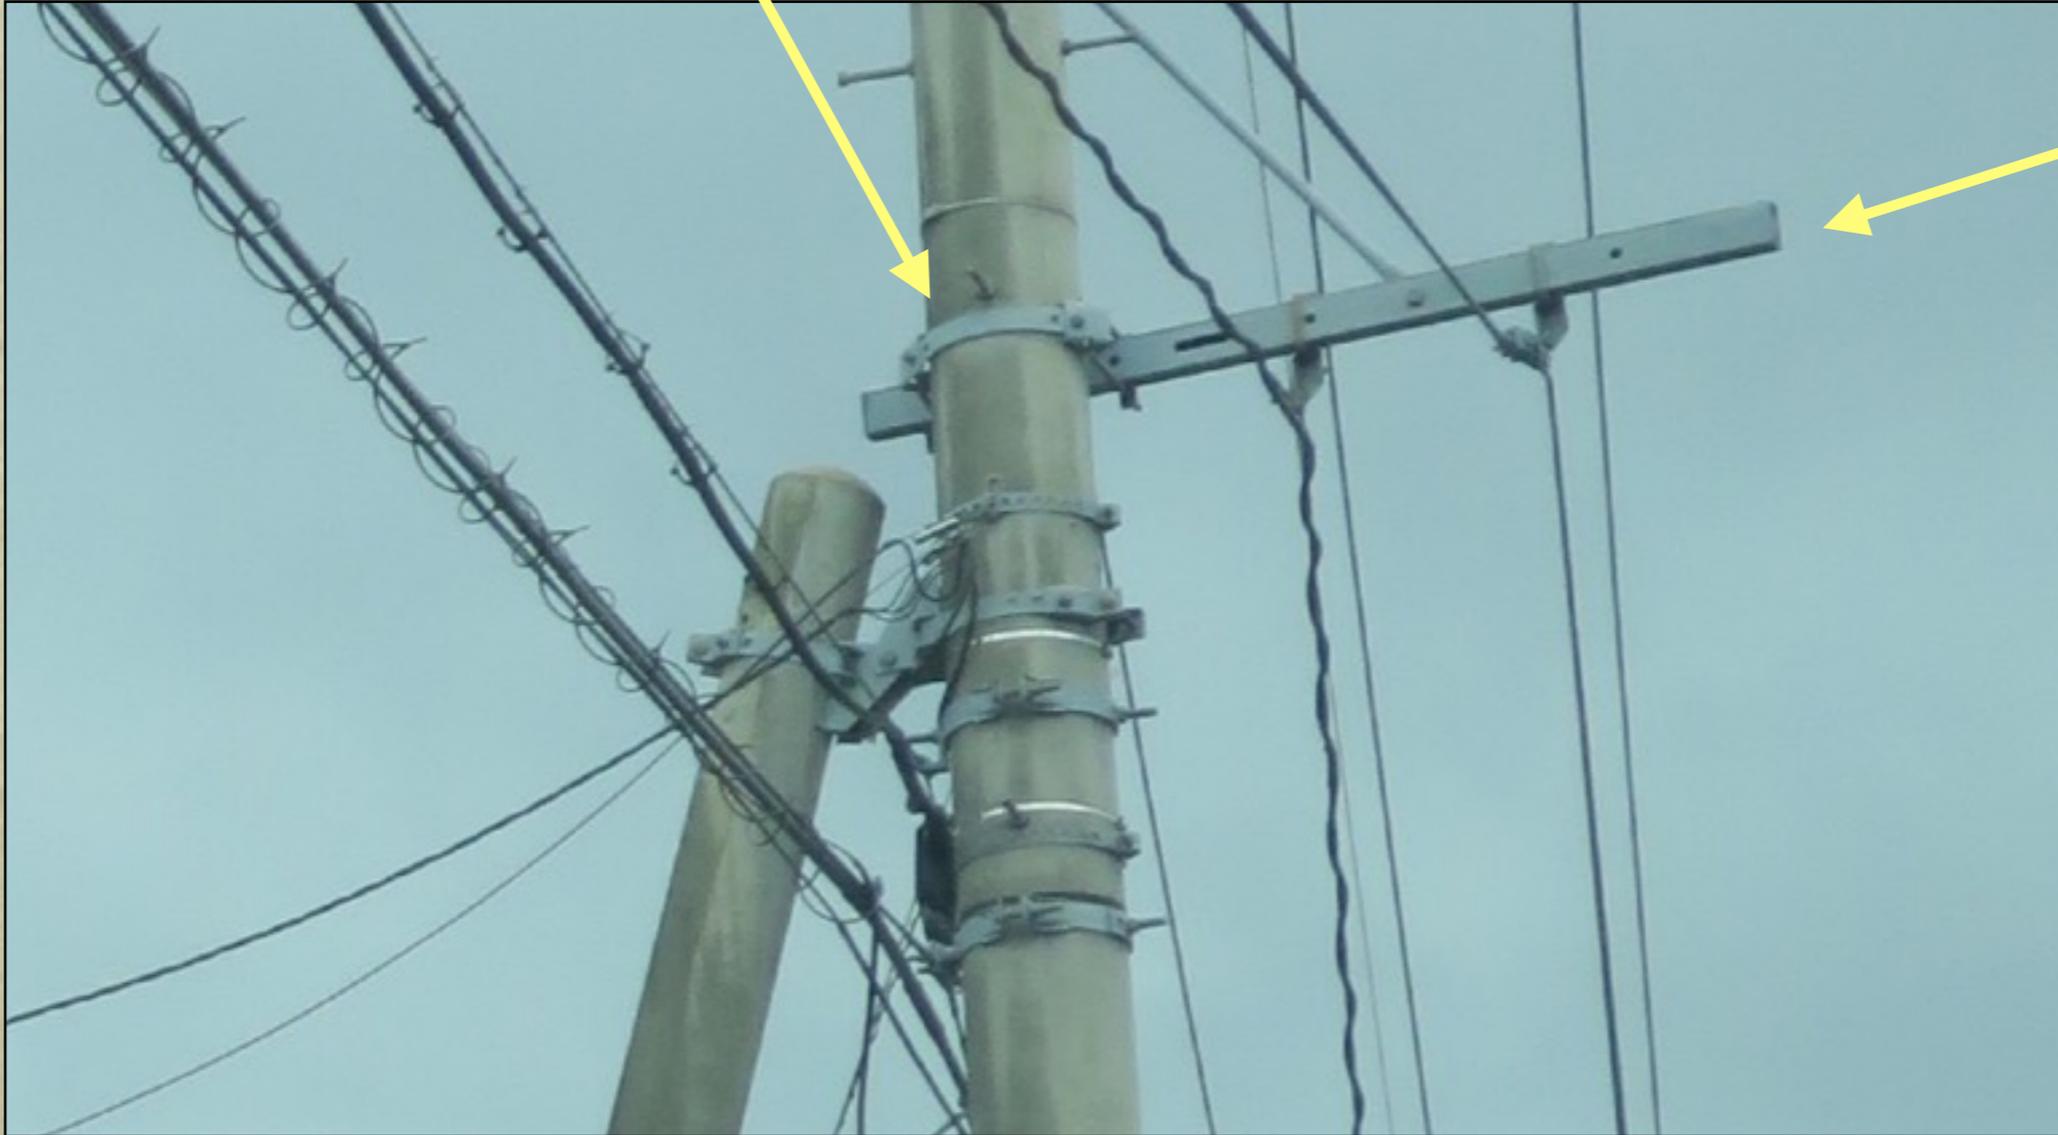
Attachments
use metal
friction clamps

Pulldowns +
PGDs
sometimes
rotate the
clamps, leading
to faults
