Kumamoto M 6.0 and 7.0 Earthquakes of April 14, 16 2016

Electric Power
John Eiding
G&E Engineering Systems Inc.
September 15 2016

Electric Power

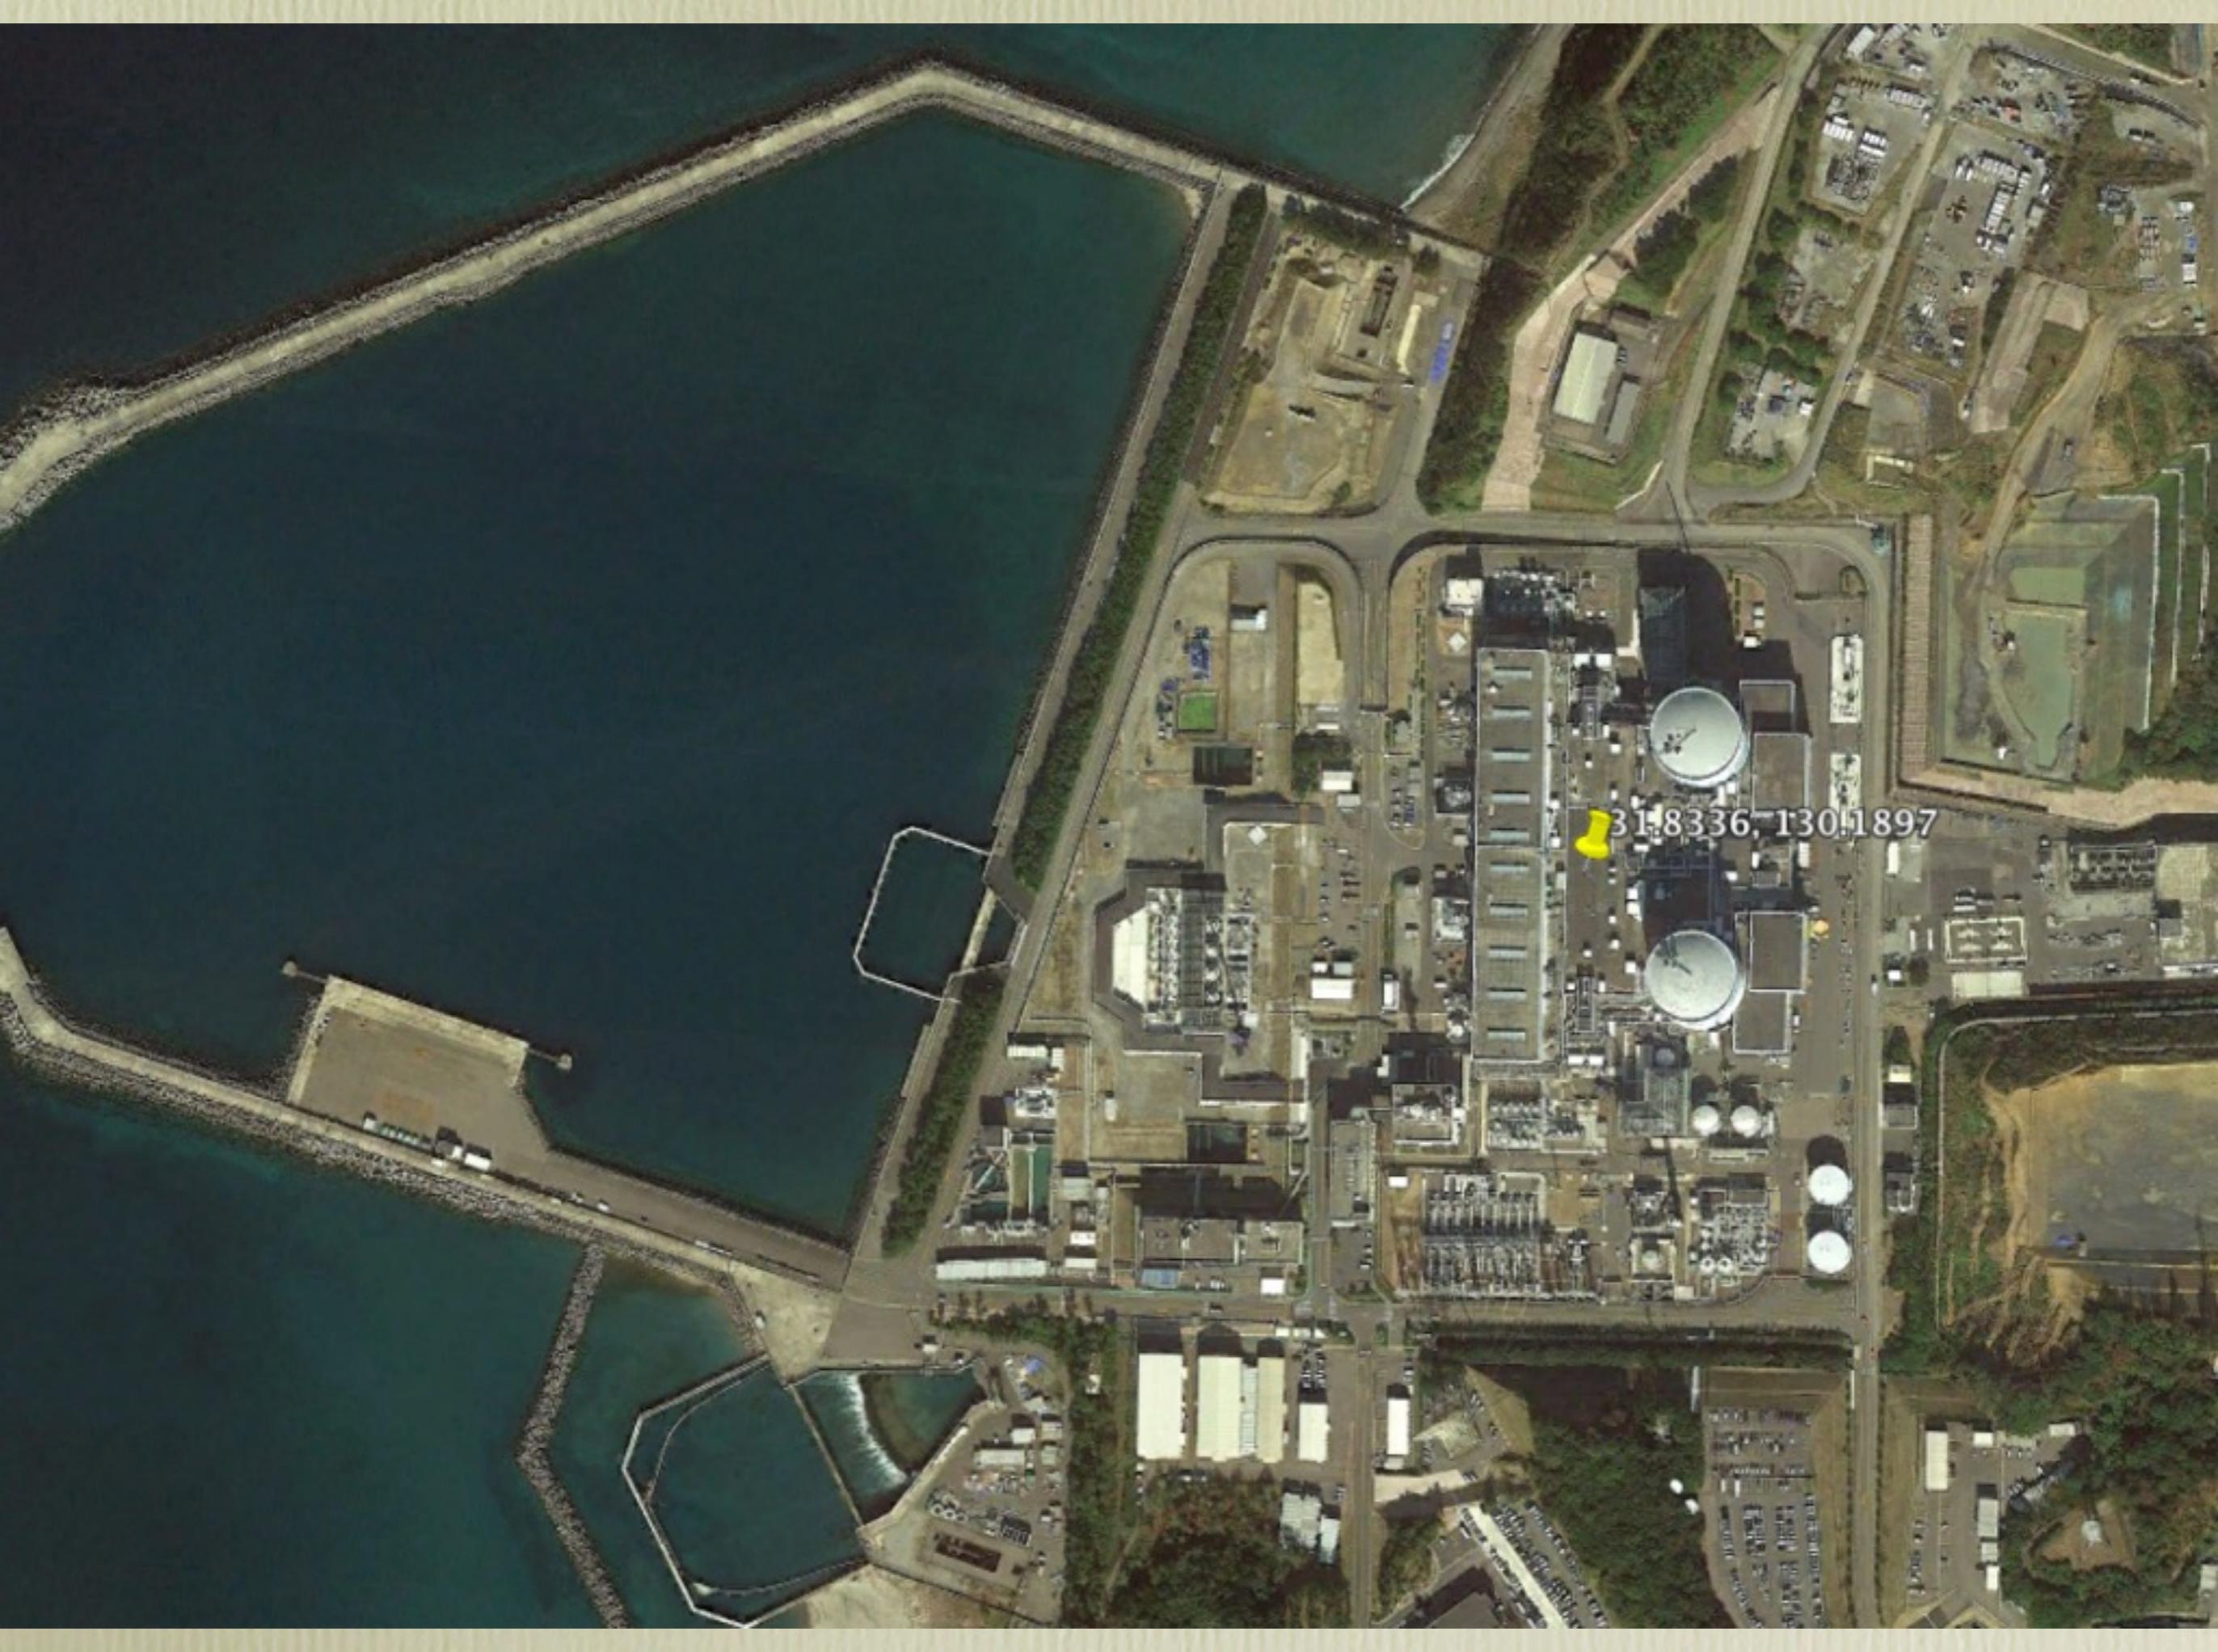
• Sendai Nuclear Power Station

Sendai: In operation at the time of the earthquake.

Date and Time	JMA Seismic Intensity (Satsumasendai City, Kagoshima pref.)	Sendai Nuclear Power Station (Kyushu Electric Seismic Intensity)			
				Lowest floor of auxiliary building (on base rock)	Upper floor of auxiliary building (1 st floor)	Ground surface
①	16 April 2016 01:25 JST	4	Seismic Intensity	3	3	3
			Maximum Acceleration (gal)	8.6	12.6	30.3
②	16 April 2016 01:46 JST	2	Seismic Intensity	1	1	2
			Maximum Acceleration (gal)	2.5	3.0	5.3
③	16 April 2016 03:55 JST	1	Seismic Intensity	0	—	1
			Maximum Acceleration (gal)	0.8	—	1.2
④	16 April 2016 09:48 JST	2	Seismic Intensity	1	1	1
			Maximum Acceleration (gal)	1.4	1.7	2.4

2 x 890 MW (1984, 1985). All PWR

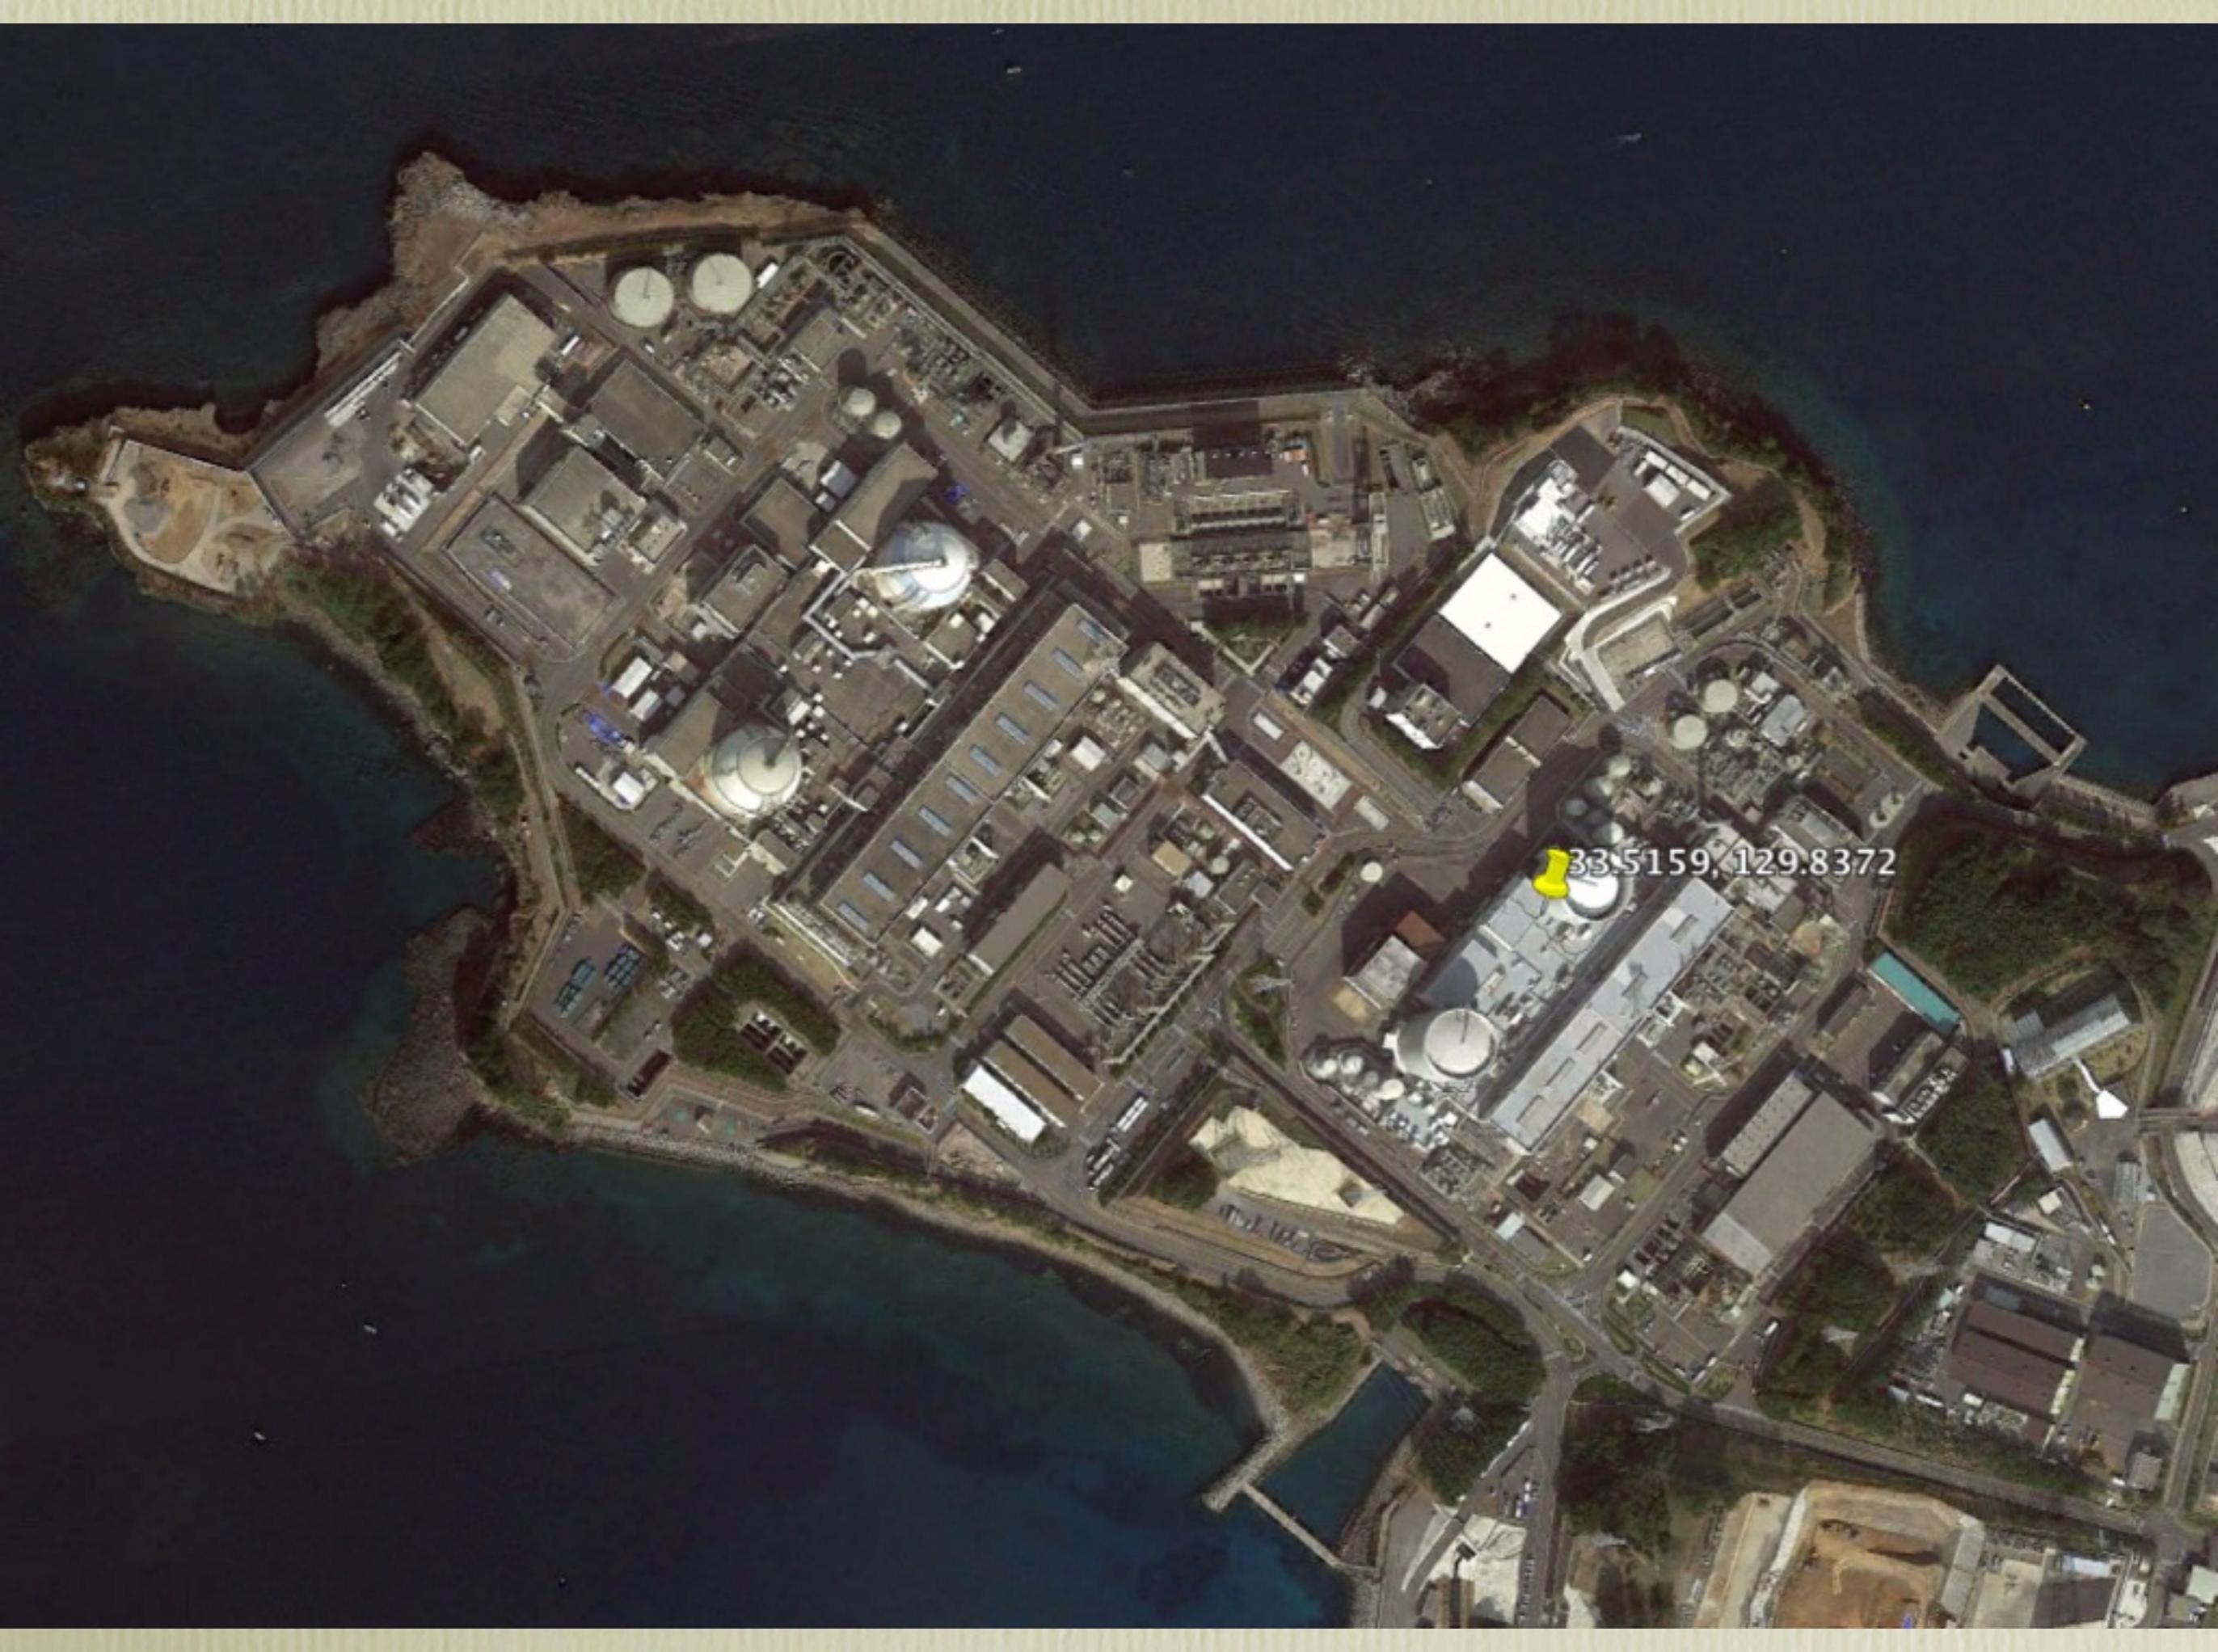
• Genkai Nuclear Power Station

Genkai: Not in operation at the time of the earthquake.

Date and Time	JMA Seismic Intensity (Karatsu City, Saga pref.)	Genkai Nuclear Power Station (Kyushu Electric Seismic Intensity)			
				Lowest floor of auxiliary building (on base rock)	Upper floor of auxiliary building (1 st basement floor)	Ground surface
①	16 April 2016 01:25 JST	4	Seismic Intensity	3	3	3
			Maximum Acceleration (gal)	20.3	30.1	23.5
②	16 April 2016 01:46 JST	3	Seismic Intensity	2	2	2
			Maximum Acceleration (gal)	7.7	15.0	9.8
③	16 April 2016 03:55 JST	2	Seismic Intensity	1	1	1
			Maximum Acceleration (gal)	2.6	4.7	2.6
④	16 April 2016 09:48 JST	2	Seismic Intensity	1	2	1
			Maximum Acceleration (gal)	3.3	7.6	3.1

2 x 559 MW (1975, 1980) + 2 x 1180 MW (1993, 1996). All PWR
