# Lifelines, M 9.0 Tohoku Japan, March 2011

John Eidinger  
August 11, 2011

G&E Engineering Systems Inc.  
[eidinger@geEngineeringSystems.com](mailto:eidinger@geEngineeringSystems.com)

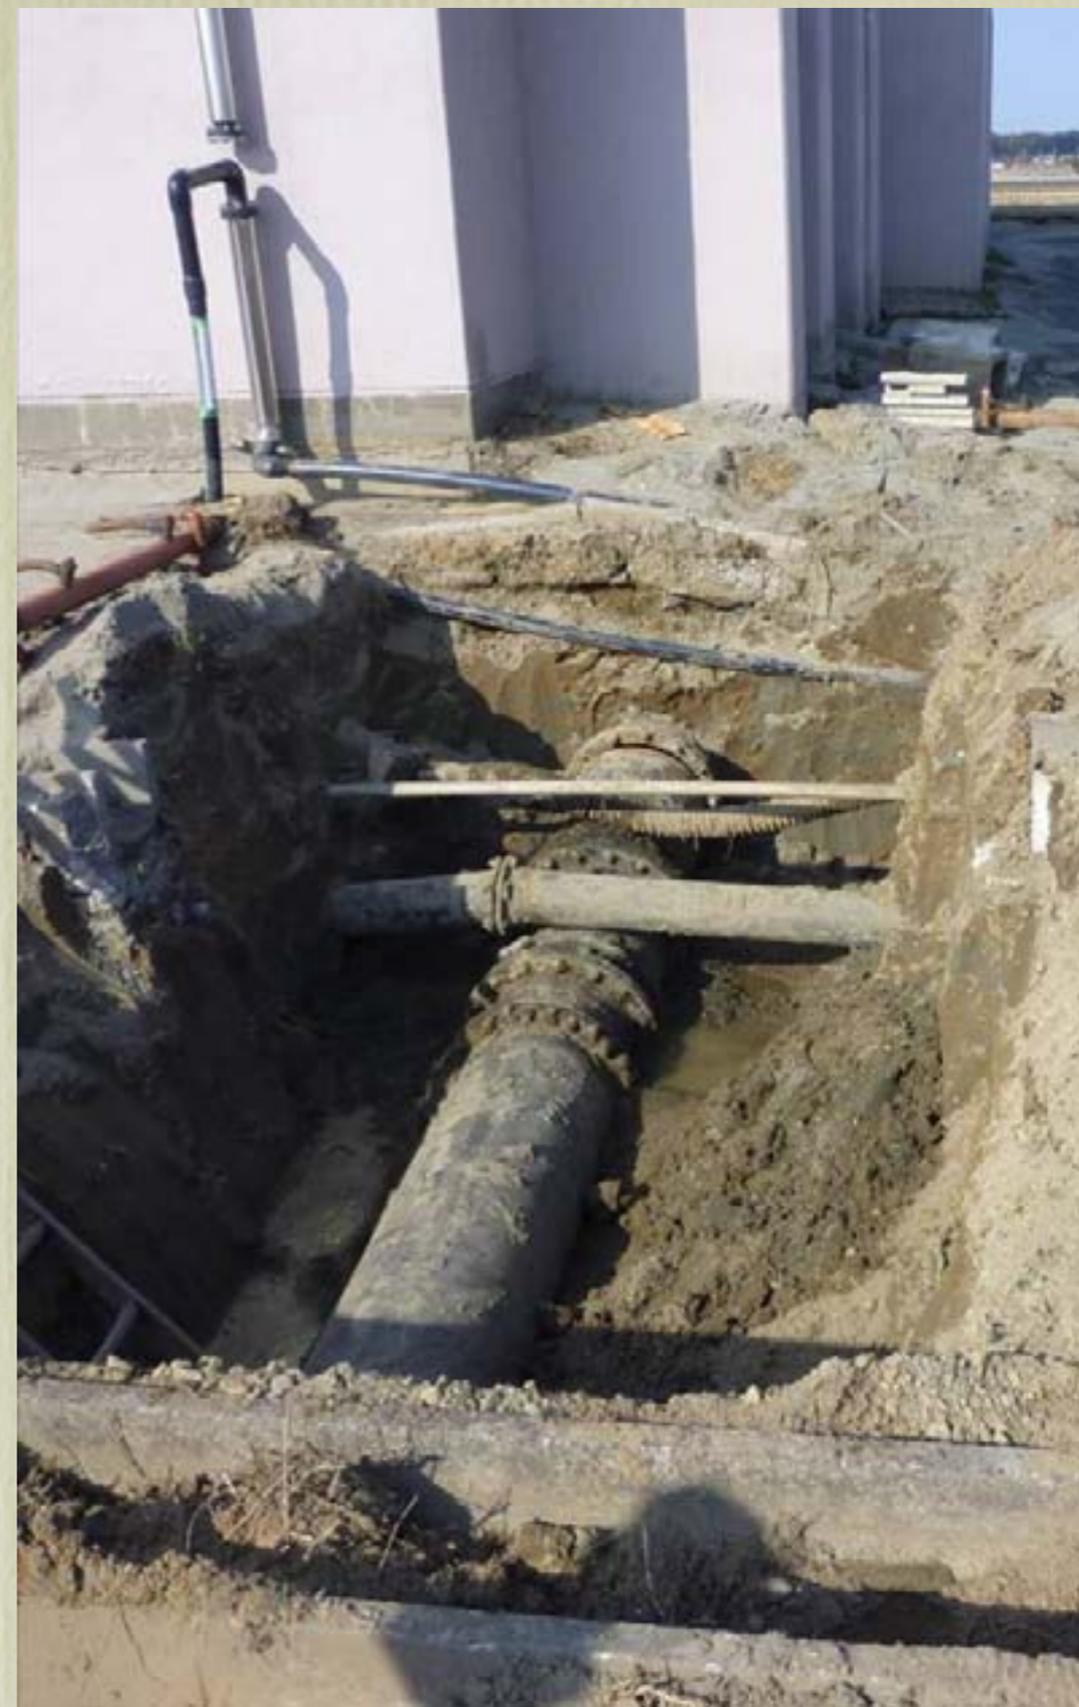
鹿行広域水道用水供給事業の取水棟への取り付け部の伸縮可とう管  
φ600。周辺小口径管路が地盤と共に沈下したため、継手部で漏水

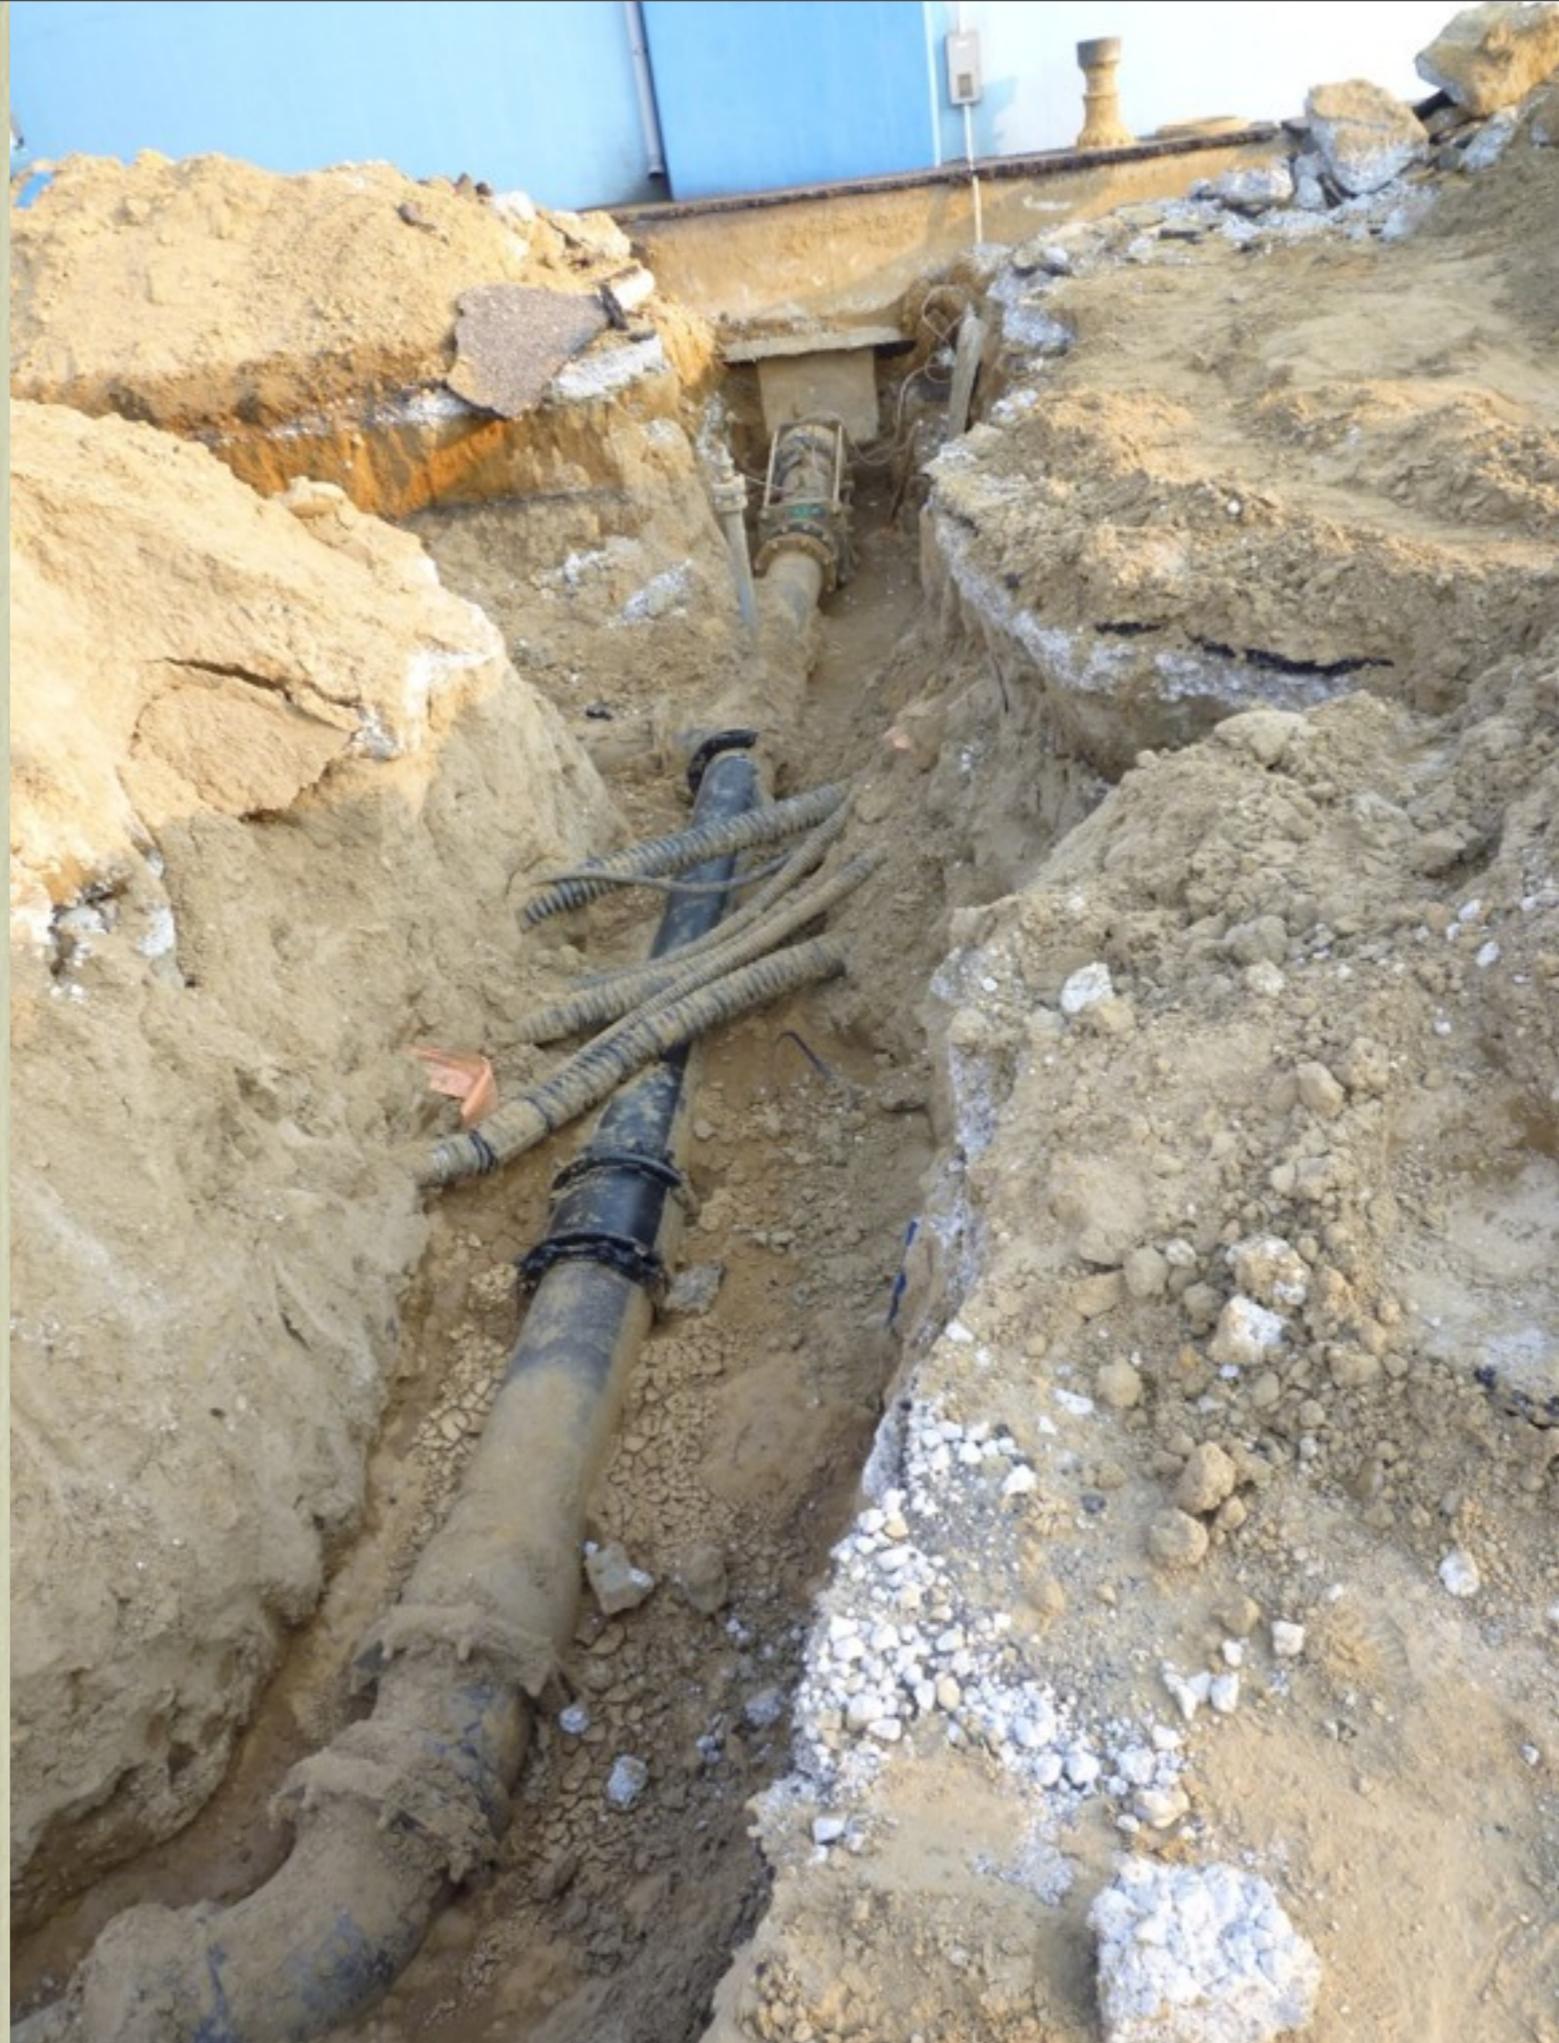
DIP 300  
mm. Joint  
Ring  
cracked.

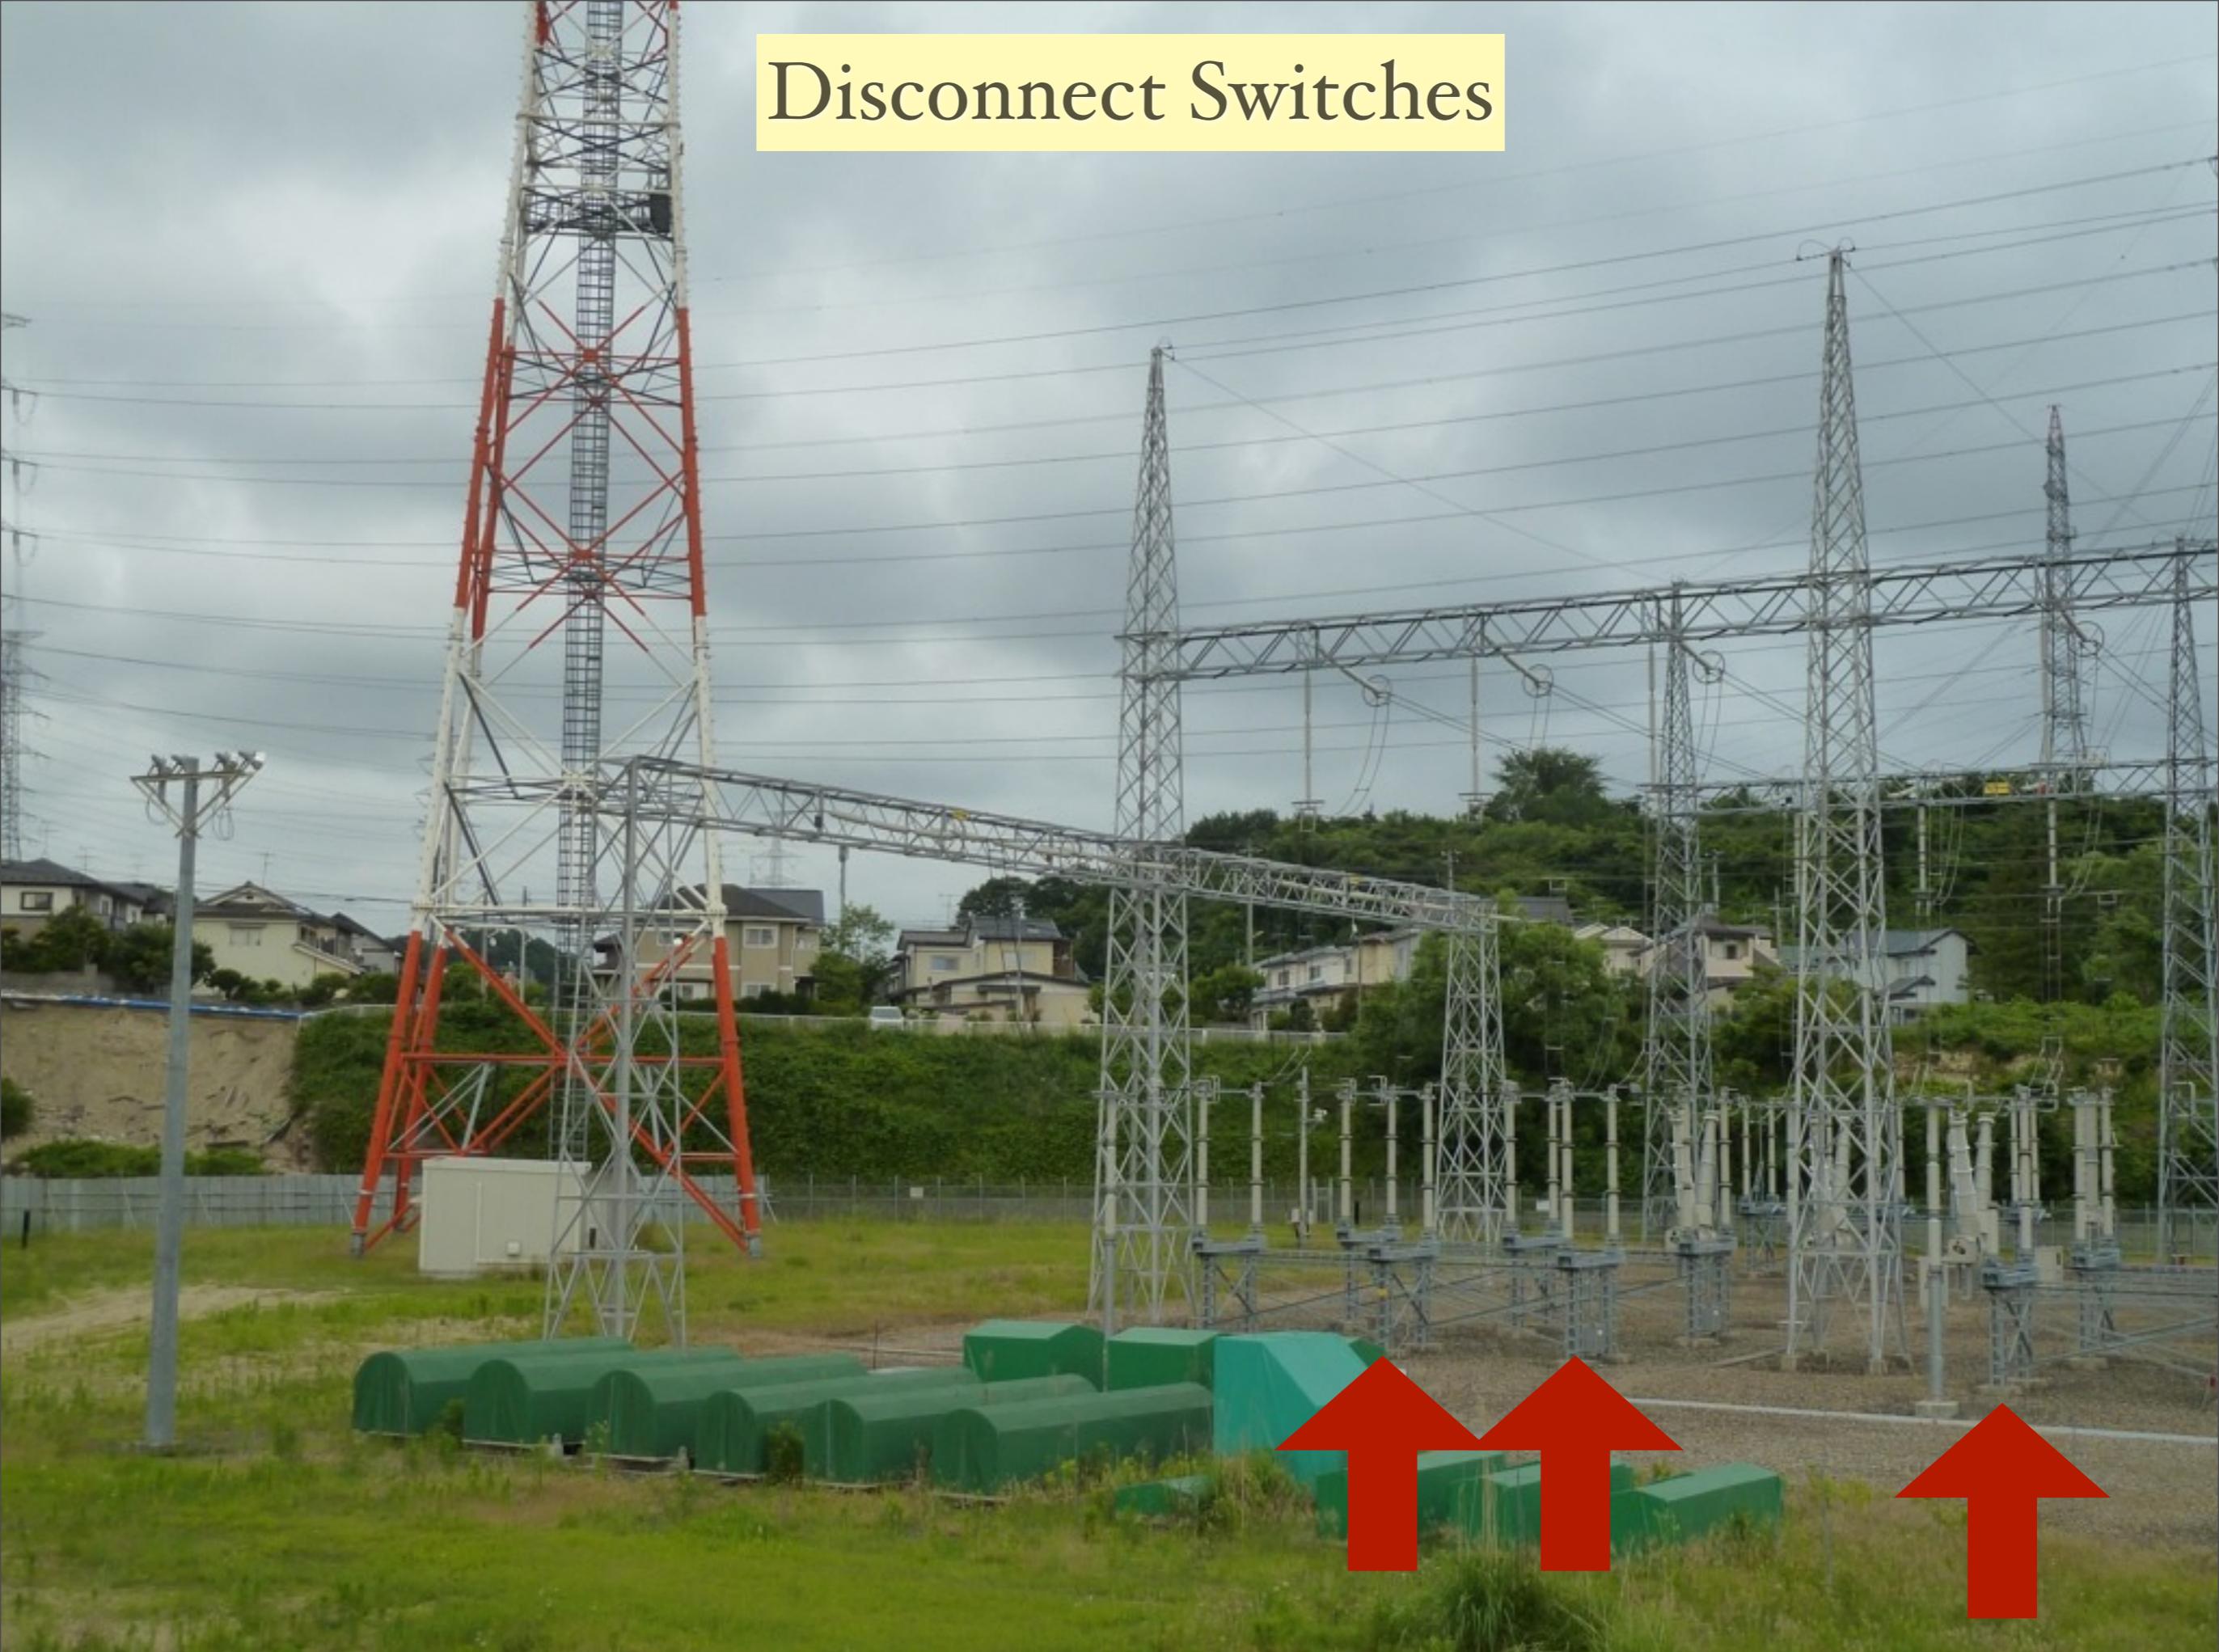
# Disconnect Switches

275 kV Bushings

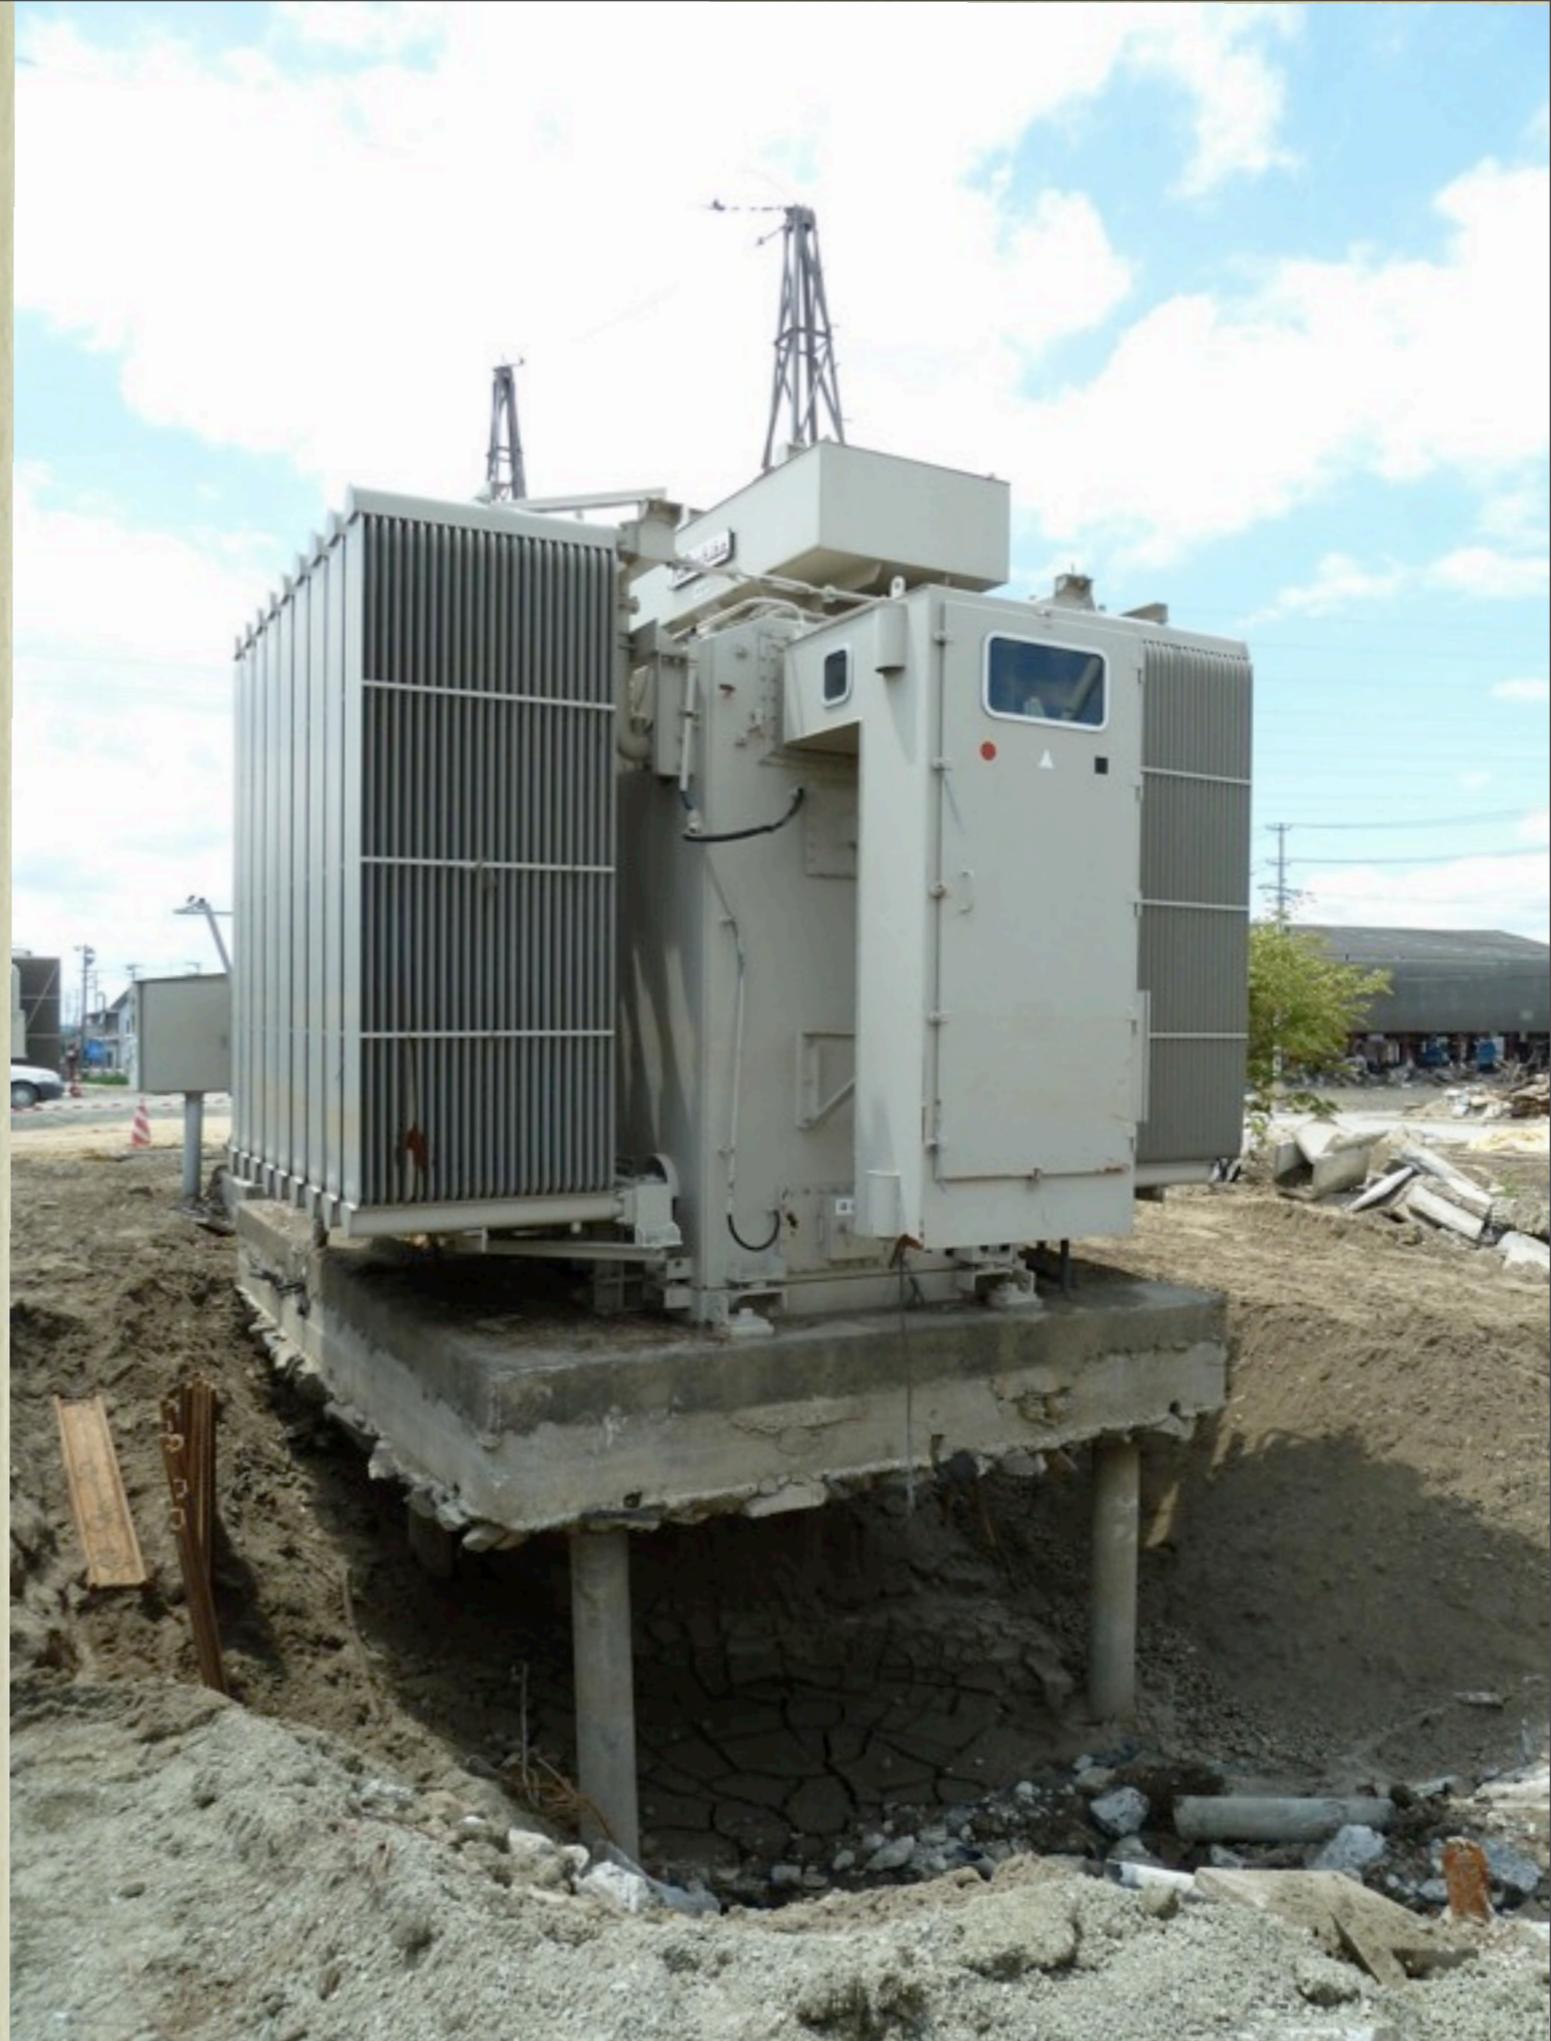
66 kV tsunami  
inundation, with  
scour

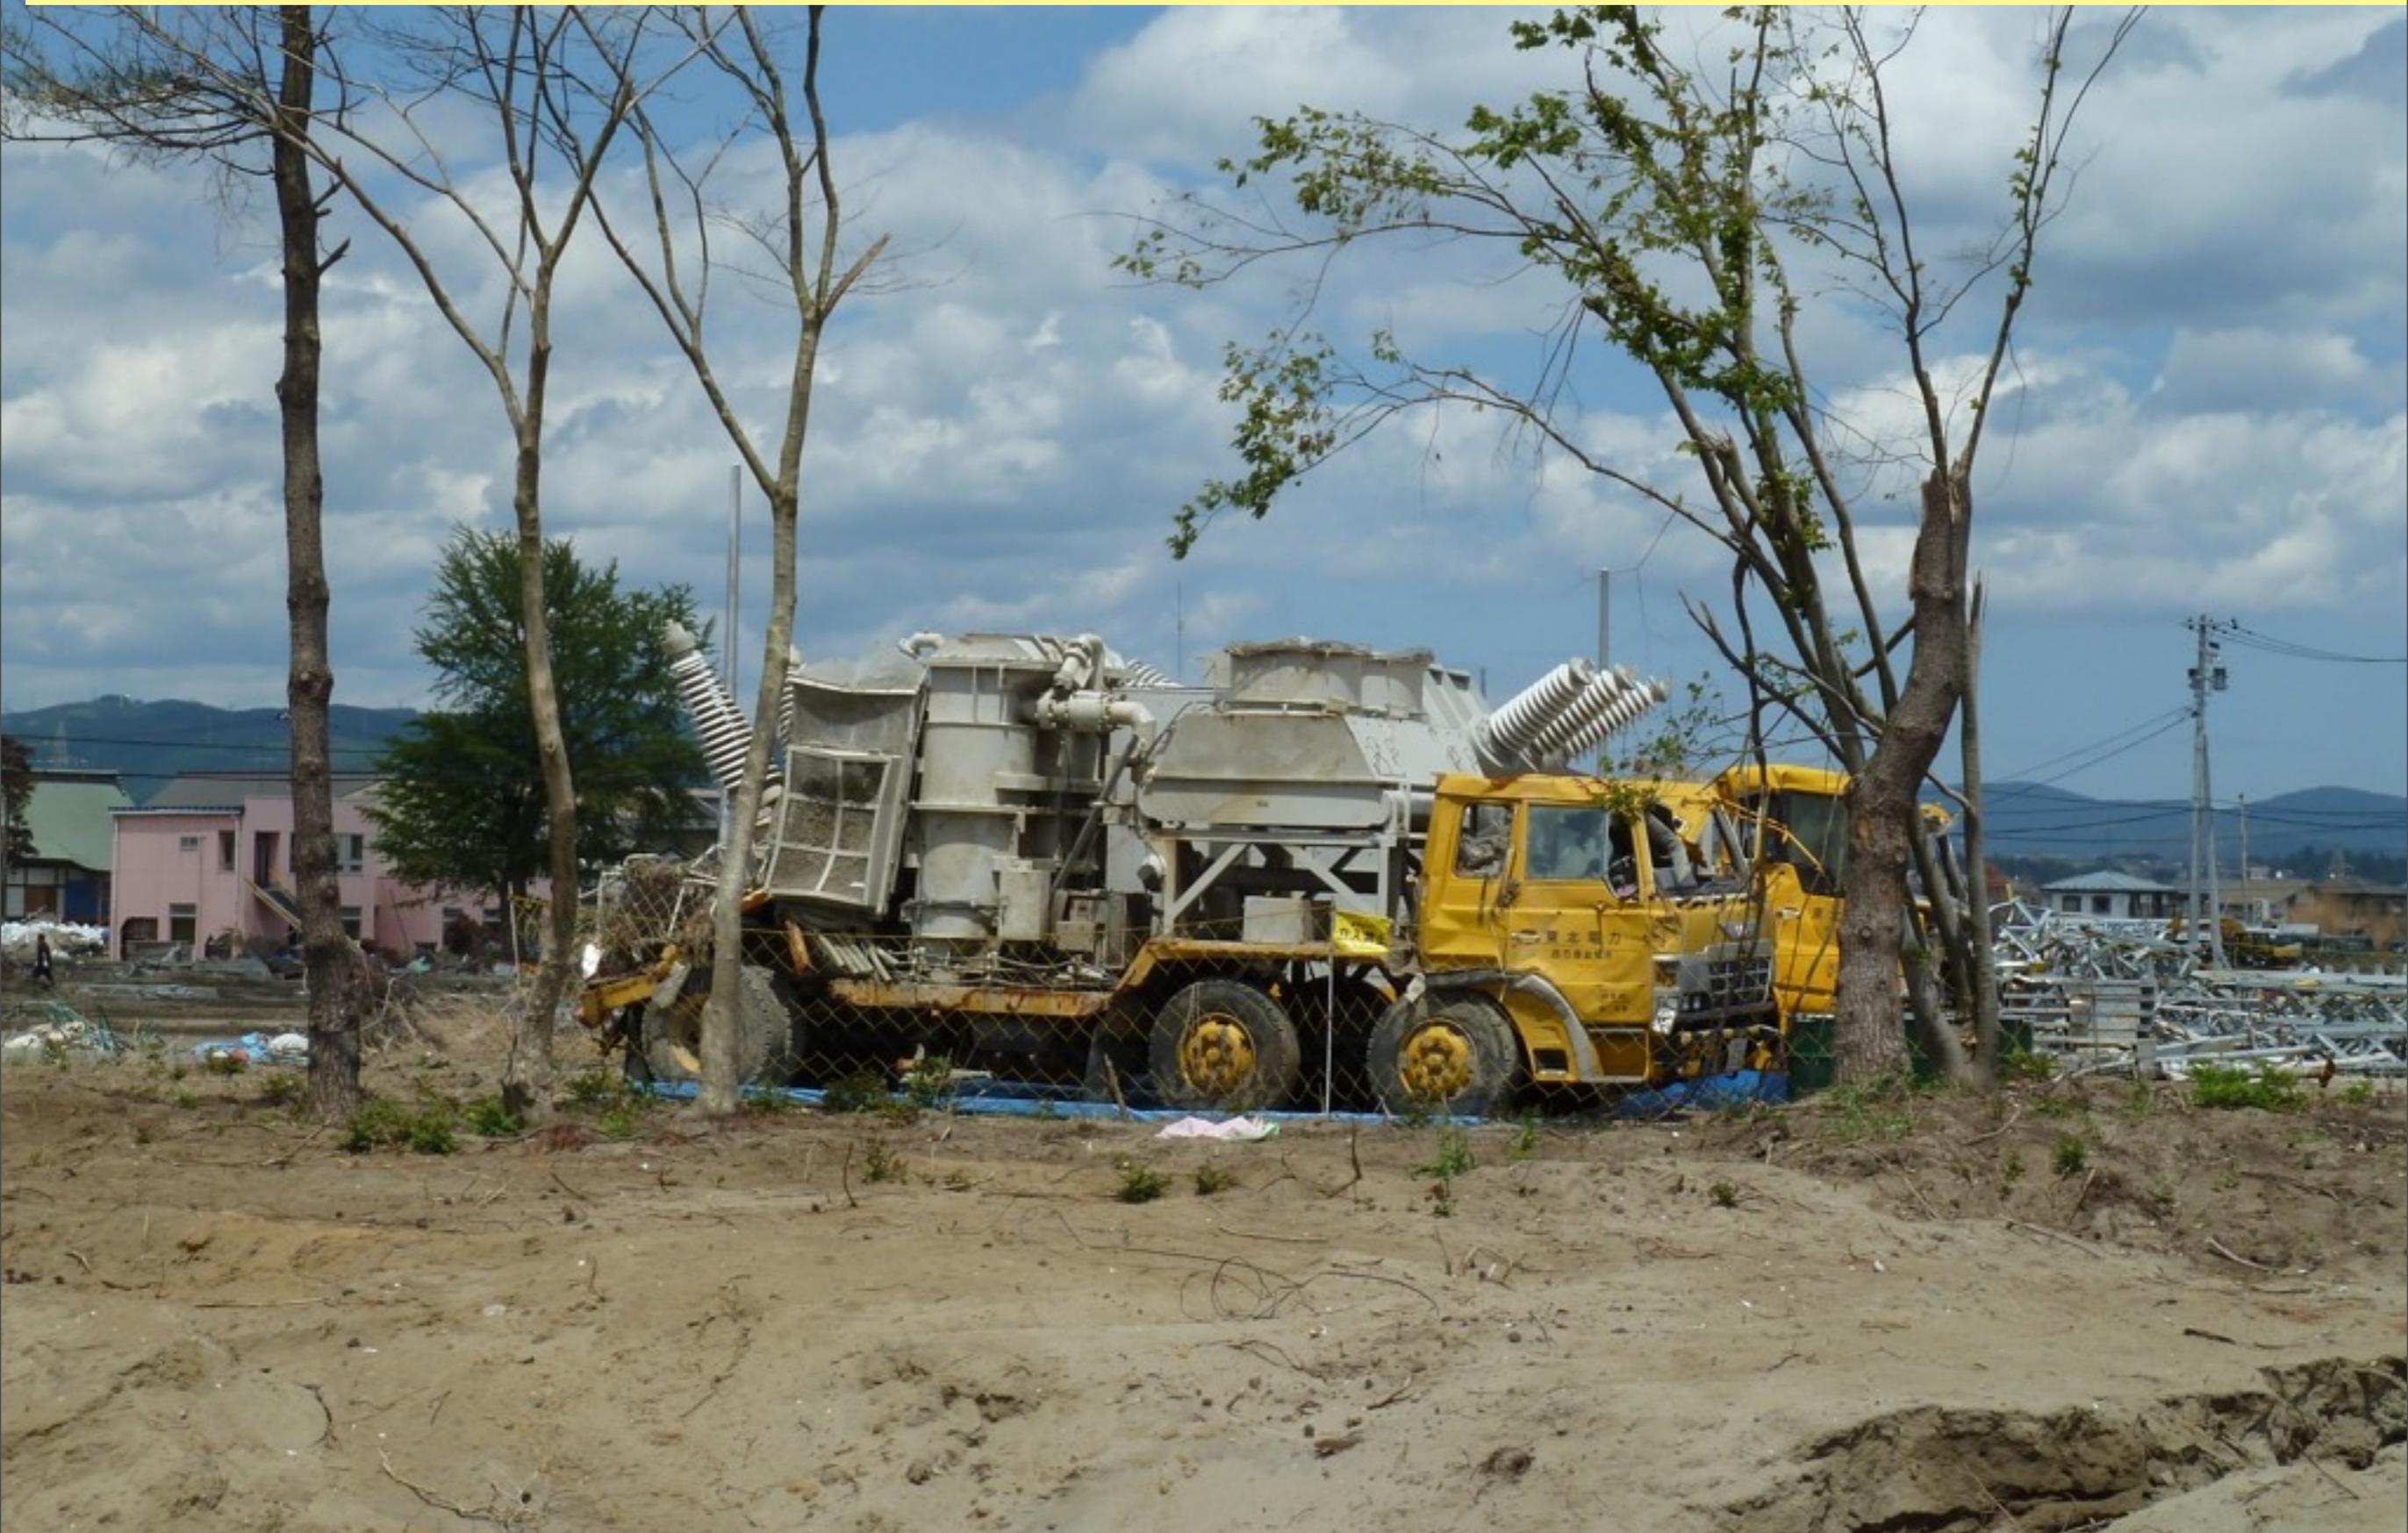
# Truck-mounted Portable 66 kV Substations (destroyed by Tsunami Inundation)

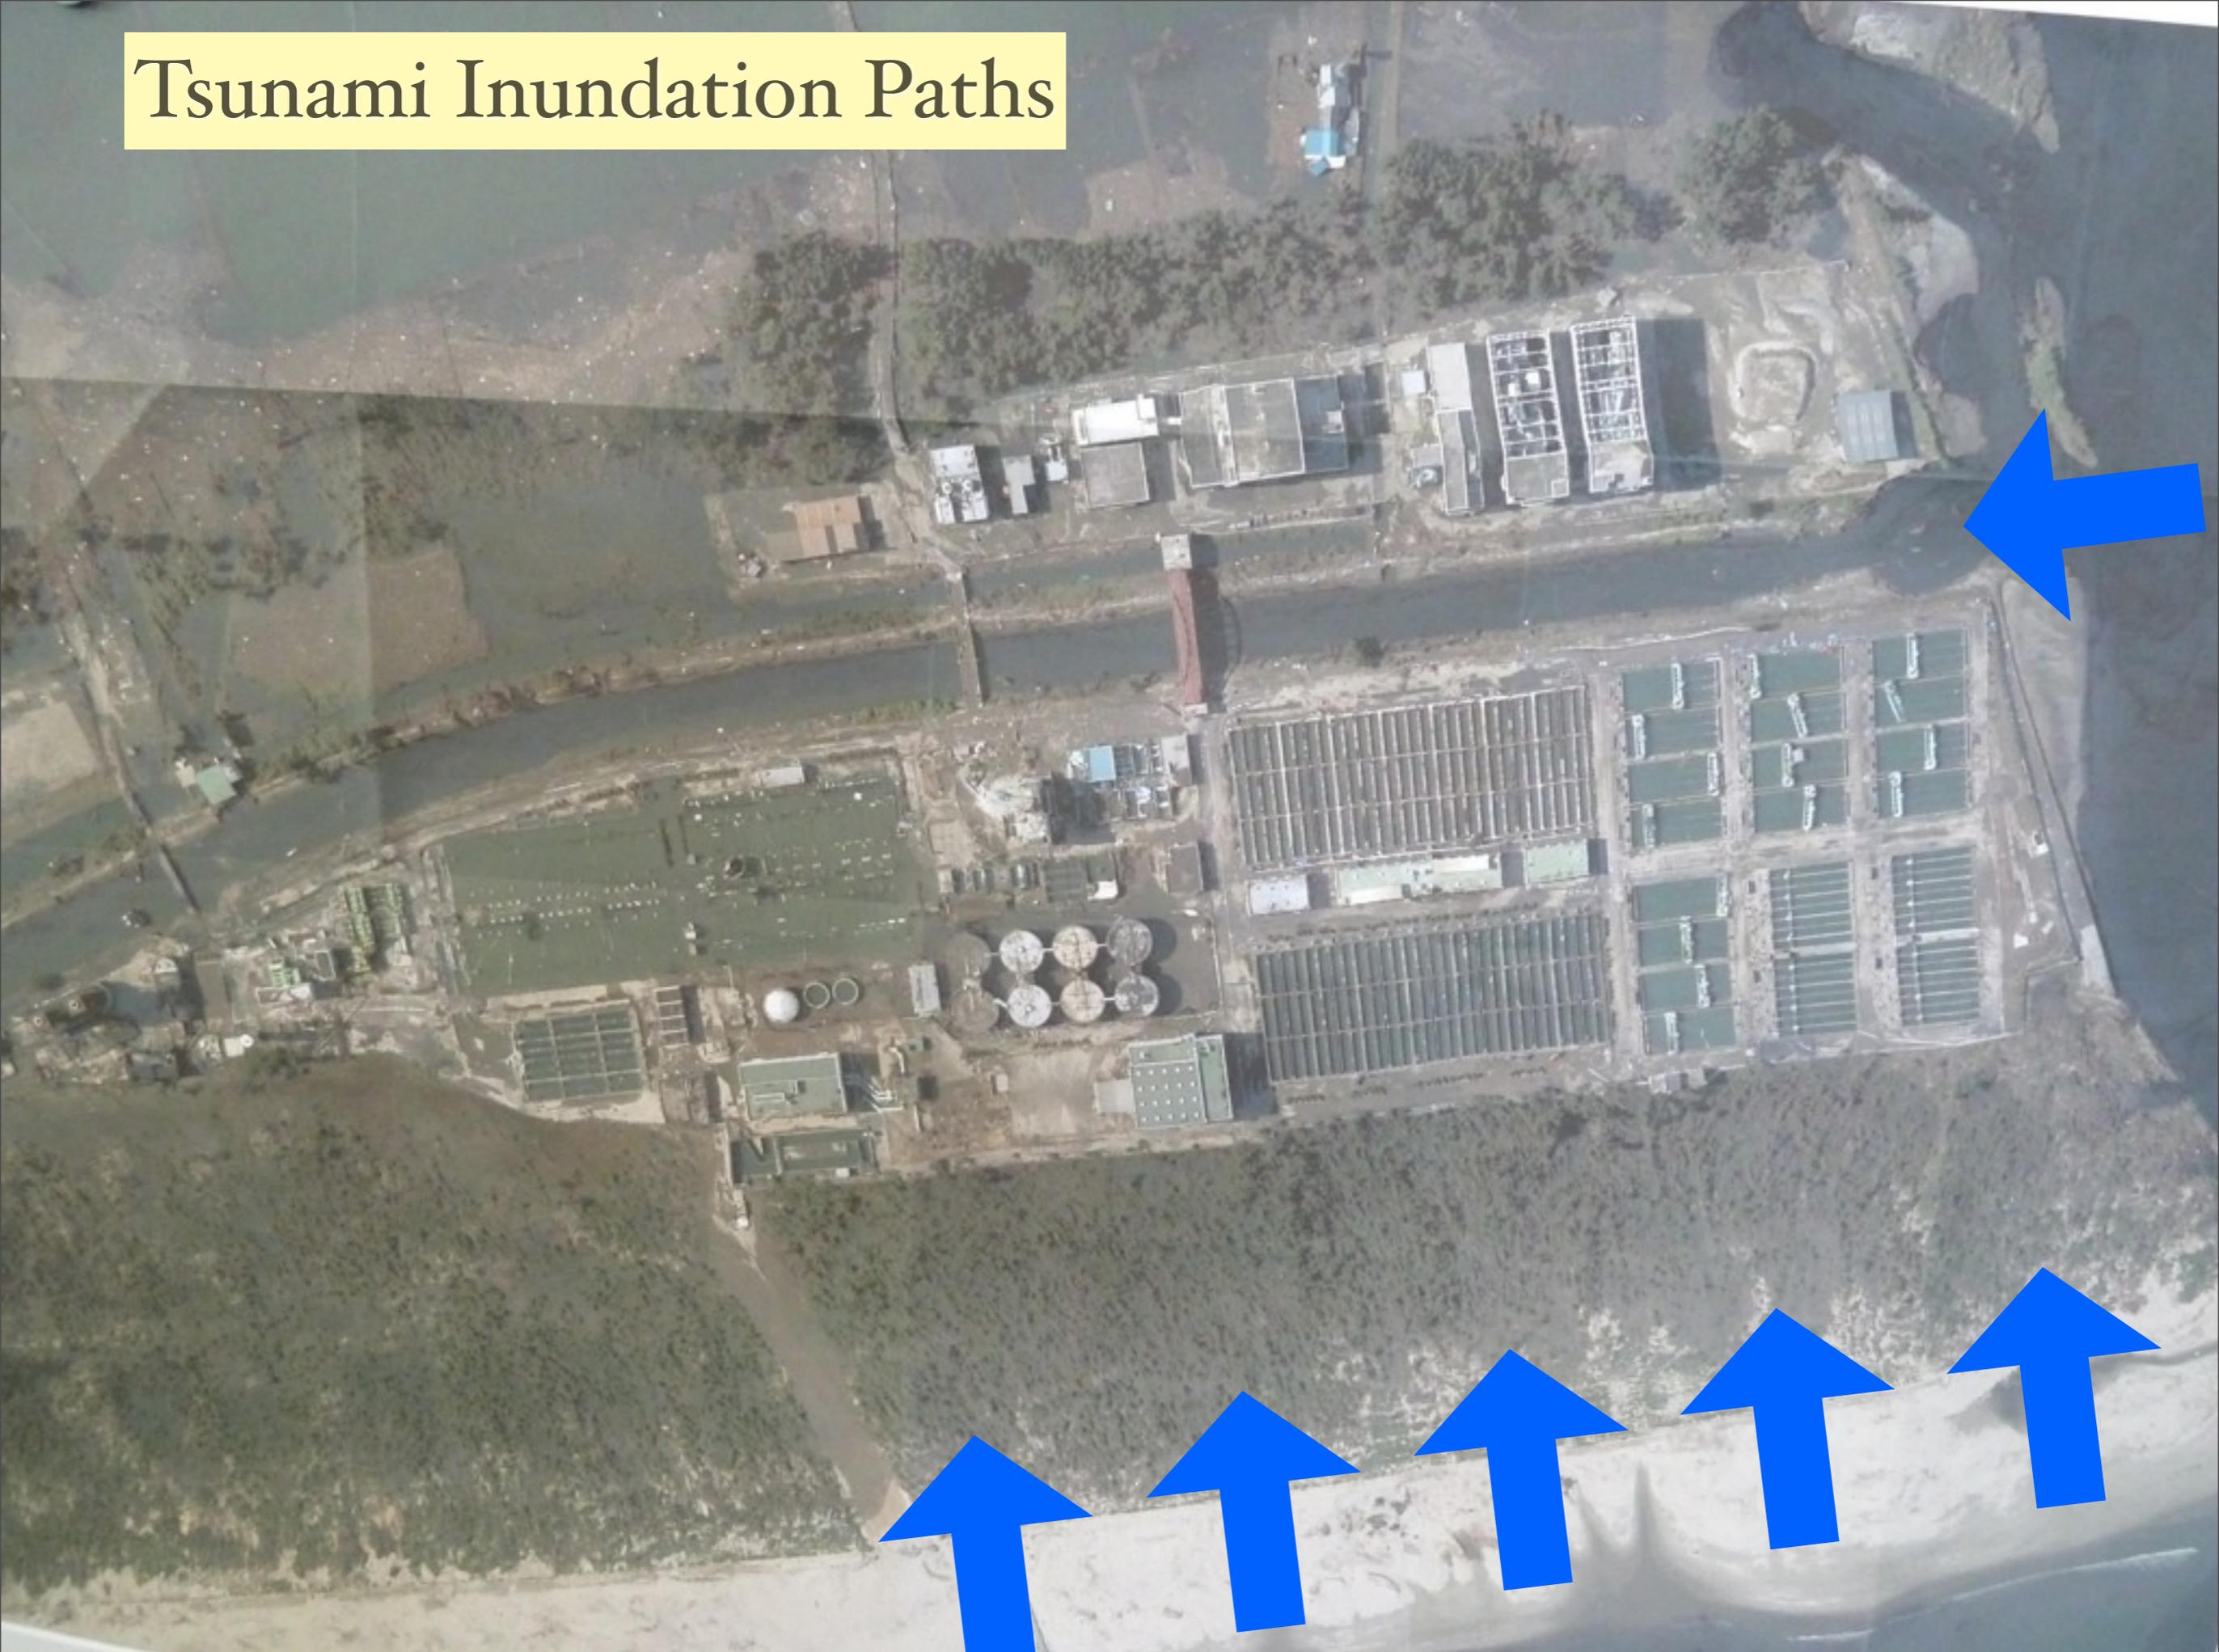
# Tsunami Inundation Paths

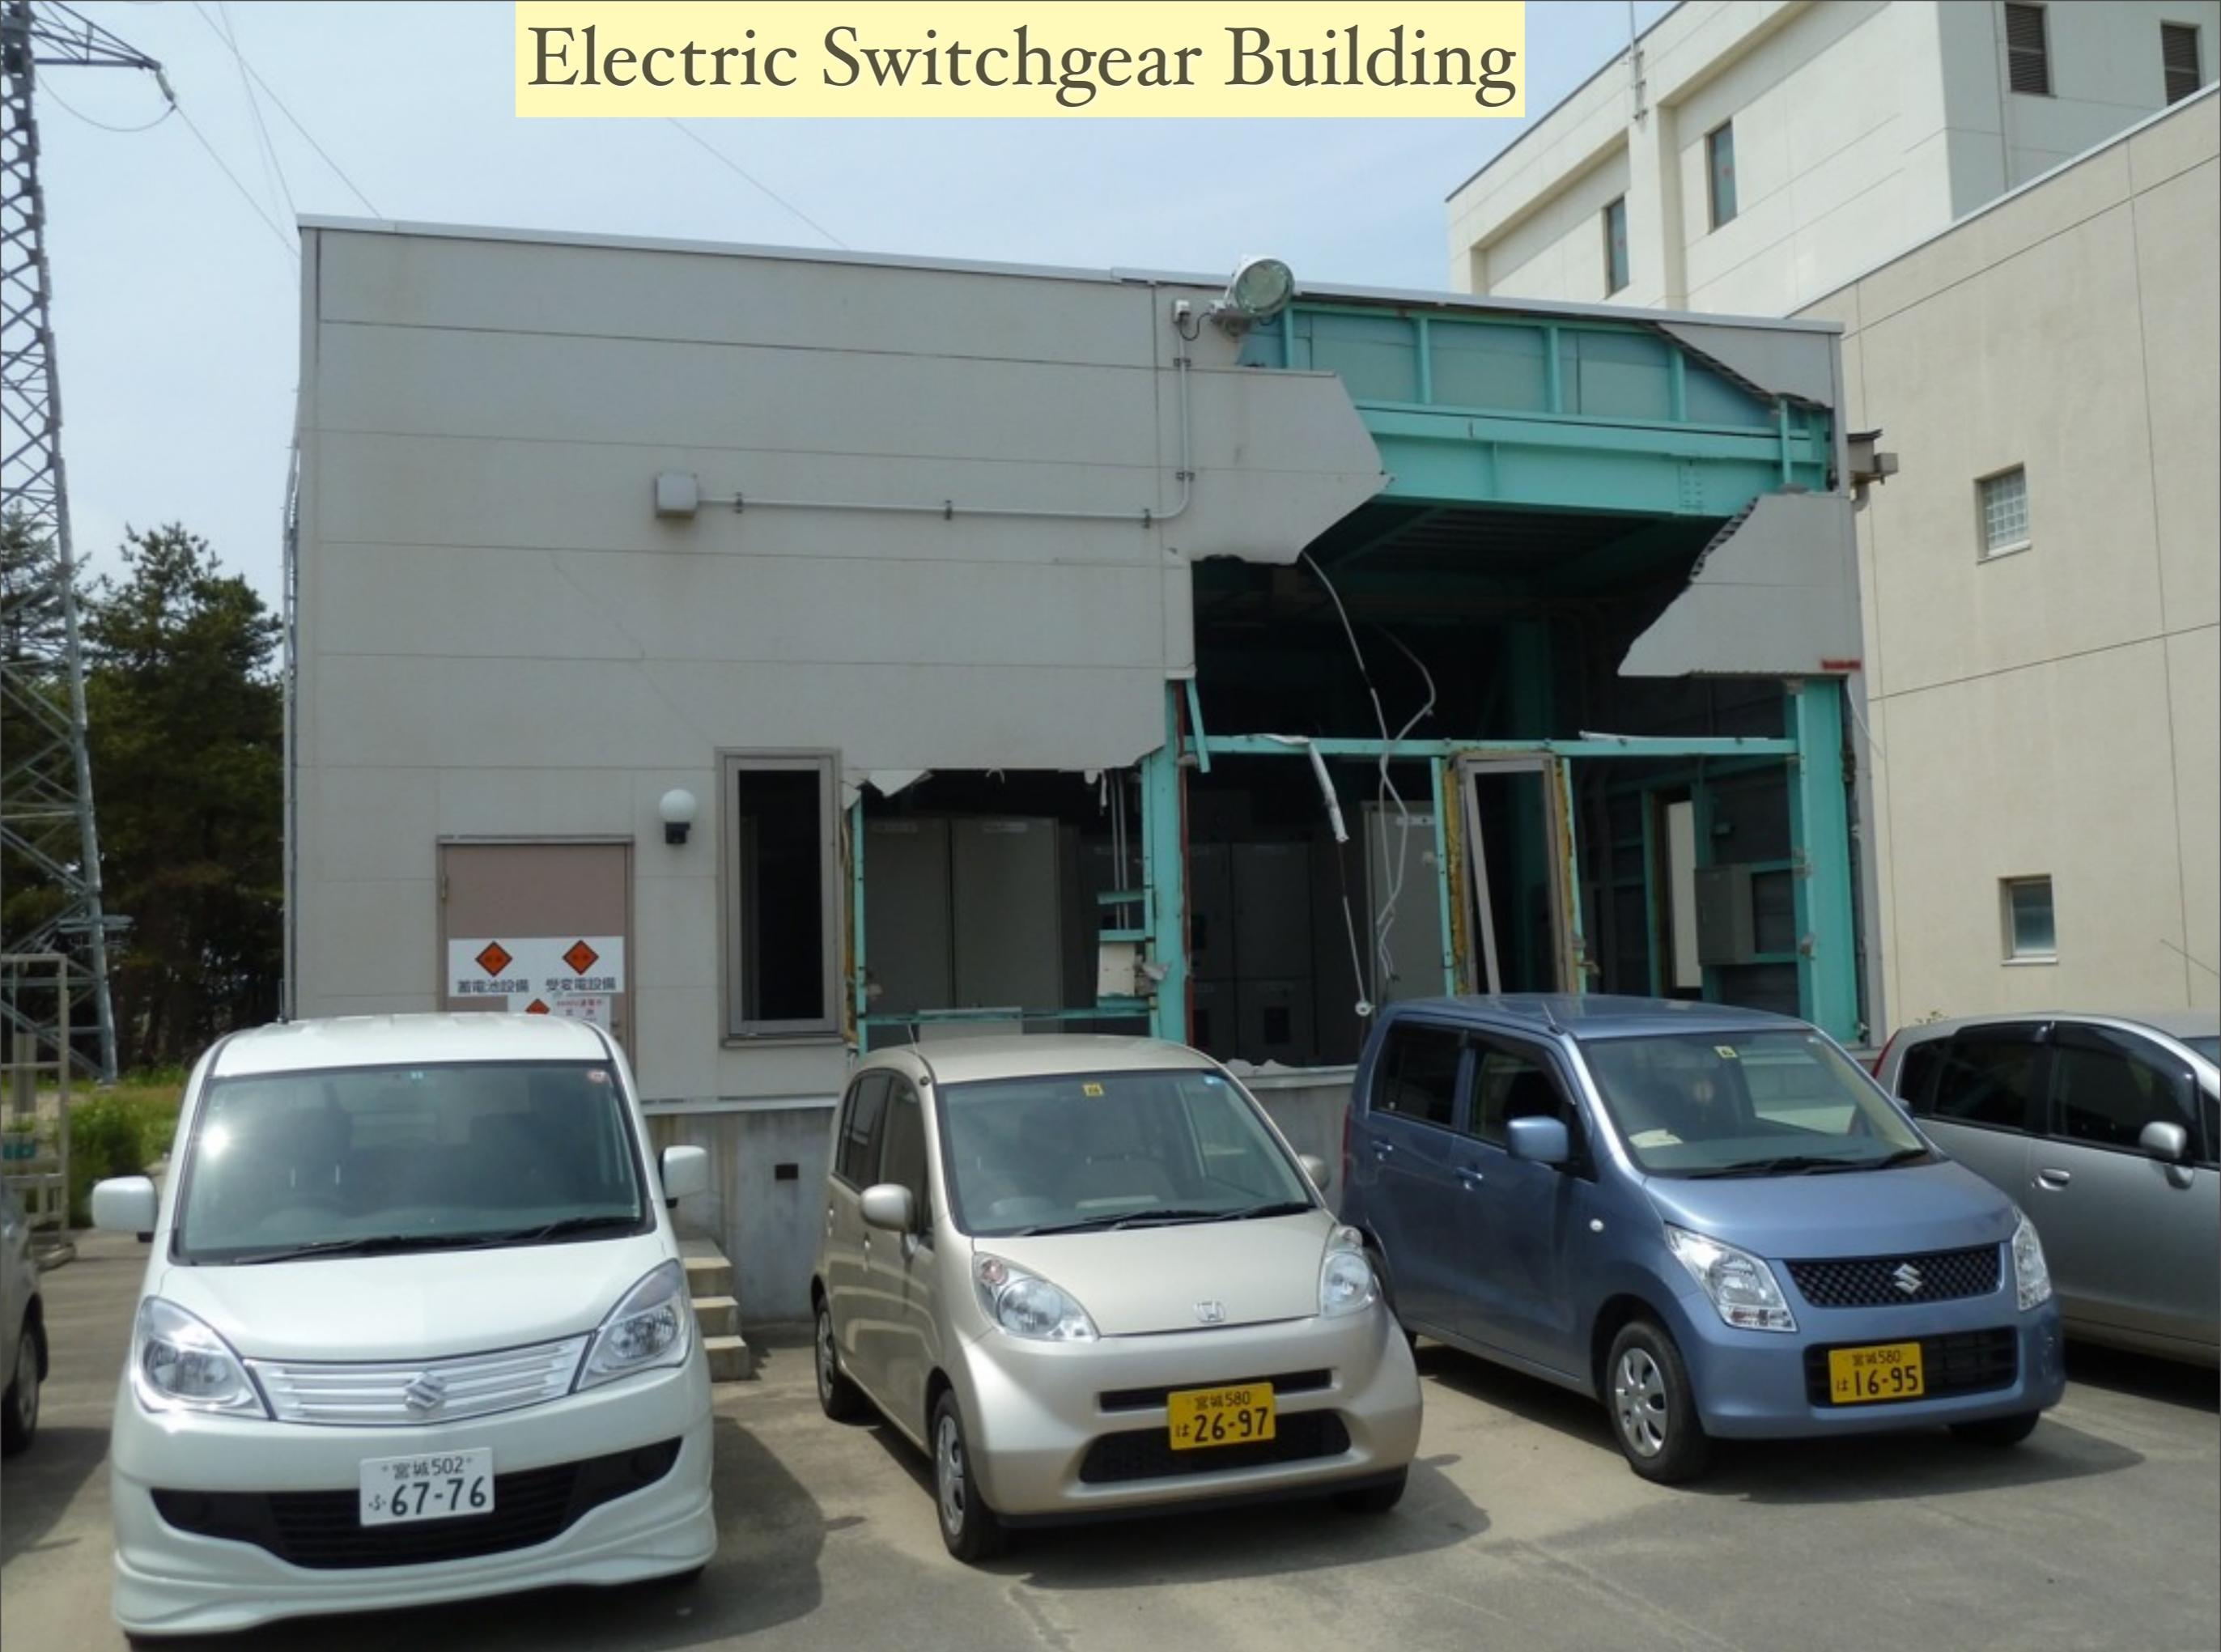
# Electric Switchgear Building
