# Lifelines, M 9.0 Tohoku Japan, March 2011

John Eidinger  
August 11, 2011

G&E Engineering Systems Inc.  
[eidinger@geEngineeringSystems.com](mailto:eidinger@geEngineeringSystems.com)

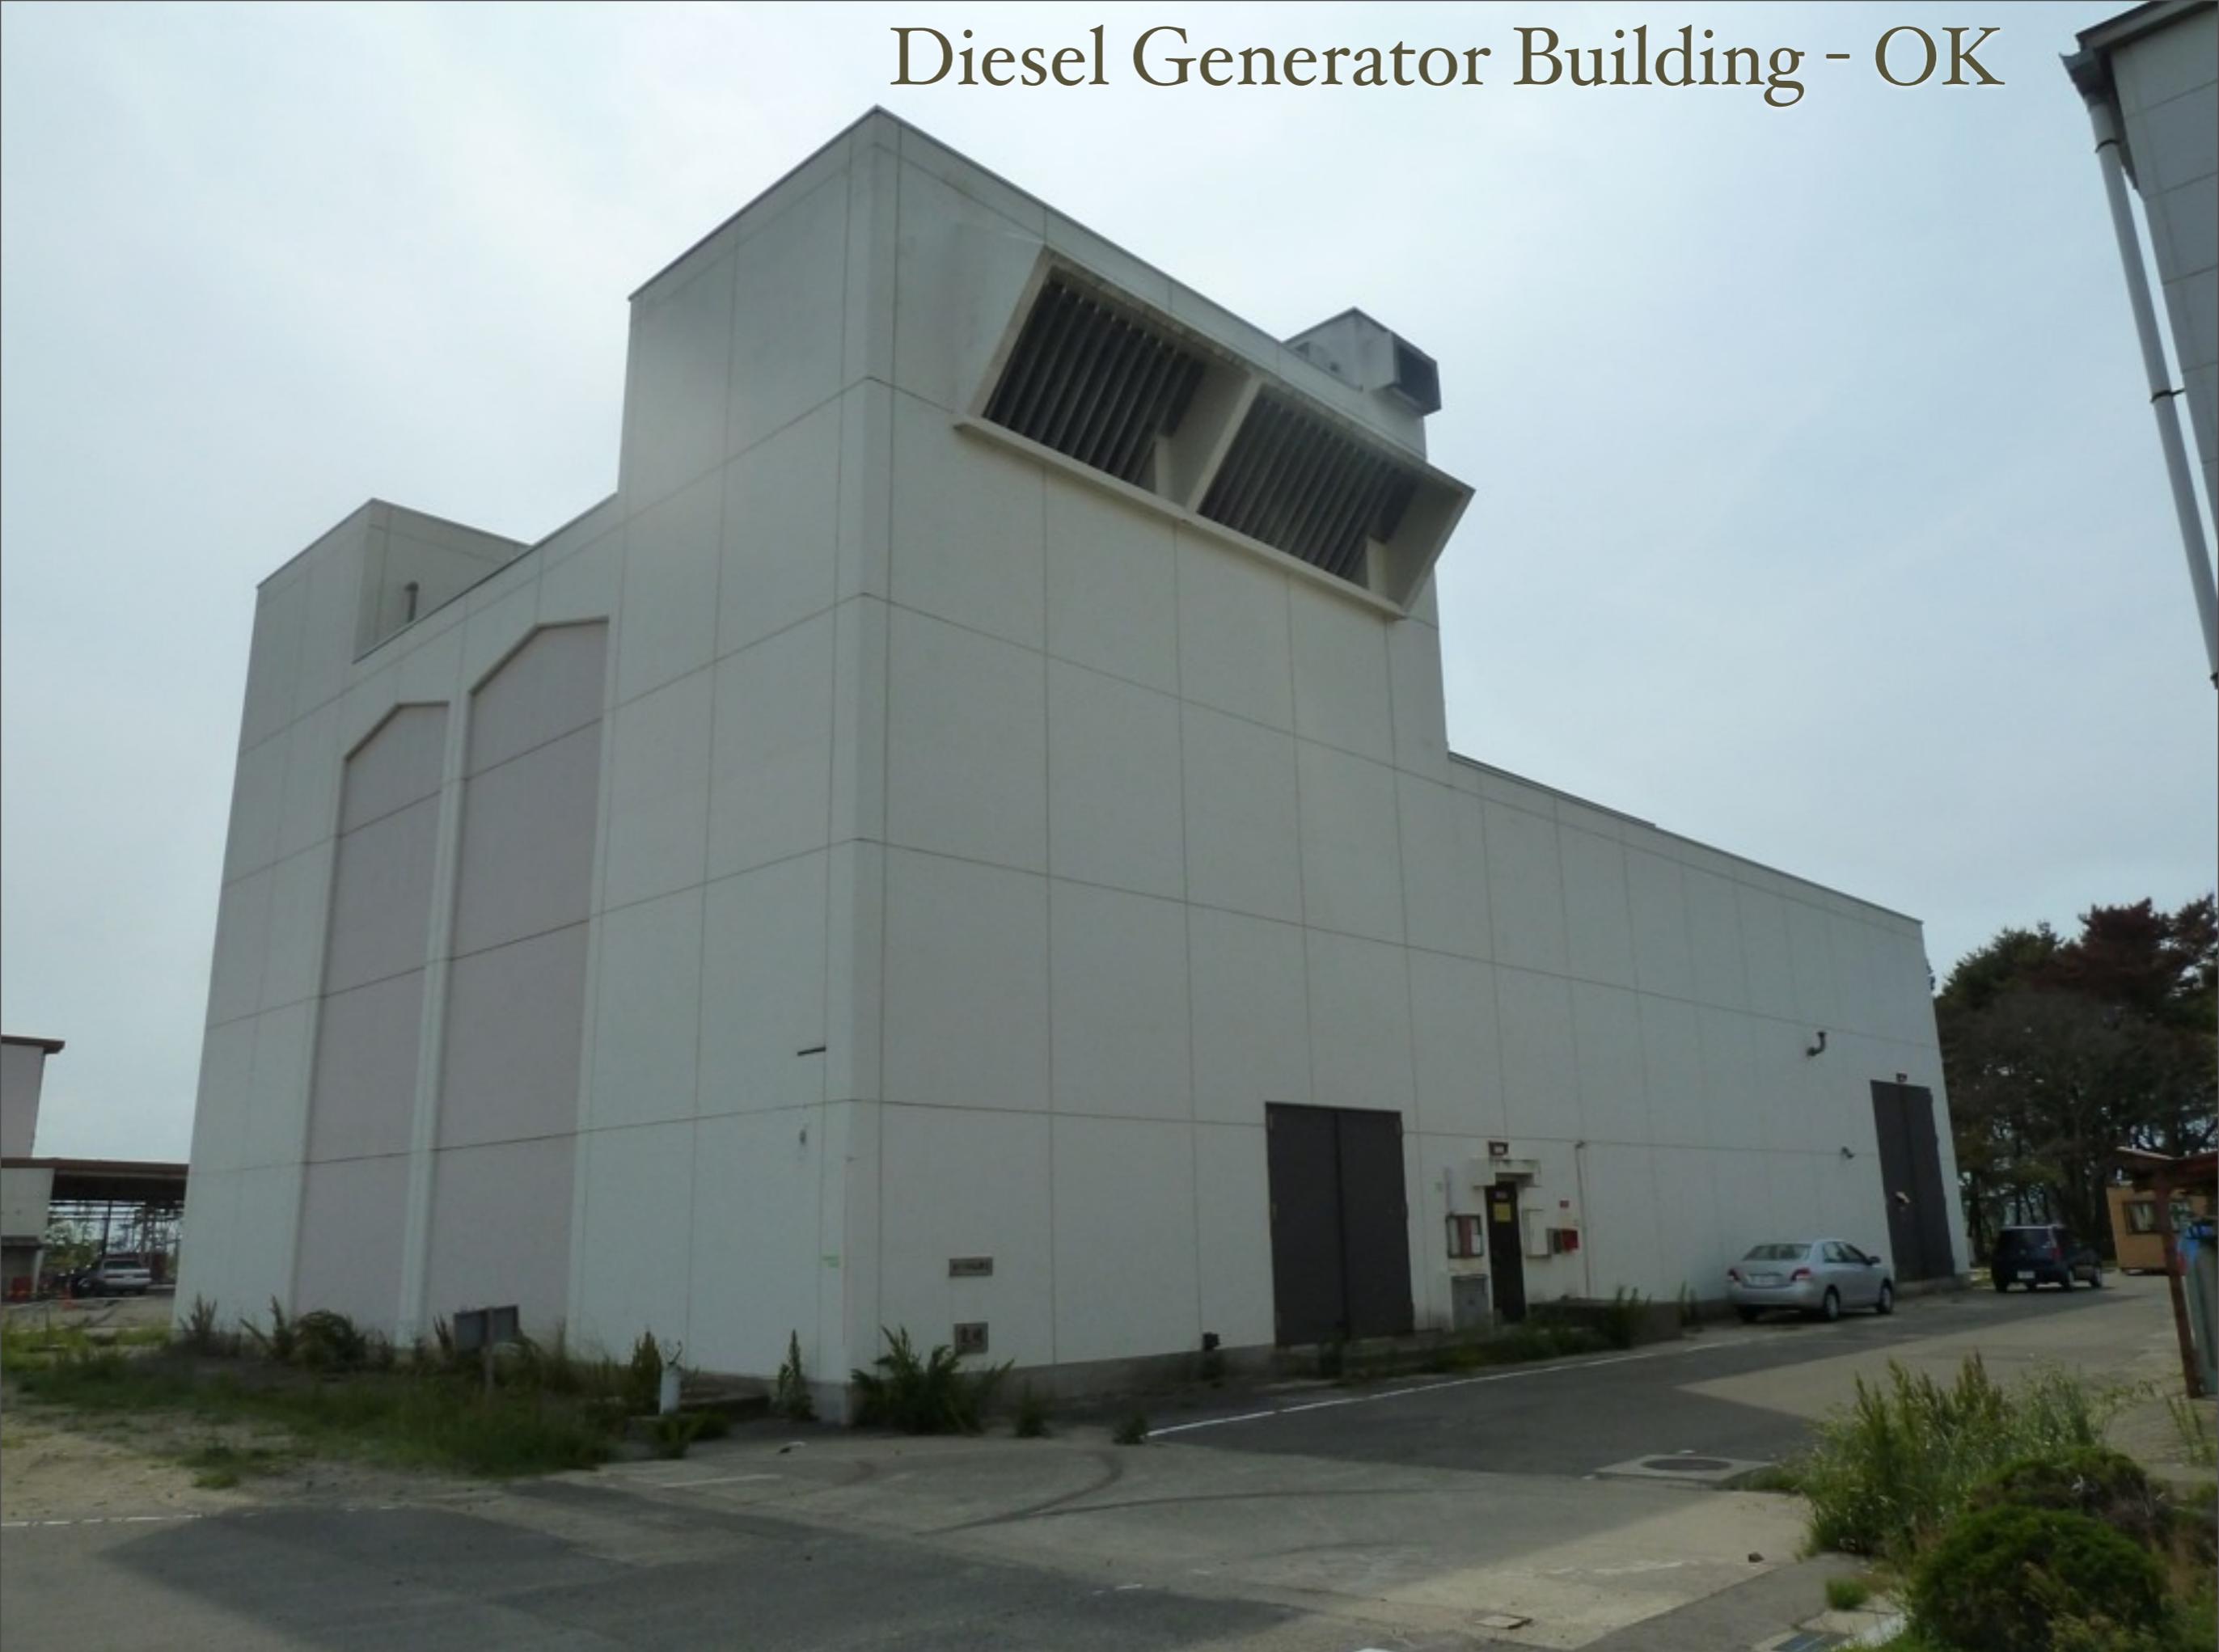
# Diesel Generator Building - OK

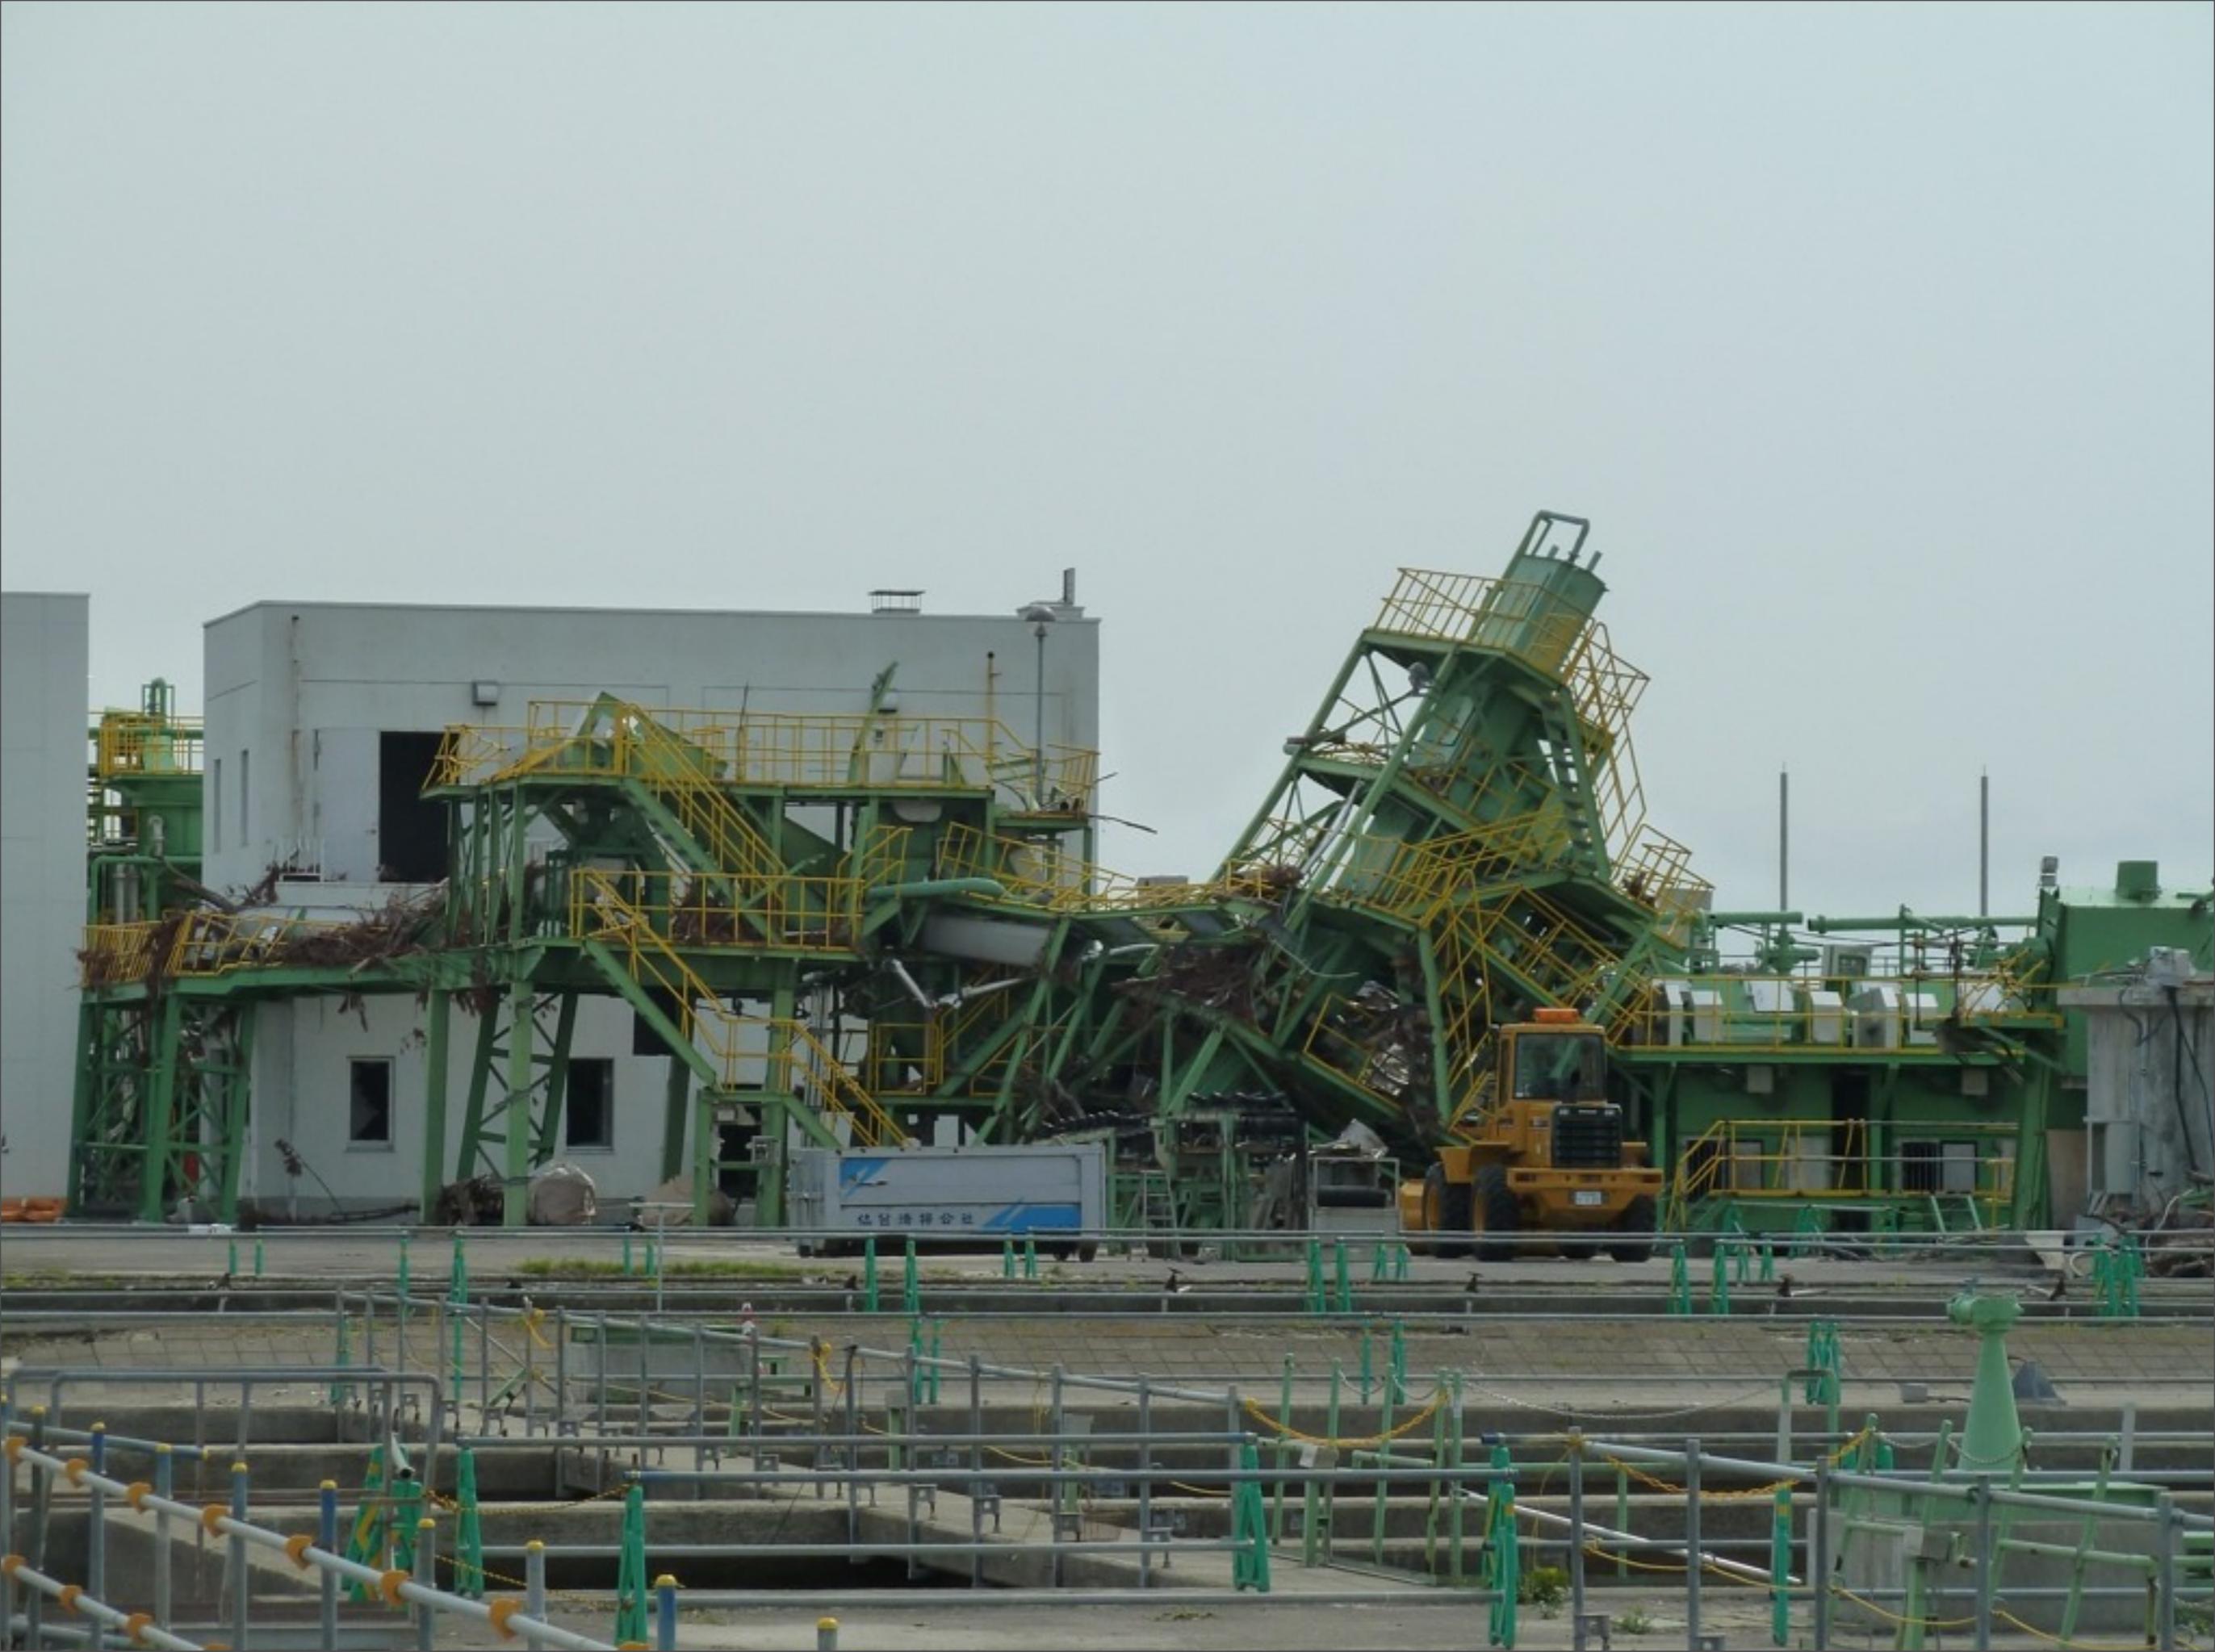
# Foundation bearing failure due to tsunami

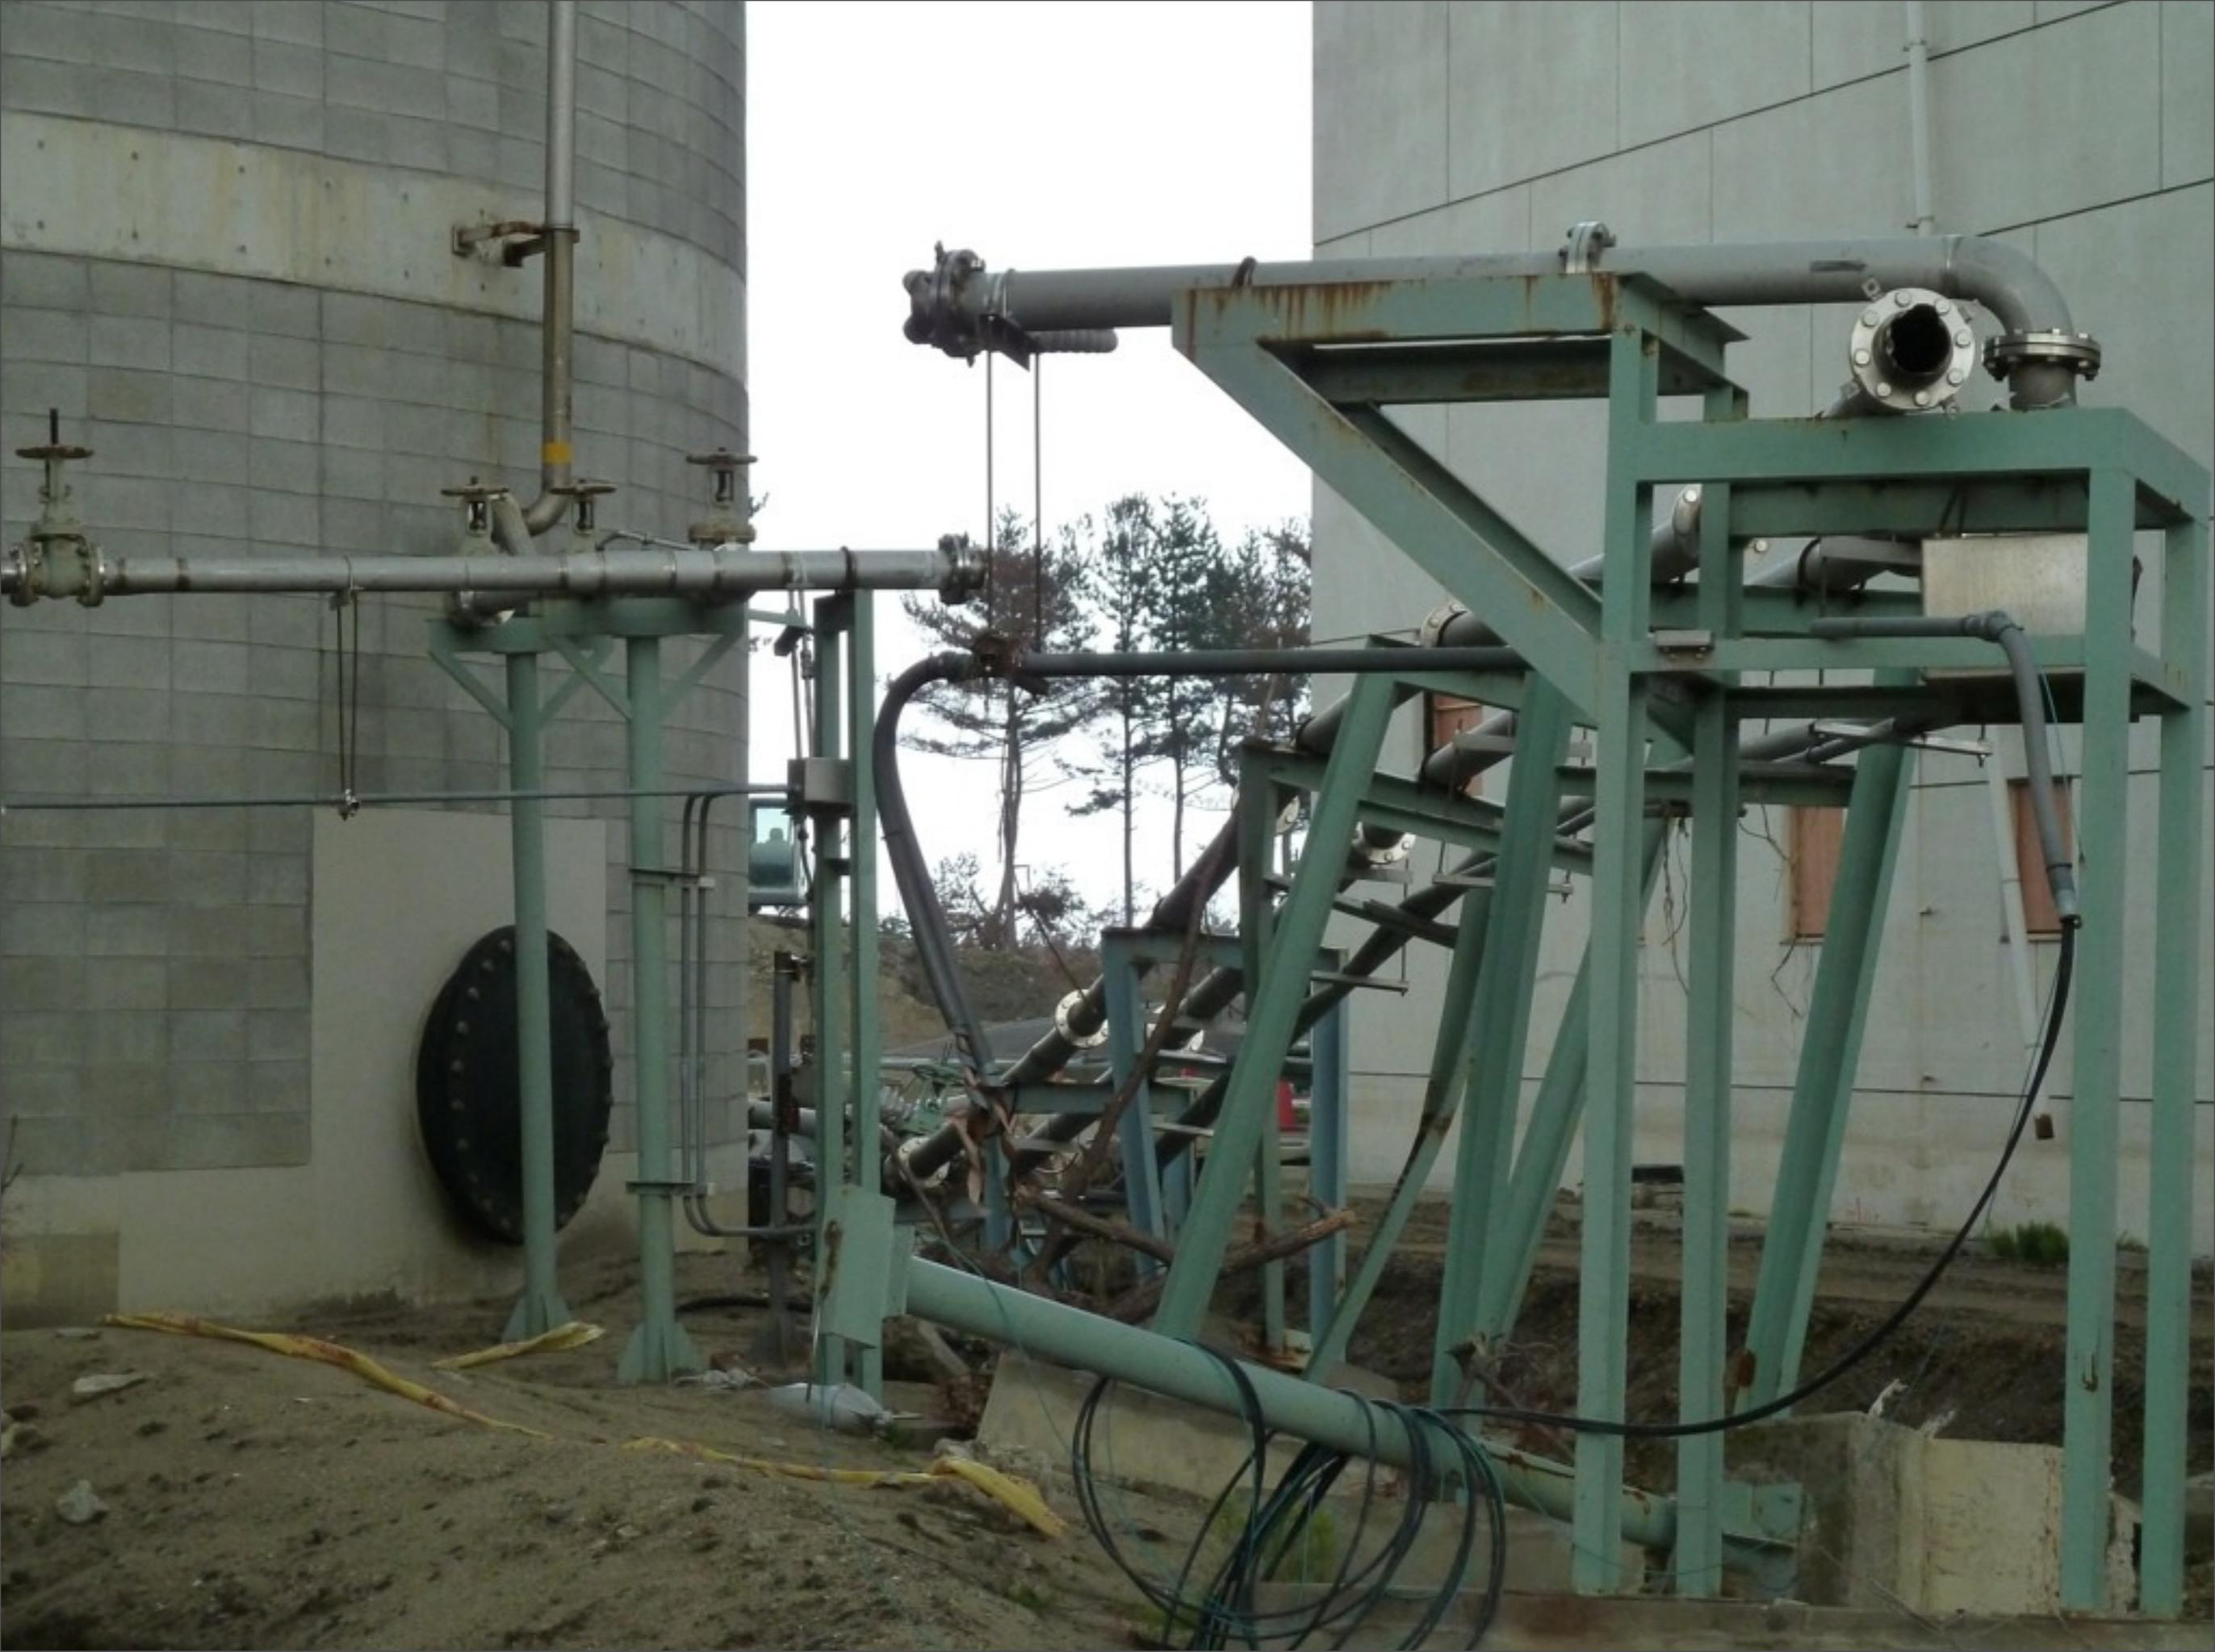
Broken Pipe and Flange
