Magna M 5.7 2020

John Eiding, G&E

October 23 2020

- Magna M 5.7, March 18 2020
- Gas Pipes in Ridgecrest 2019, Alaska 2018, Napa 2014, Eureka 2010, Northridge 1994, Imperial Valley 1979, San Fernando 1971, Long Beach 1933, and others
- Data analysis (fragility)
- The issue of mobile homes and gas meters

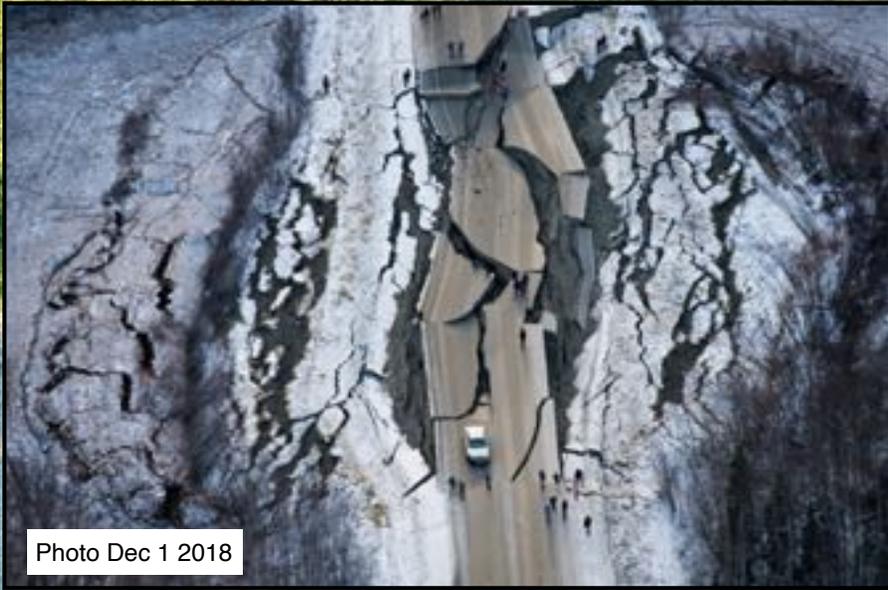
Photo Dec 1 2018

~4.5" x 0.25" steel gas pipe
 No leaks
 Very soft soils ($S_u \sim 300$ psf?)
 Will be Replaced
 Still in service EQ+6 months

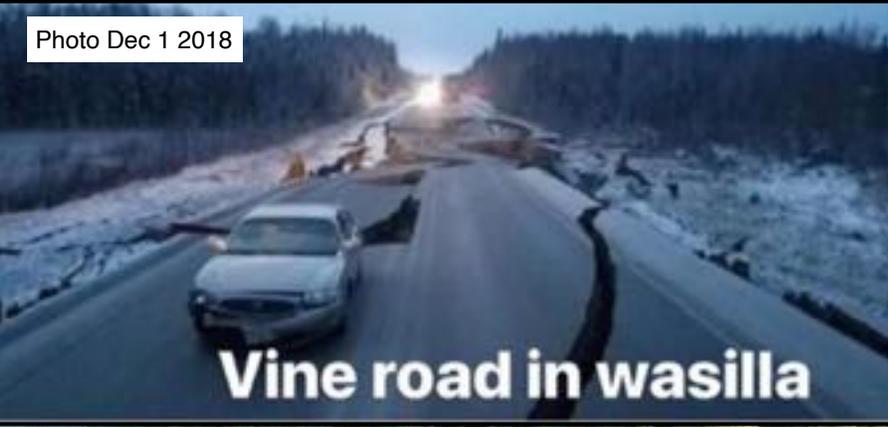
Photo Dec 1 2018

Vine road in wasilla

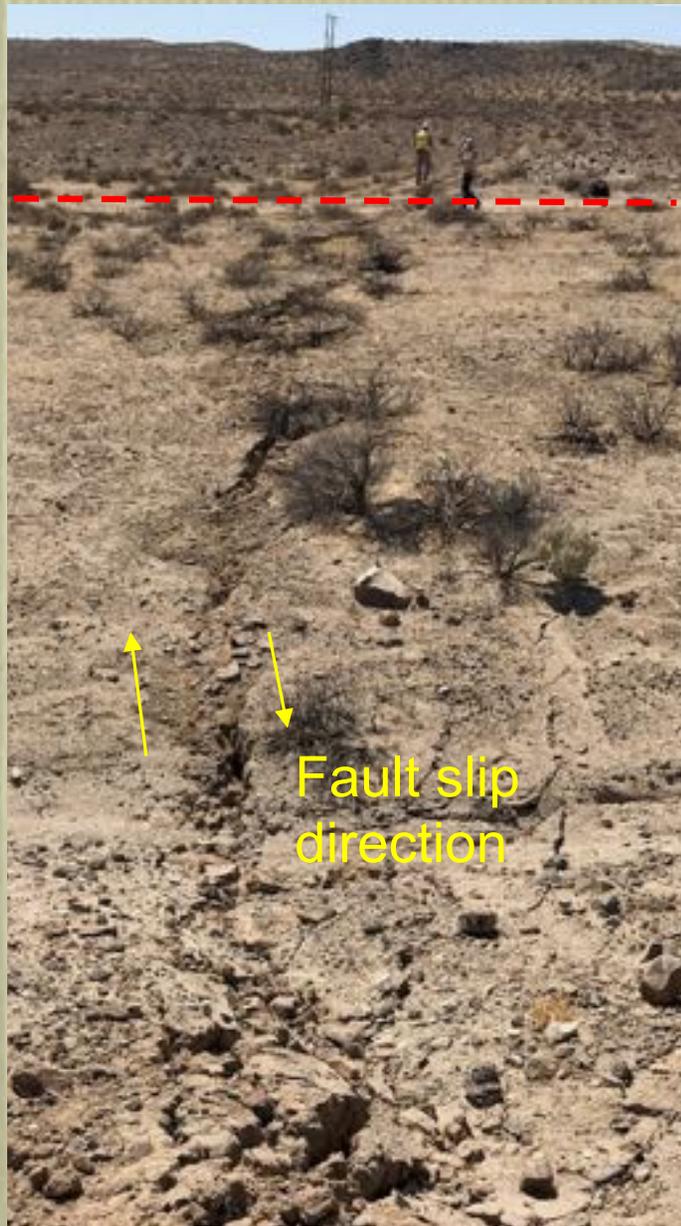
Looking Southeast

Original pipe partially excavated

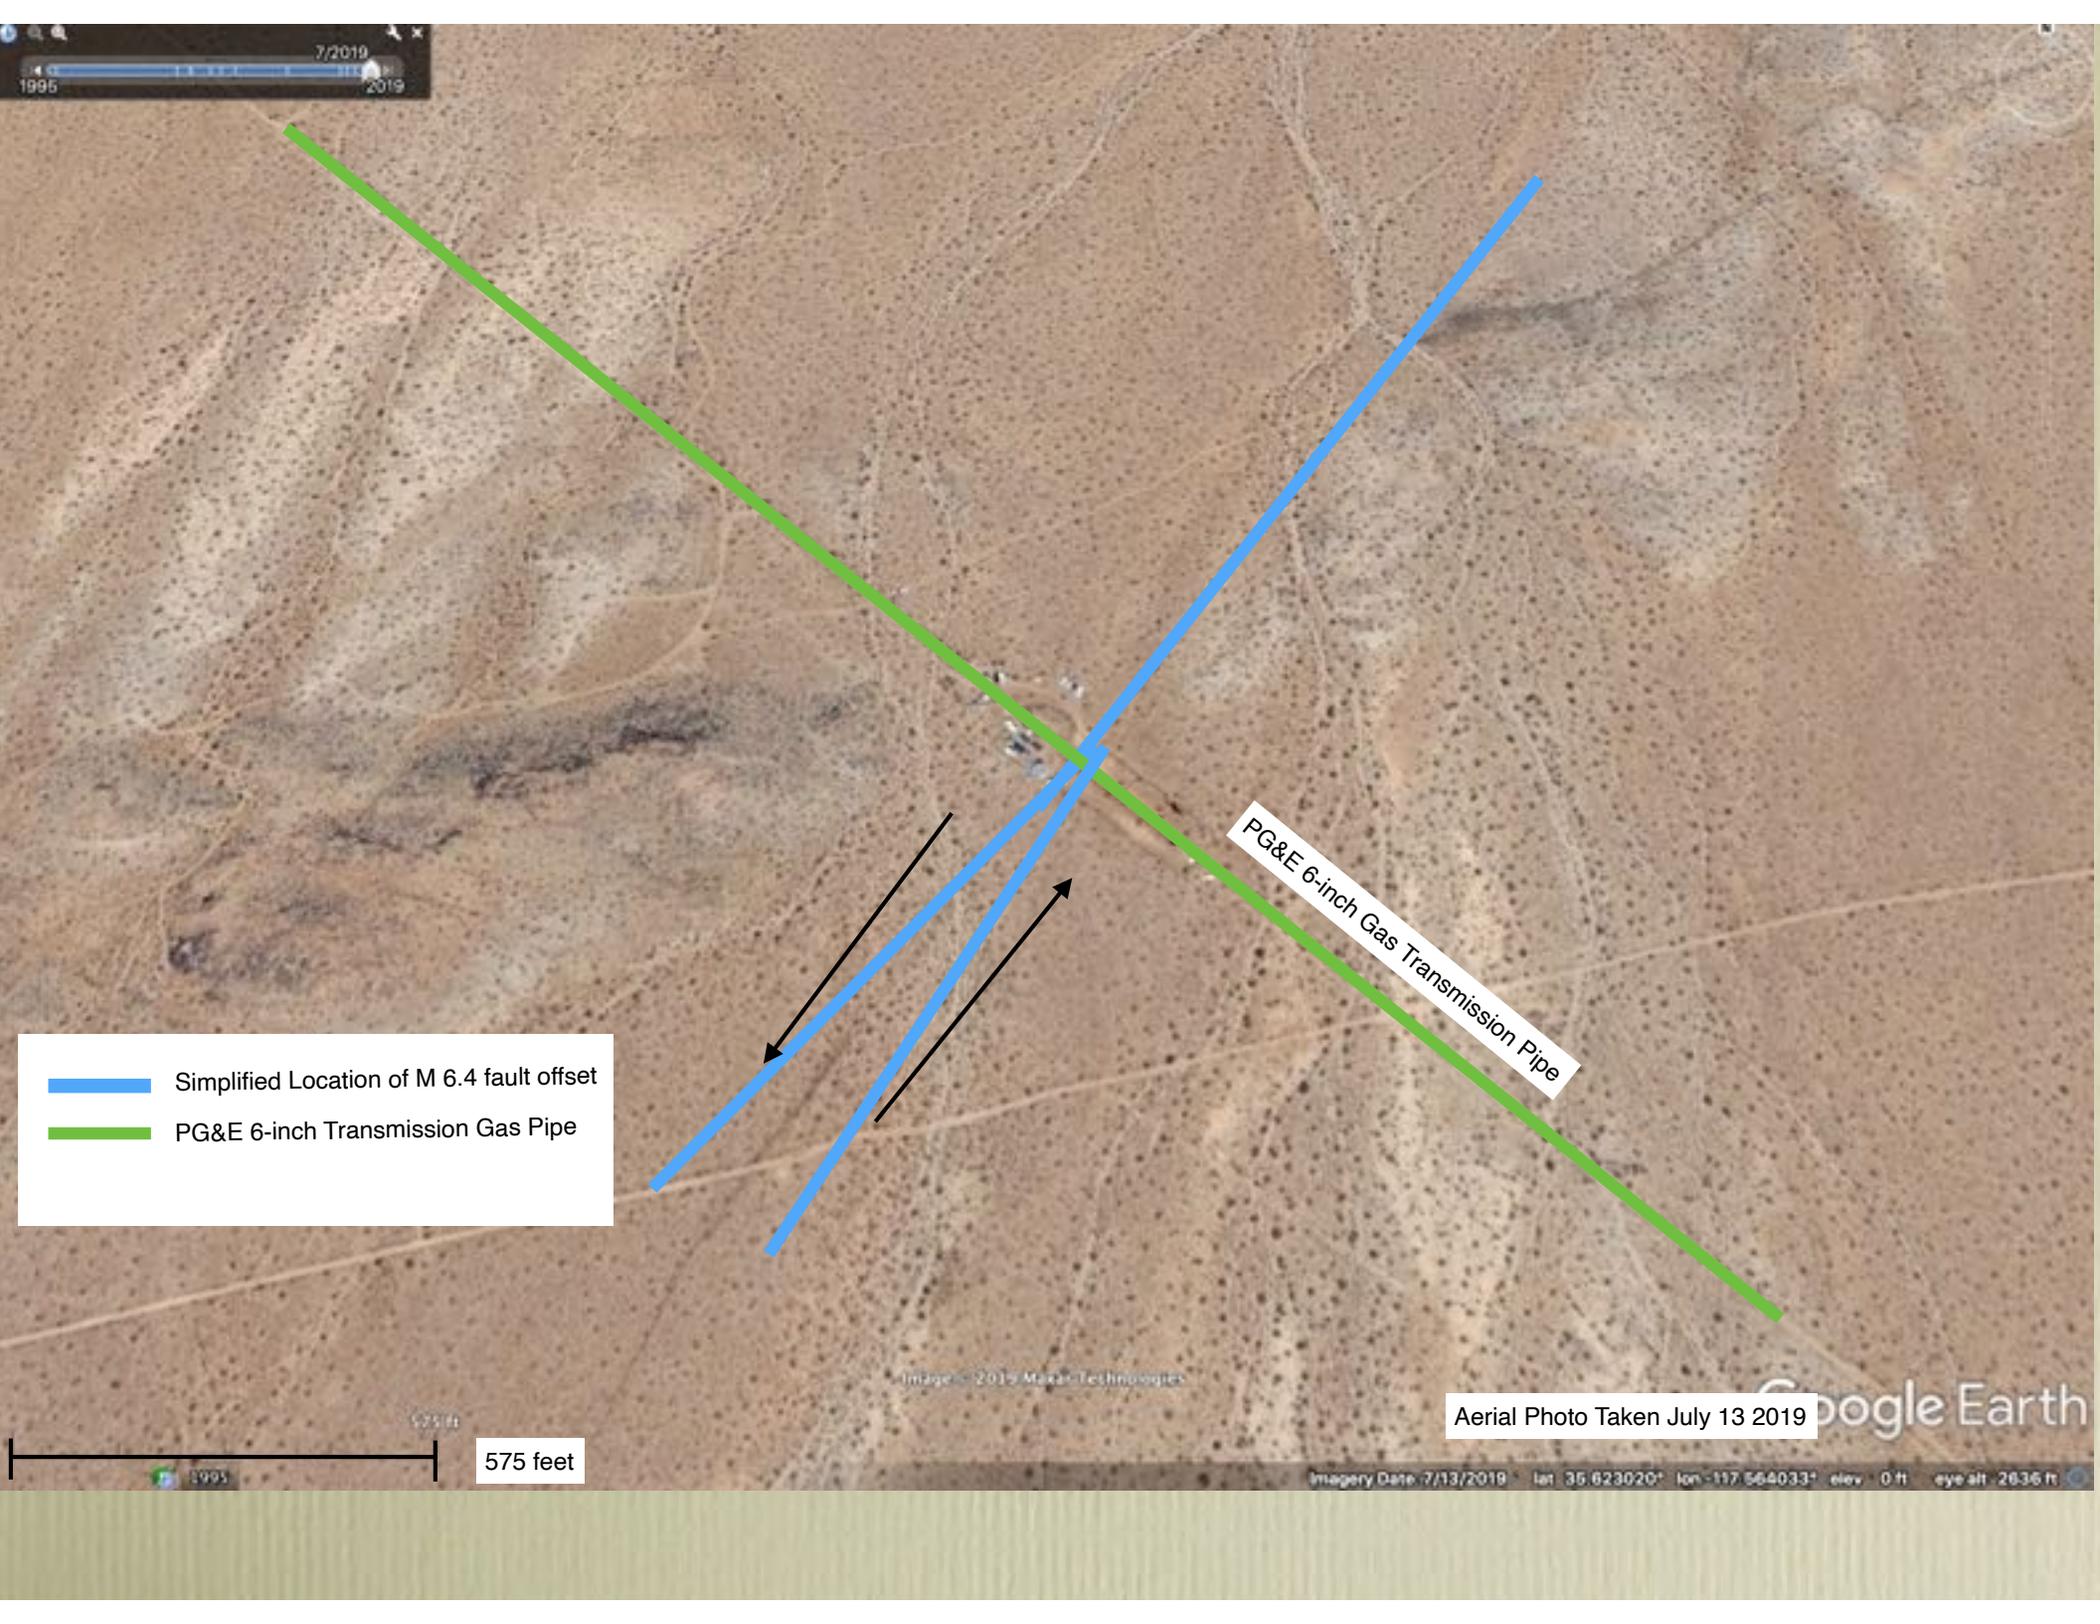
PG&E 6-inch Gas Transmission Pipe

- Simplified Location of M 6.4 fault offset
- PG&E 6-inch Transmission Gas Pipe

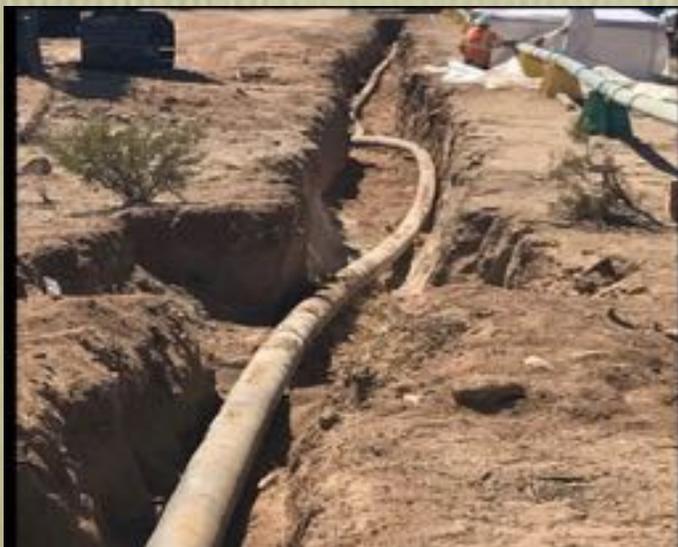
Original pipe partially excavated

Original pipe after fully excavated

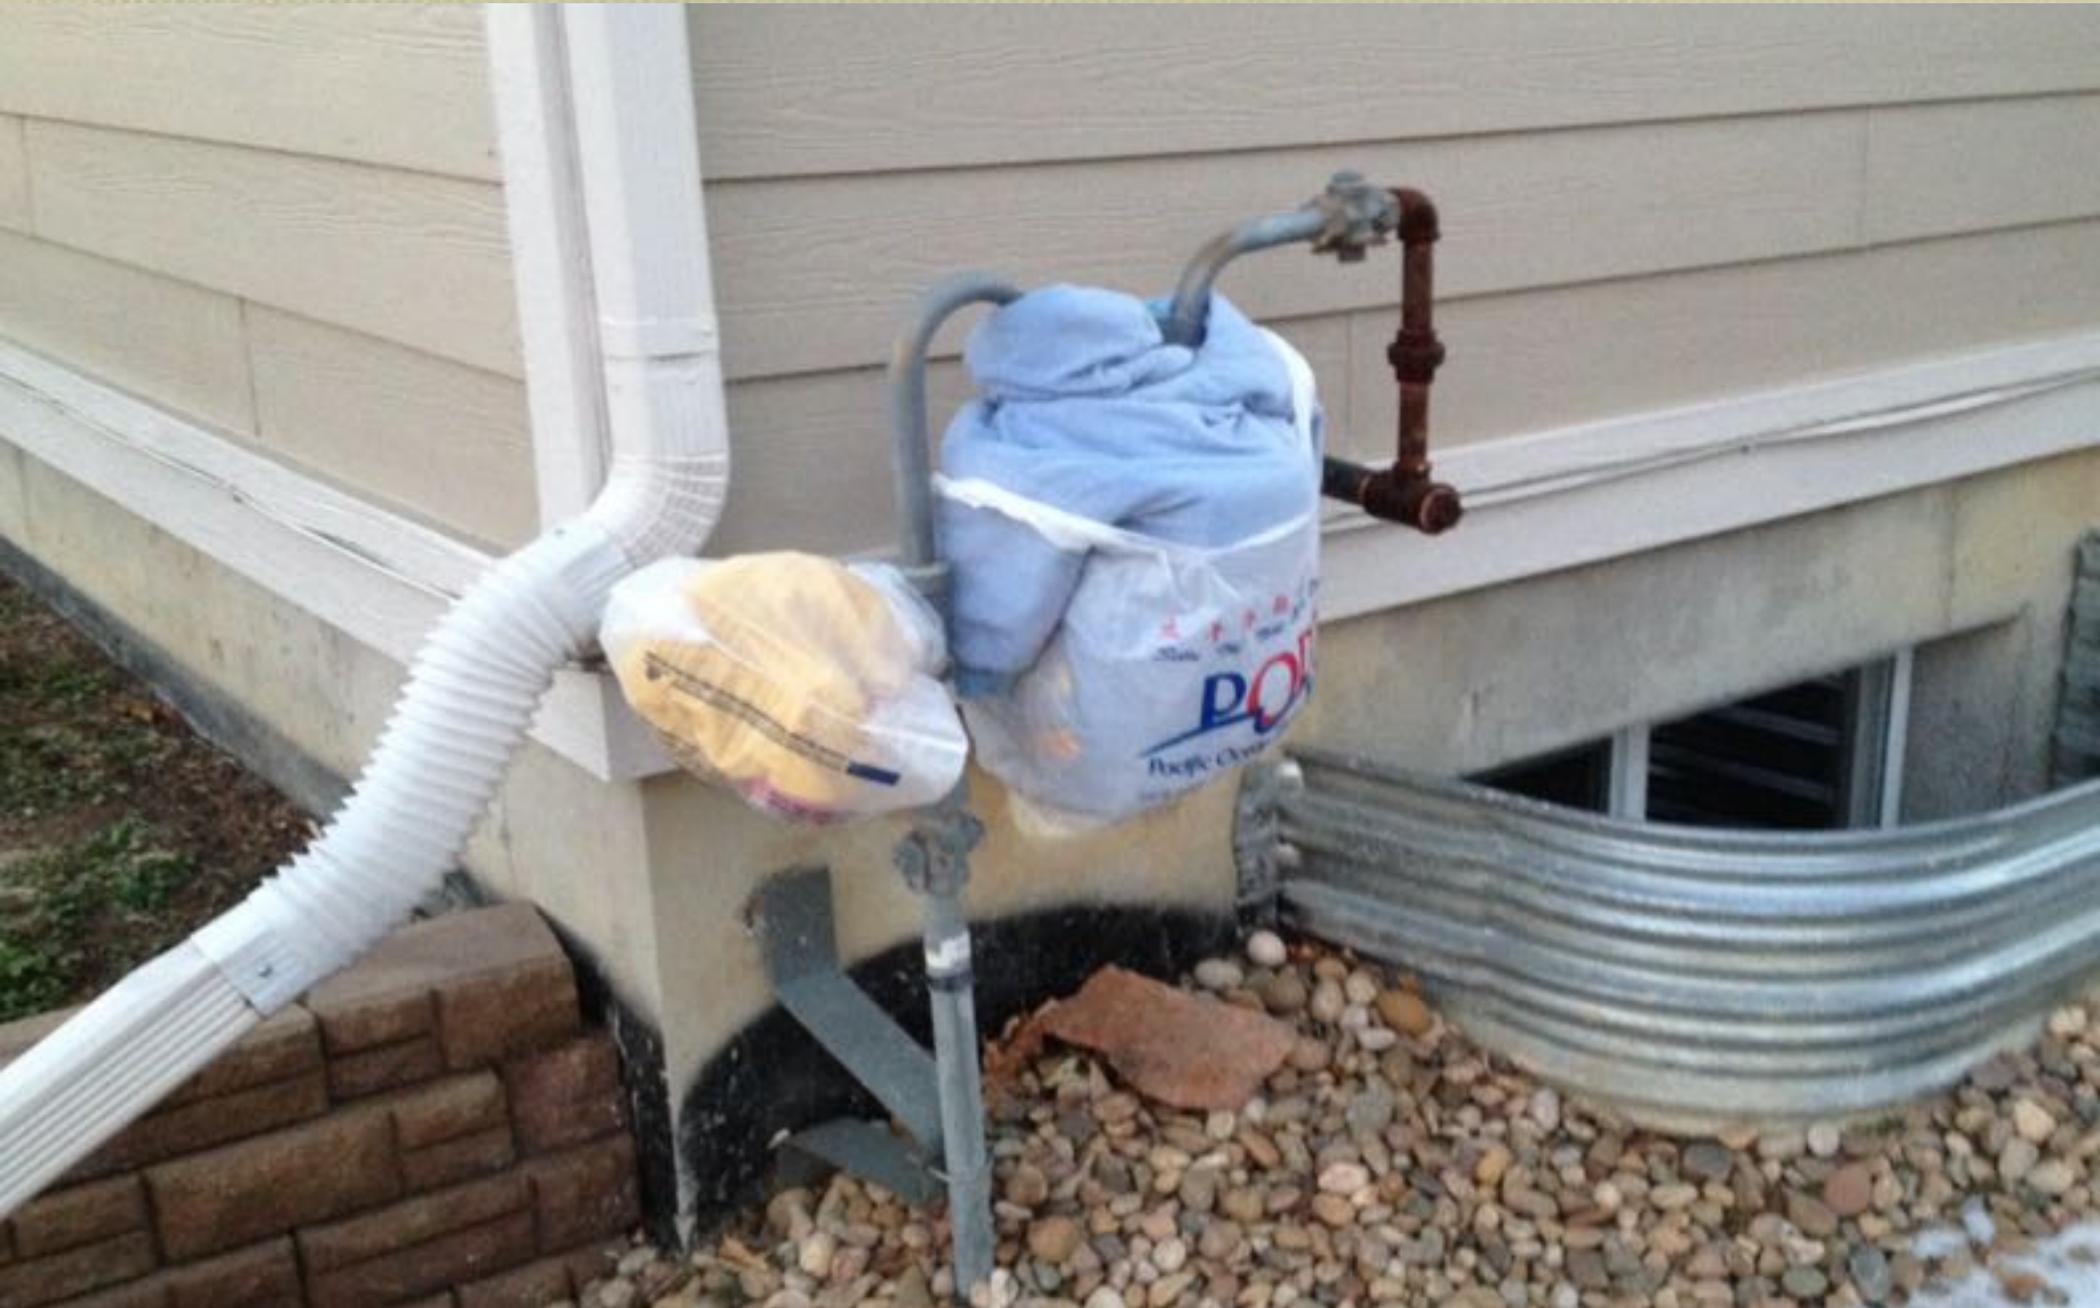
Is this "ideal" if the house slides off its foundation?

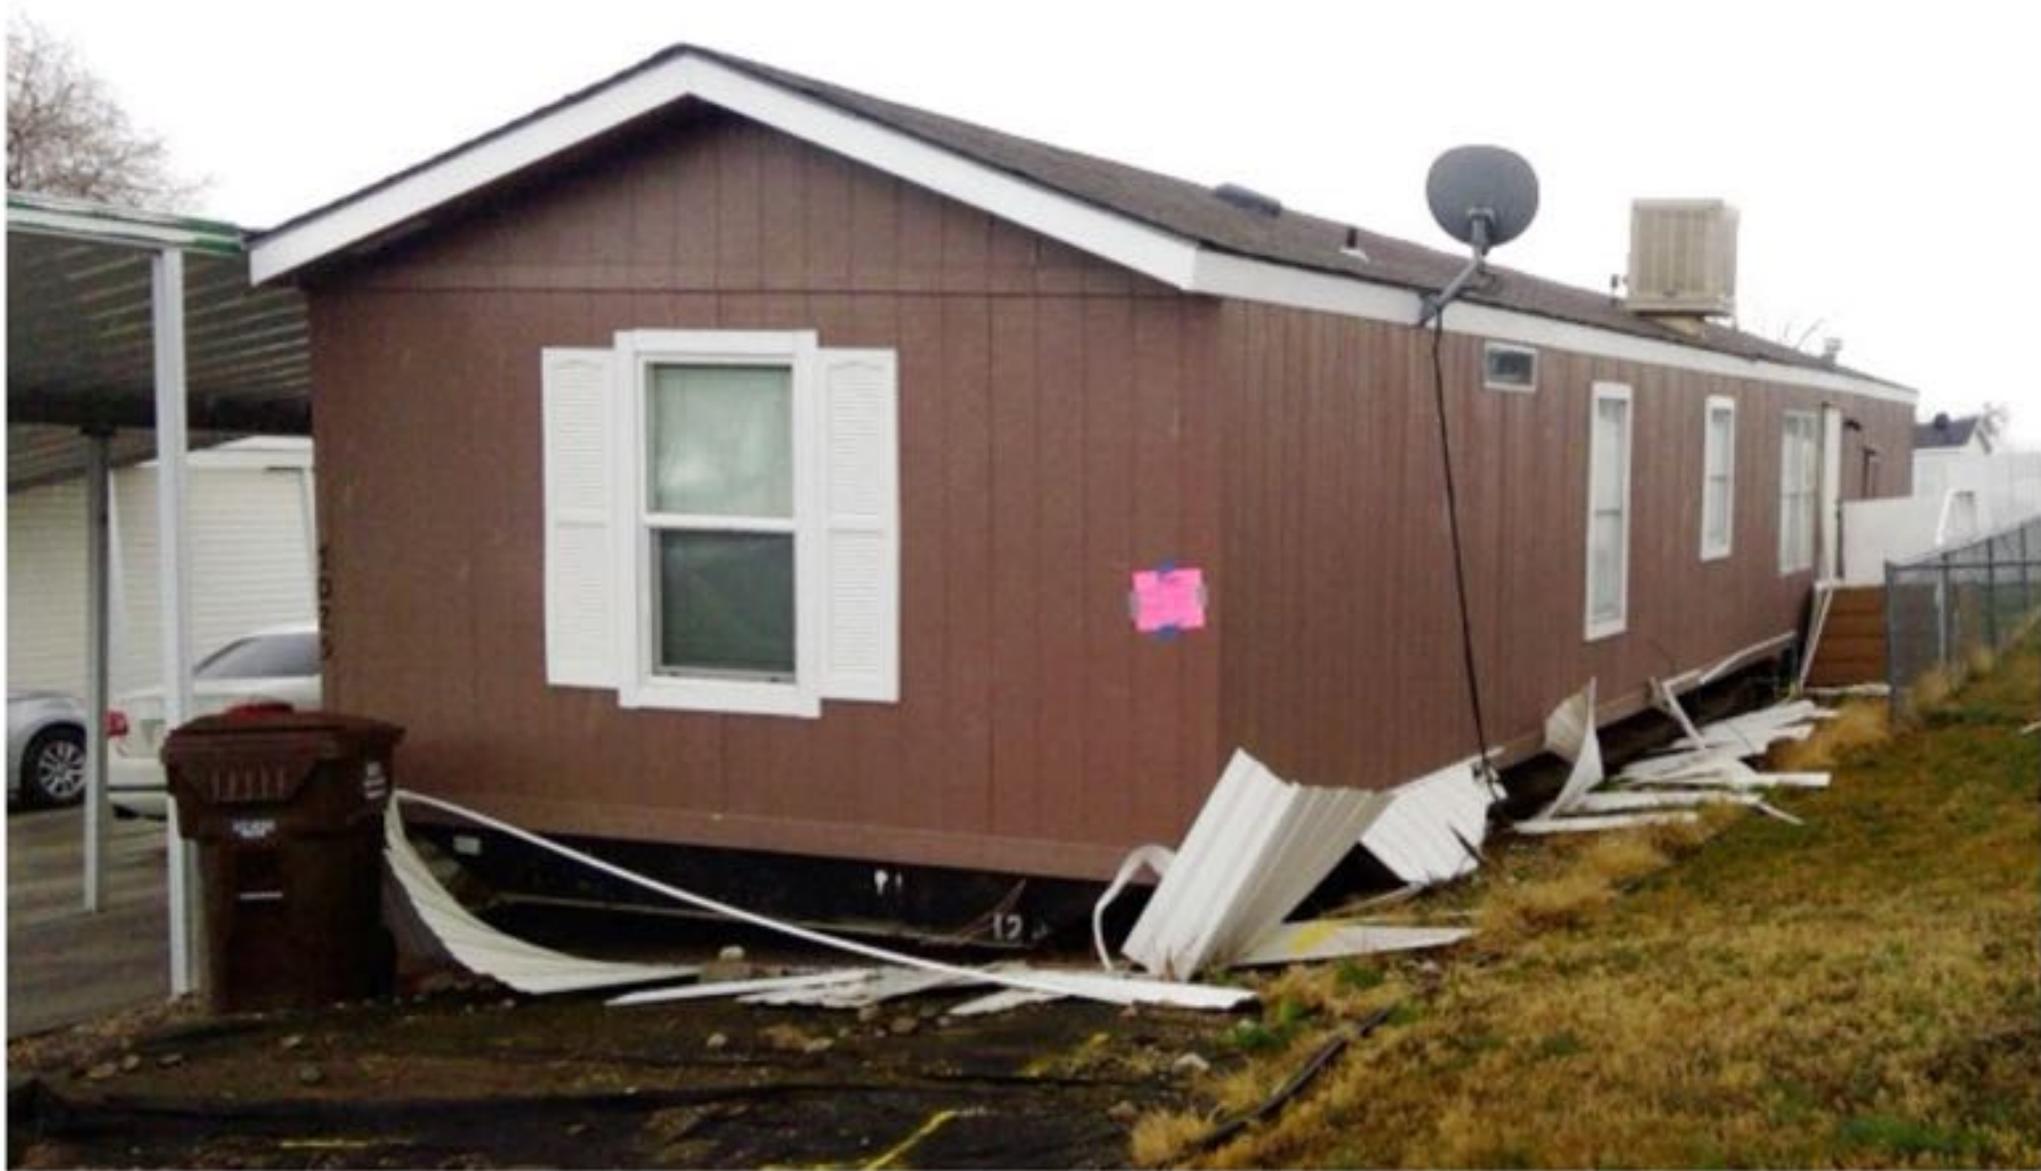
Single-Wide Home

Underneath Home

Chassis Girder

Broken Strap
